# SITE HAZARD ASSESSMENT

## Worksheet 1

### Summary Score Sheet

Marine Lumber Service S. Monroe R-O-W  
525 S. Chicago St  
Seattle, King County, WA 98108

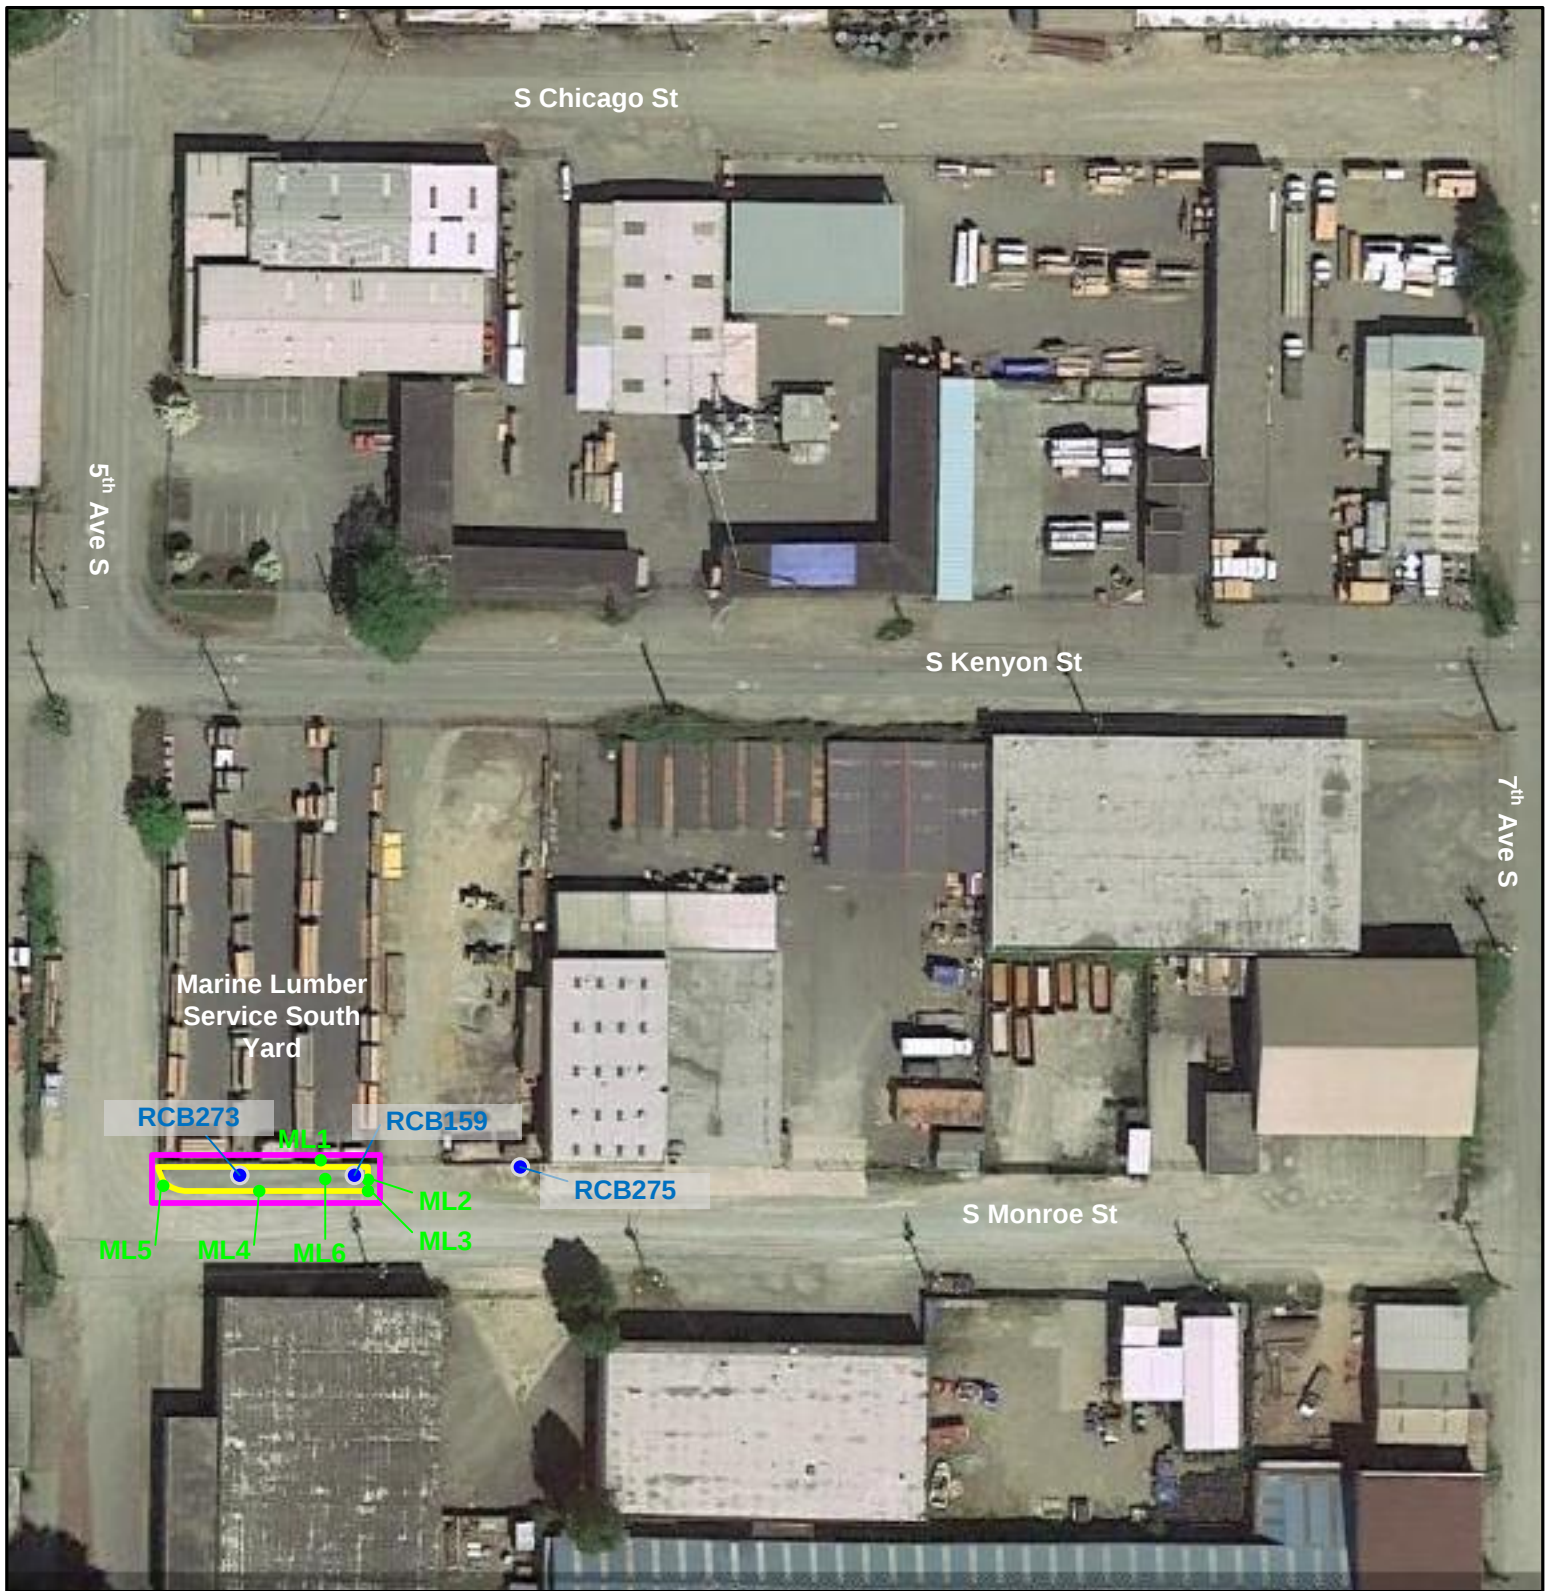
- Property location (approximate)
- Excavation area (approximate)
- Pre-excitation soil/solids sample (approximate)
- Post-excitation soil sample (approximate)

Soil samples were collected during source control investigation activities conducted by SPU after wood preservative staining was observed on pavement on the Marine Lumber Service property at 7915 5th Ave South (the South Yard, CSID 8993) and was suspected to have run off the South Yard and onto the Site. Concentrations of arsenic in soil were present above the MTCA Method A cleanup level in the city-owned right-of-way adjacent to the Marine Lumber Service Property.
