# MEMORANDUM

Project No.: 110125

**Re: Lora Lake Pump Down/Pump-back Test Memorandum**

This memorandum summarizes the Lora Lake pump down/pump-back test activities performed by Aspect Consulting, LLC (Aspect) and Port of Seattle (Port) representatives, and describes observed groundwater and surface water conditions in the vicinity of Lora Lake. This memorandum was revised to incorporate additional information provided by Port representatives.

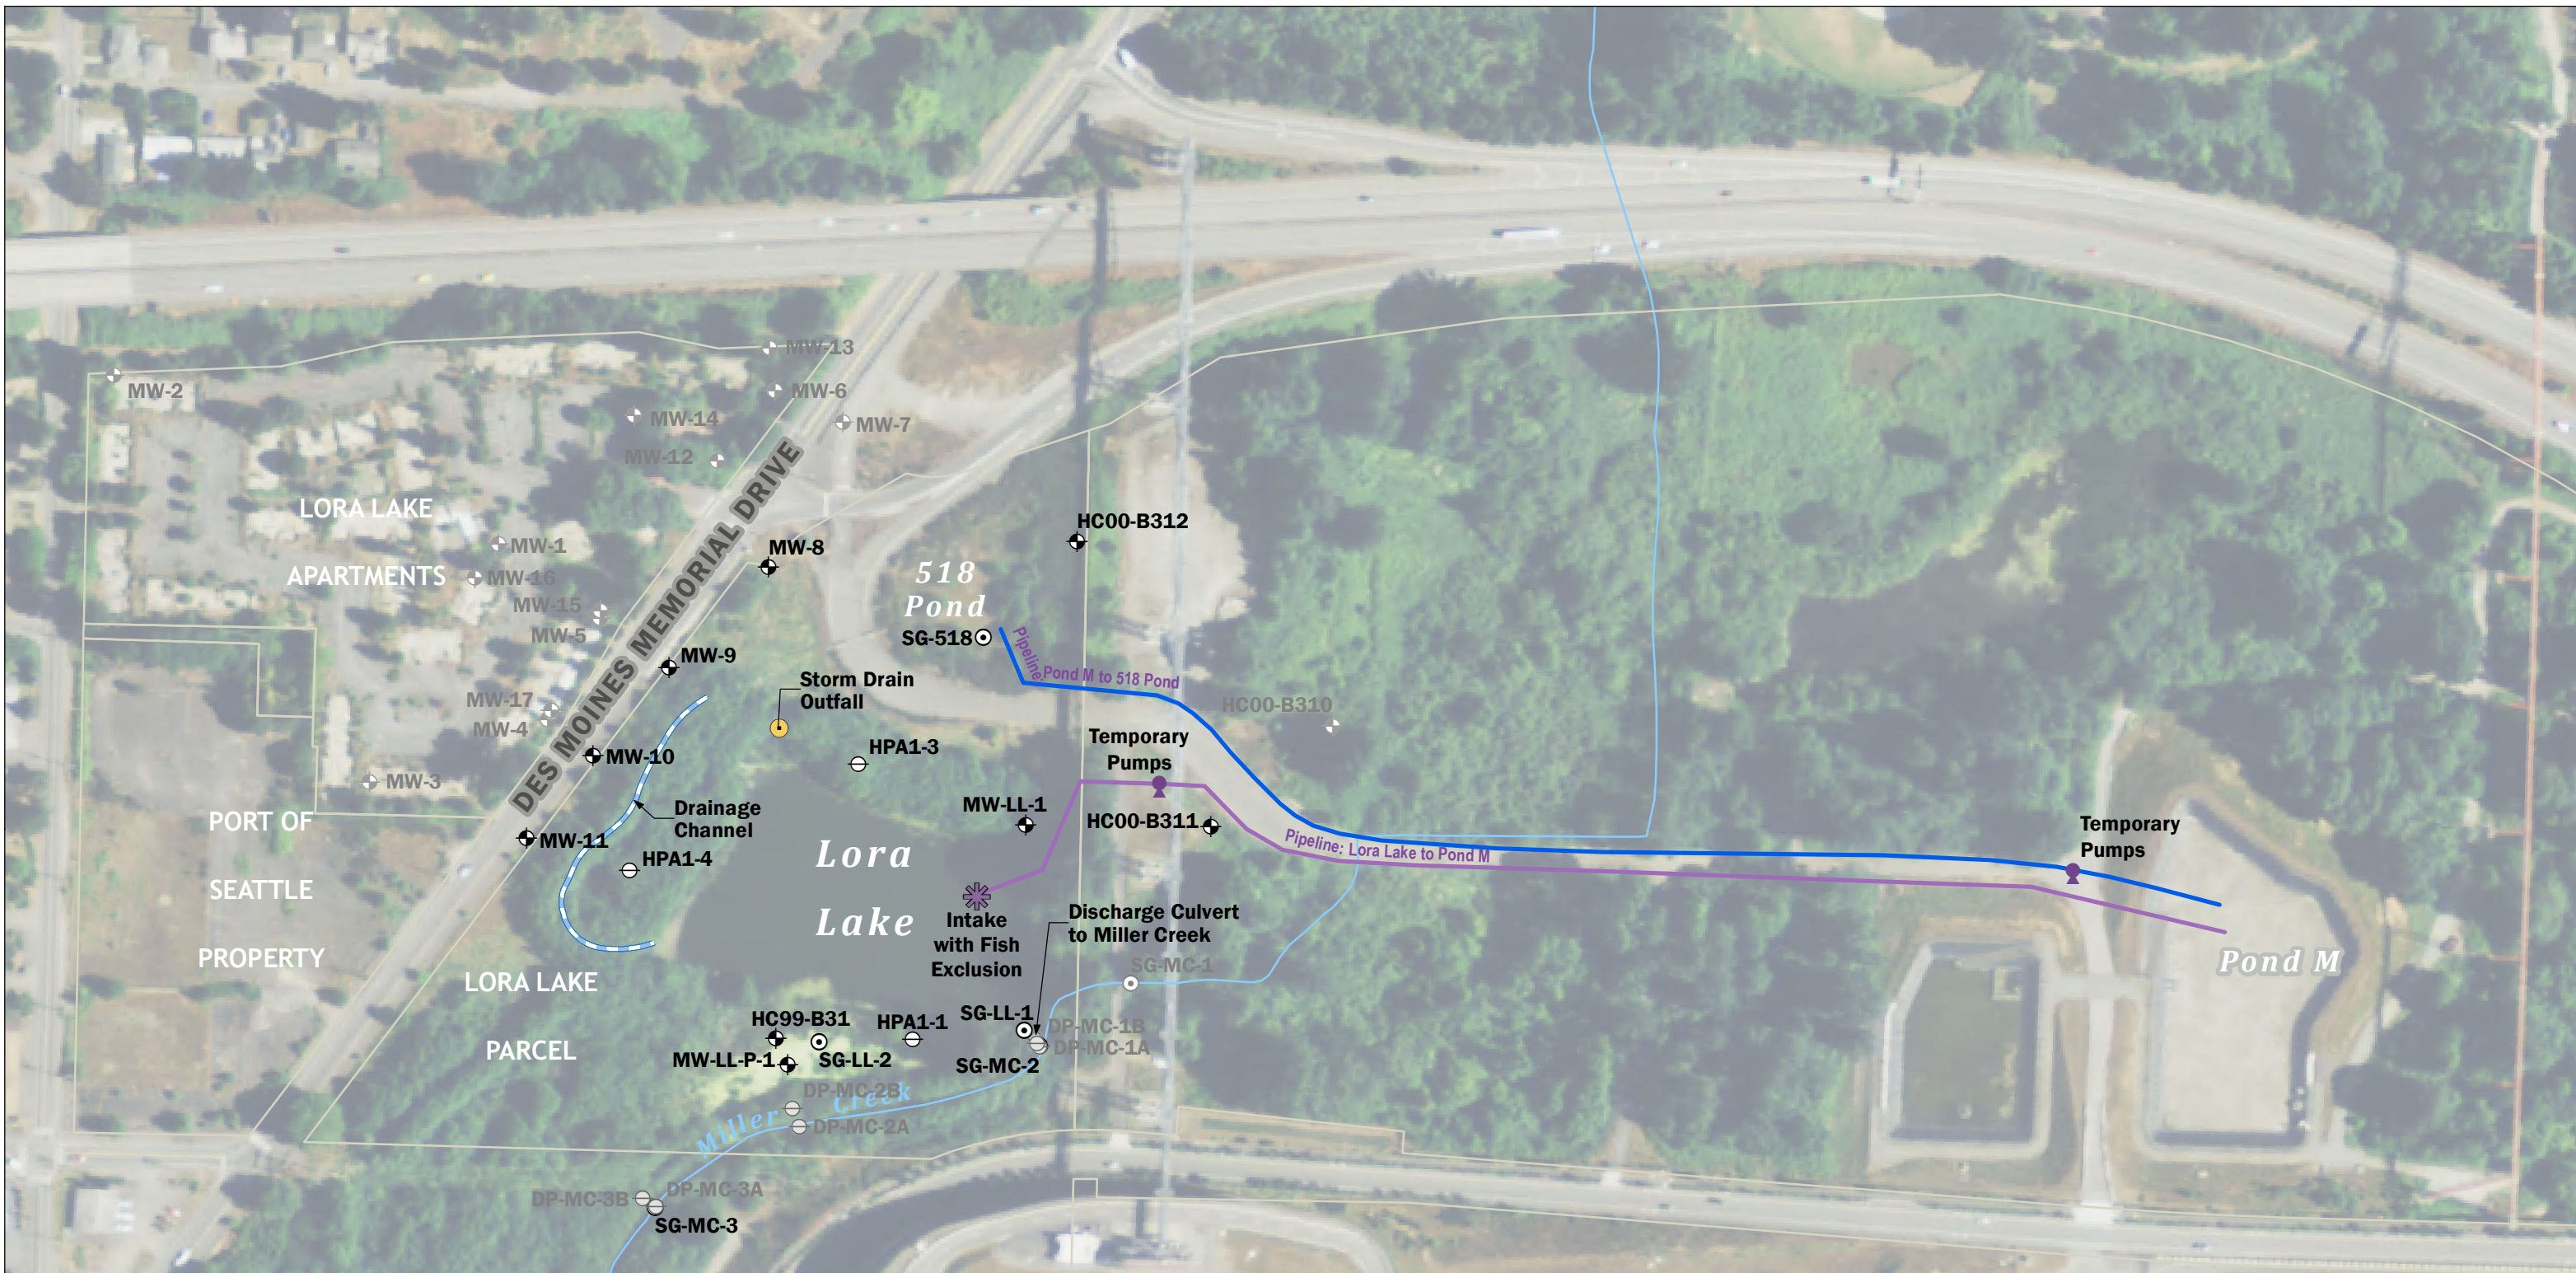
**Site Map**  
Lora Lake Test Memo  
Burien, WA

- 1) Rock berm location digitized based on 1985 aerial photo of parcel.
- 2) Location of drainage channel is approximate and is based on the apparent location of the channel as inferred from a 2009 United States Geological Survey aerial photograph of parcel.
- 3) Wetlands south of Lora Lake seasonally discharge to the lake.
- 4) Groundwater elevations for HC00 wells were derived from LiDAR ground elevations.
