RESPONSIVENESS SUMMARY

SeaTac Development (aka MasterPark Lot C) Site Remedial Investigation/Feasibility Study Report, Draft Cleanup Action Plan, and SEPA Determination

October 2011

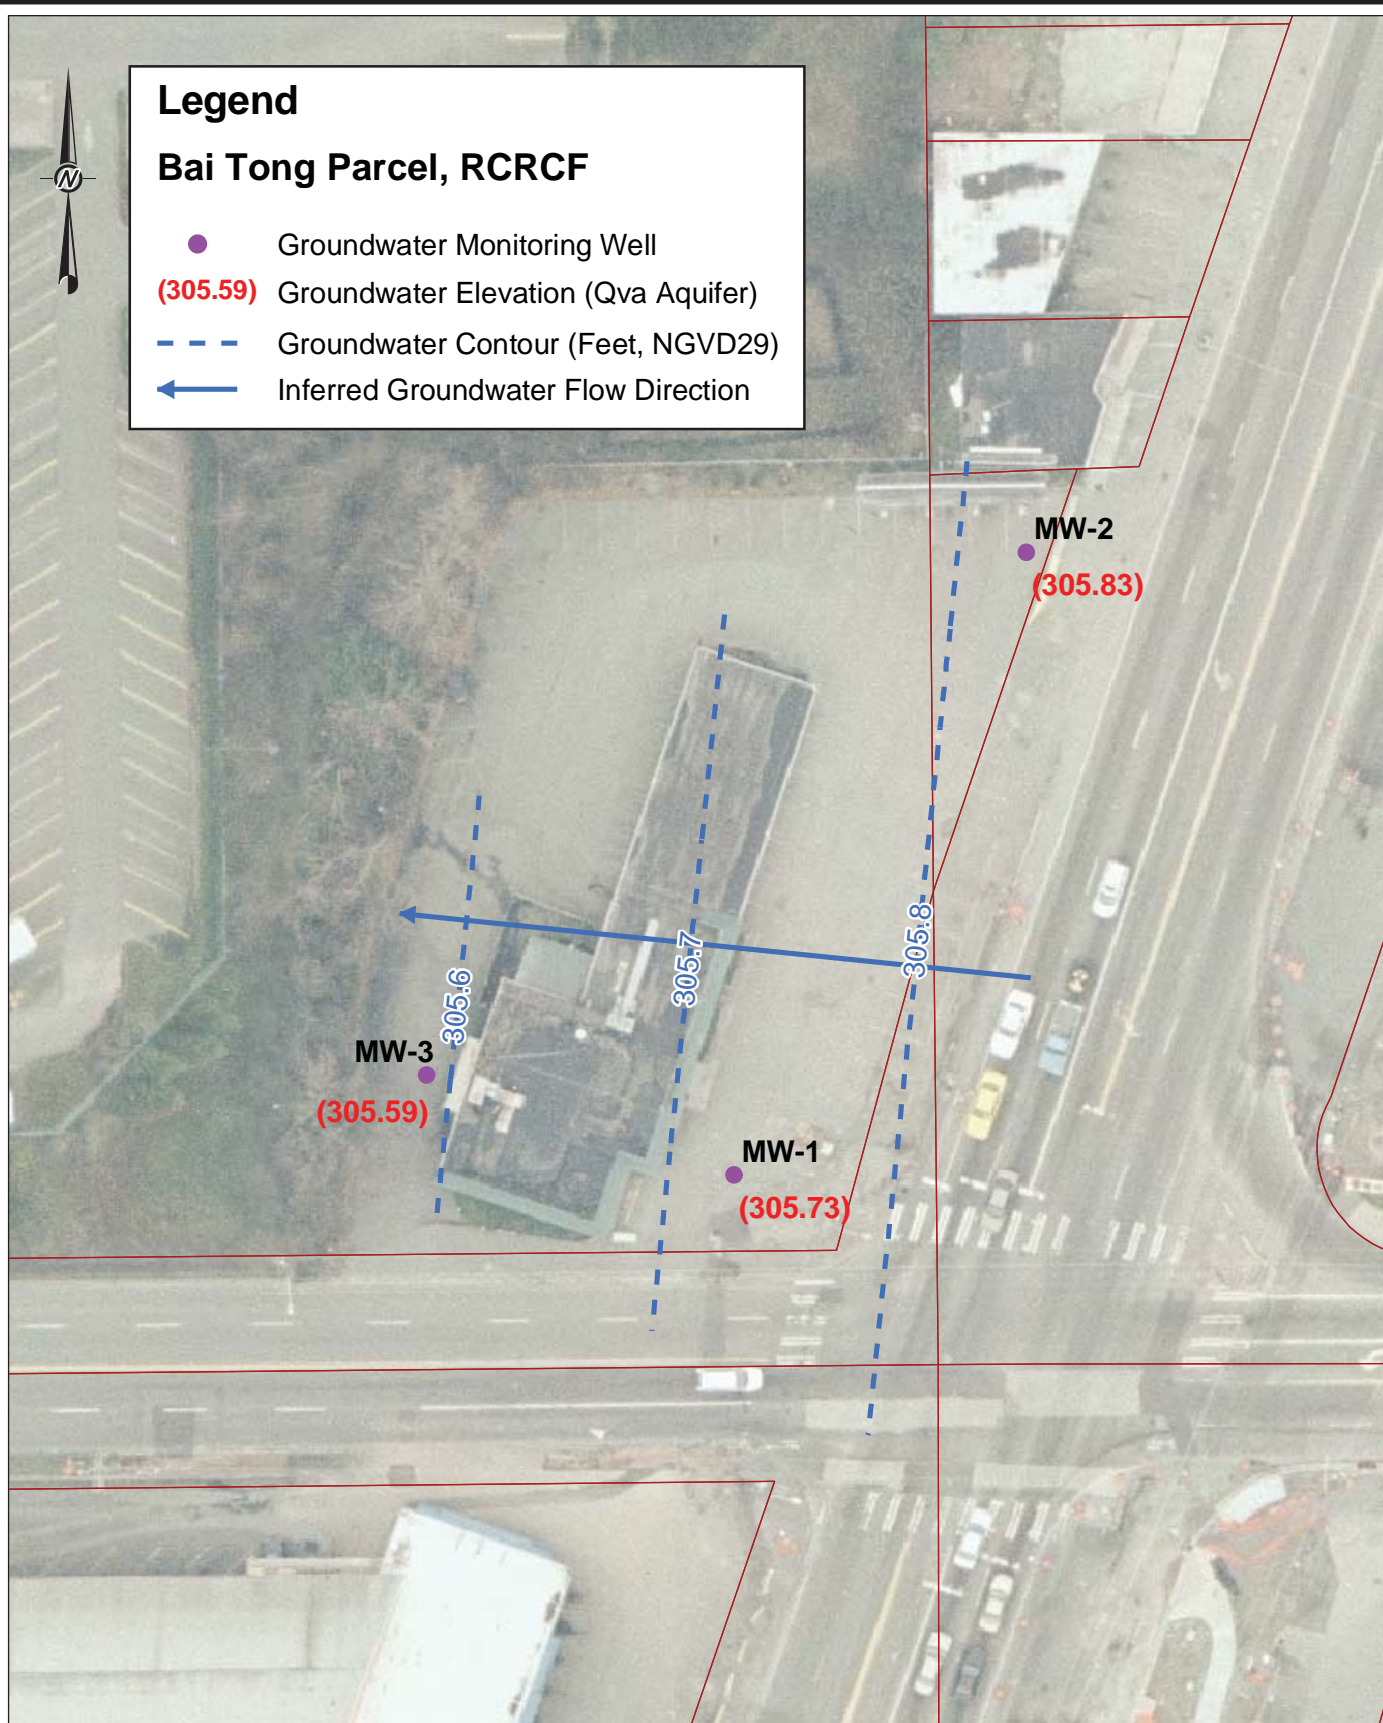
- Groundwater Monitoring Well
- (305.59) Groundwater Elevation (Qva Aquifer)
- - - Groundwater Contour (Feet, NGVD29)
- ← Inferred Groundwater Flow Direction

Source: EMS, May 2004

FIGURE 2
**GROUNDWATER FLOW DIRECTION
ON THE PORT OF SEATTLE
PROPERTY IN 2004**
RW/MASTERPARK LOT C RI/FS & REMED/WA

RESPONSE: A previous groundwater investigation by the Port of Seattle in 2004 was conducted north of South 160th Street near the intersection of South 160th Street and International Boulevard (EMS 2004). The Port of Seattle installed monitoring wells Port MW-1, Port MW-2, and Port MW-3 shown on the attached Figure 2 (as also depicted on Figure 4 of the Draft CAP). The Port of Seattle
