## TECHNICAL MEMORANDUM

**RE: ADDENDUM TO SEATAC DEVELOPMENT SITE RI/FS AND DRAFT CAP**

### 1.0 INTRODUCTION

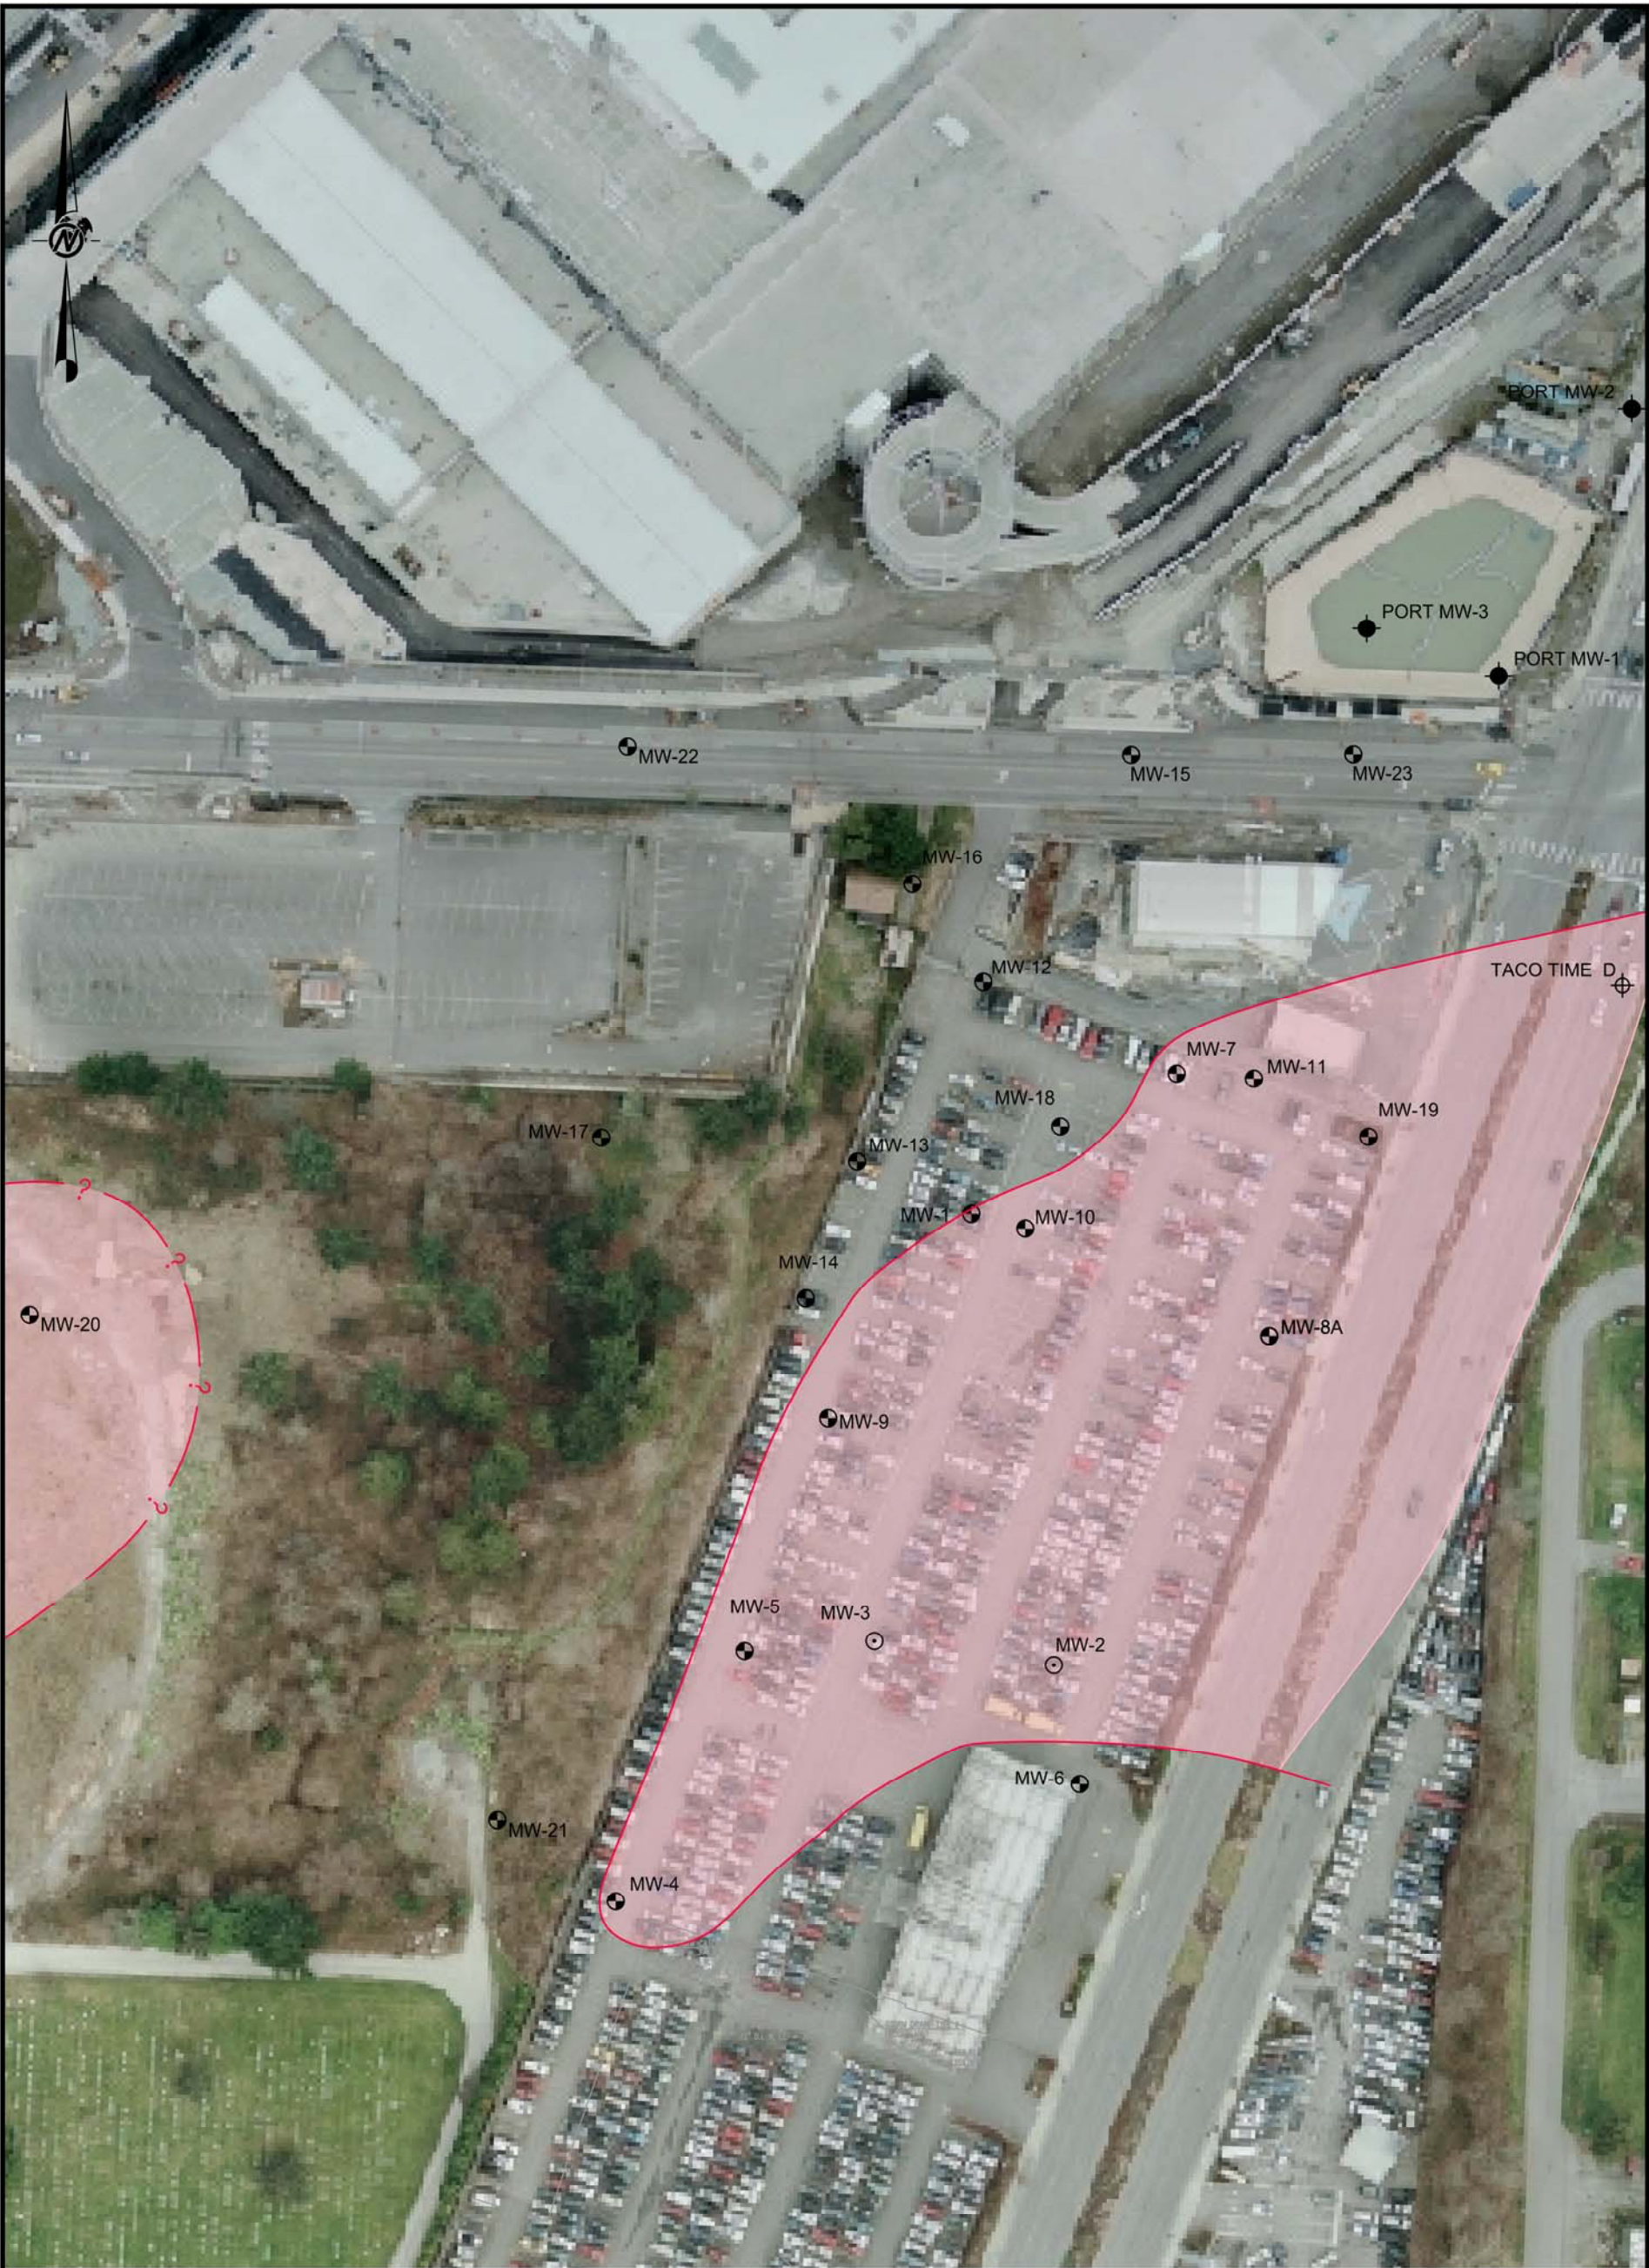
FIGURE 1  
**TILL LAYER OBSERVED IN BOREHOLES**  
SEATAC DEVELOPMENT SITE/RI/FS/WA

3. Preparation of geologic cross sections is highly recommended for hydrogeologic evaluation and for review of conclusions and proposed remediation alternatives. No geologic cross sections were presented in the RIFS or DCAP.

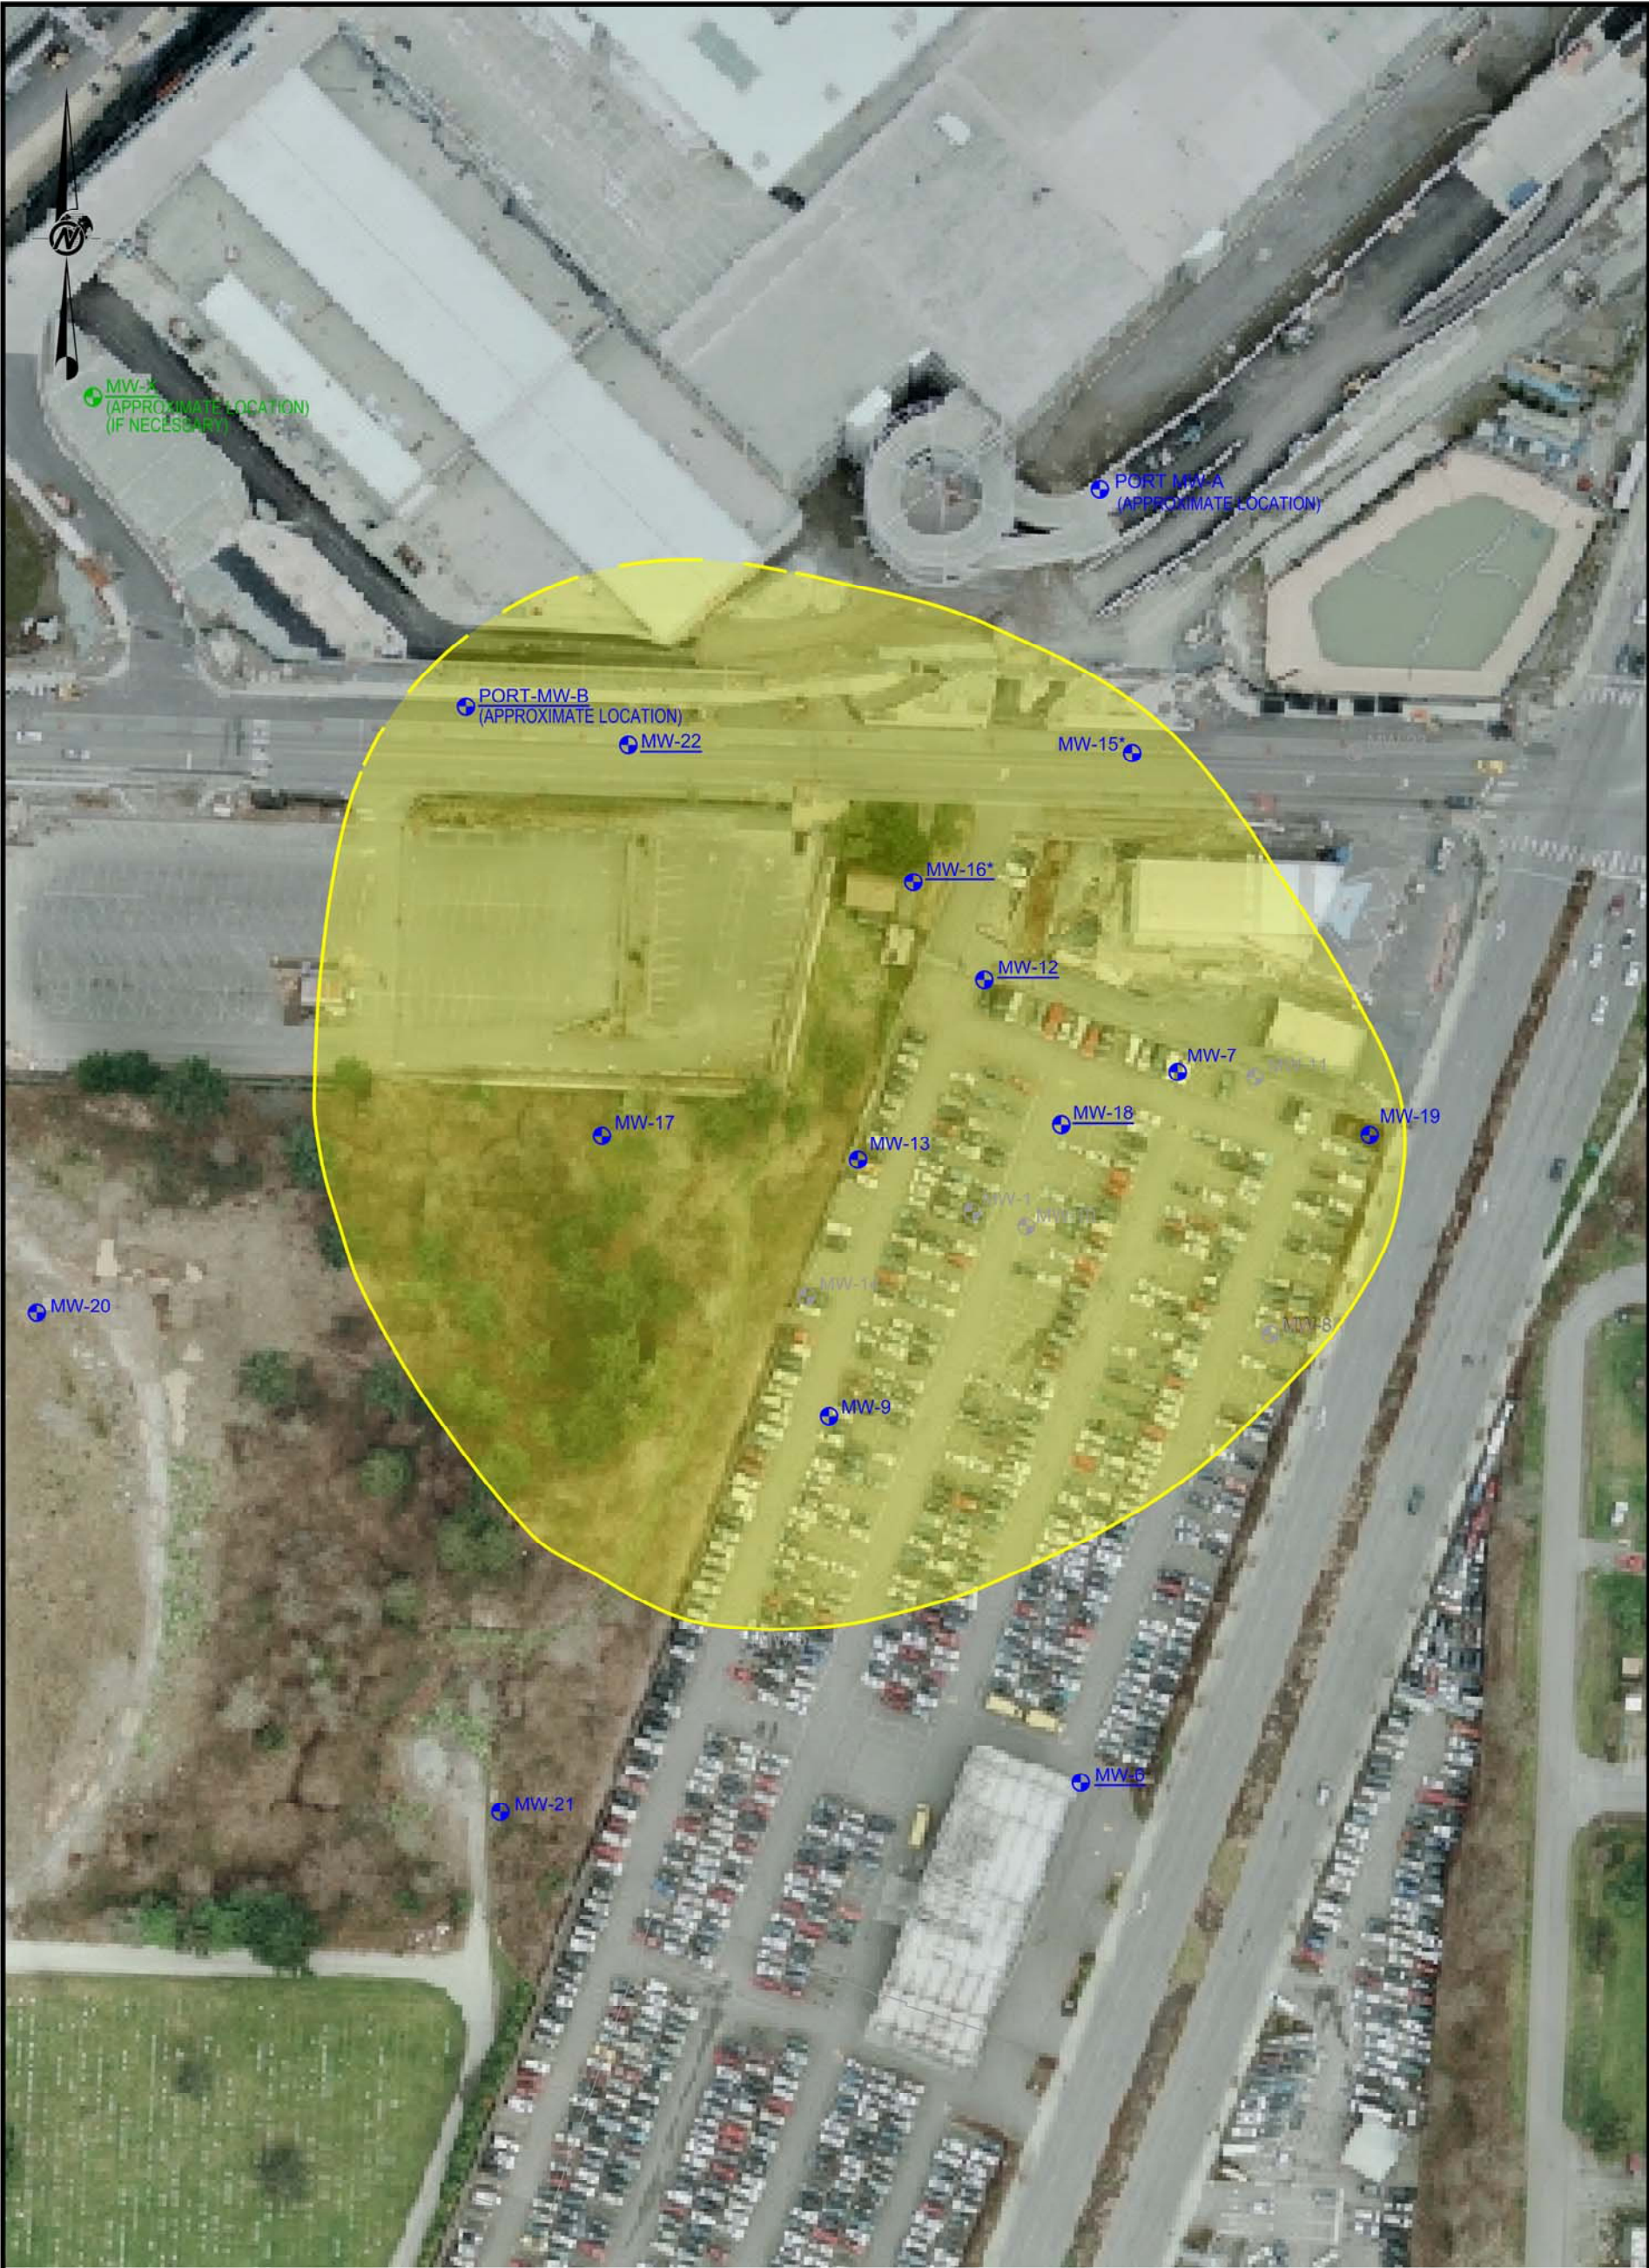
MW-XX WELL ONLY INSTALLED IF DEEMED NECESSARY. IF INSTALLED, MONITORING WILL REPLACE PORT-XX.
-

During the June 27, 2011 meeting among the Port of Seattle, Ecology and PLP Group representatives, the decision was made to install two new monitoring wells north of South 160<sup>th</sup> Street. The new wells will be included on all future maps depicting the site (see the attached Figure 4). The monitoring well, designated as Port MW-B, is within the S. 160<sup>th</sup> Street right-of-way and will be monitored in accordance with the Compliance Monitoring Plan as a replacement for well MW-X, unless well MW-X is required to be installed. Furthermore, the well, designated MW-X in the Draft CAP, does not need to be installed based on the preliminary analytical results of groundwater from Port-MW-B monitoring well. As such, the new well Port MW-B will be sampled during performance monitoring events (quarterly for year 1 and semi-annually for years 2 through the end of IAS/SVE operation) and during confirmational monitoring events (quarterly for year 1 and semi-annually for years 2 through the closure of the site). The new Port MW-B well will also be sampled for natural attenuation parameters quarterly during the first year of confirmational monitoring (unless it is eventually replaced with a new well MW-X).
