Data Summary Report Thompson-Isaacson Property Tukwila, Washington

September 2, 2009

The Boeing Company

**LANDAU
ASSOCIATES**
130 2nd Avenue South
Edmonds, WA 98020
(425) 778-0907

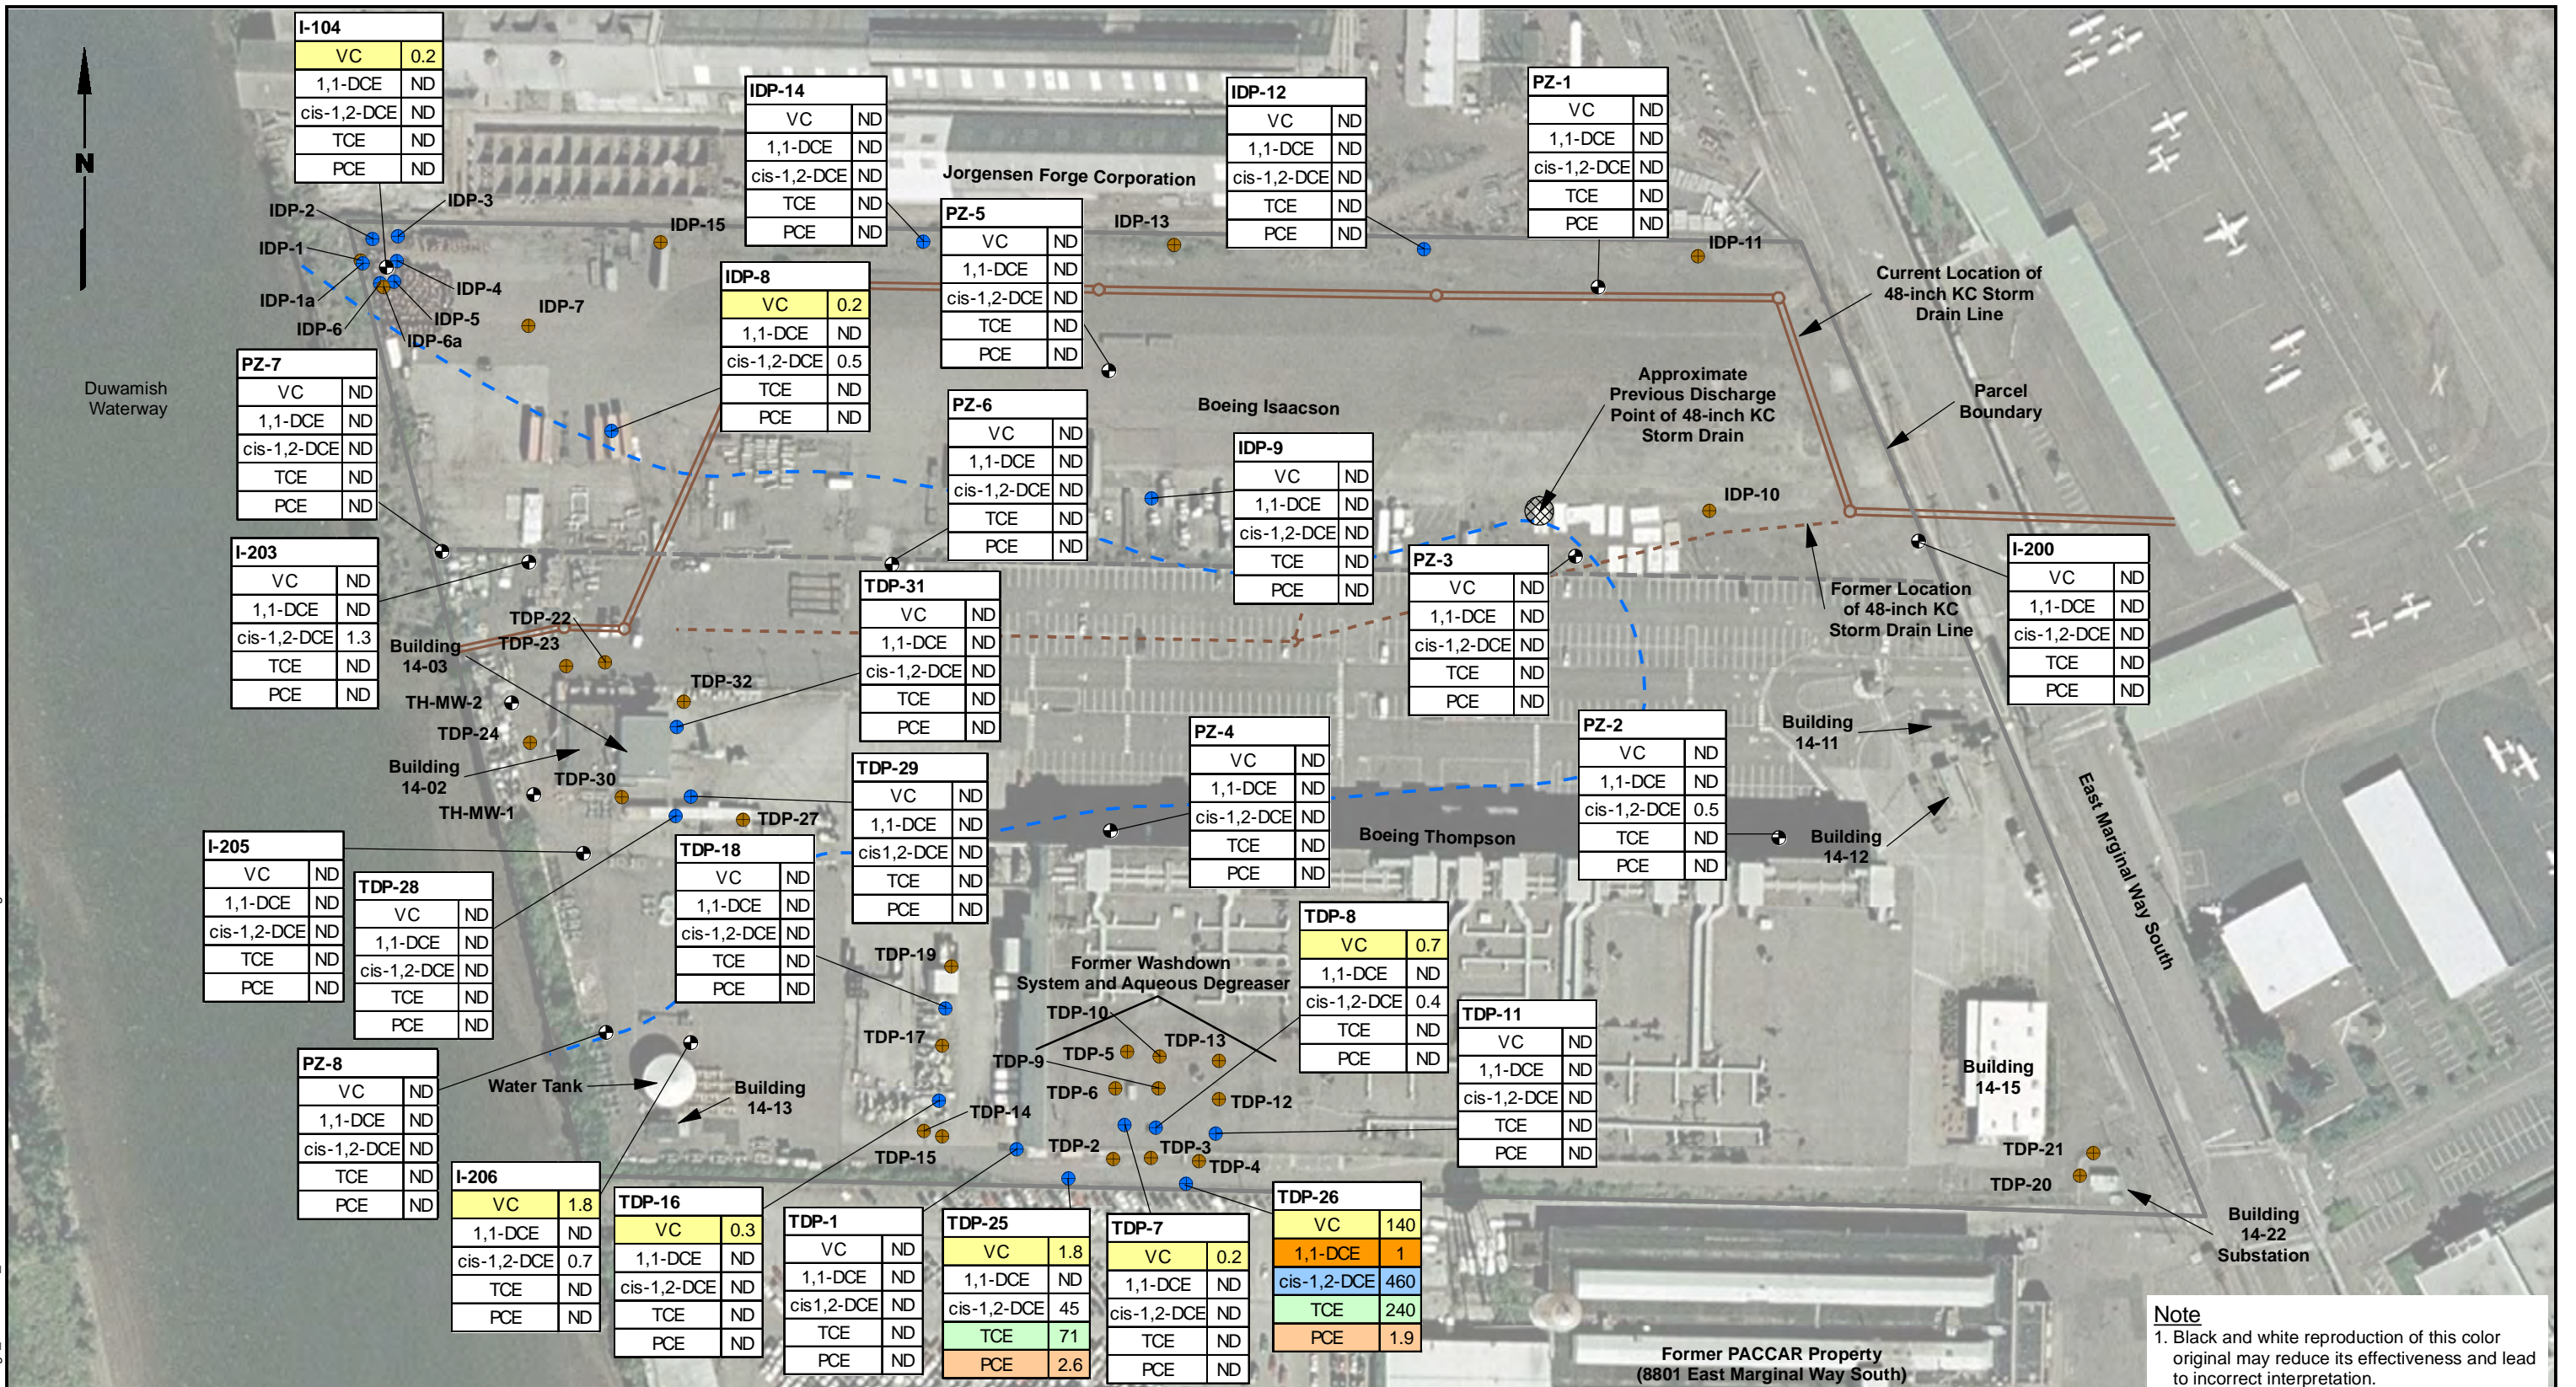
Figure 7

- Soil Sample Location
- ⊕ Existing Monitoring Well
- Soil and Groundwater Sample Location
- - - Approximate Location of Former Slip 5

Carbazole was detected in one groundwater sample (TDP1-GW) at a concentration greater than the preliminary screening level. Carbazole was not detected in any of the remaining 26 groundwater samples at concentrations greater than the laboratory reporting limits and was not detected in soil. Bis(2-ethylhexyl)phthalate (BEHP) was detected in five groundwater samples at concentrations greater than the preliminary screening levels. The distribution of BEHP in groundwater is shown on Figure 7.
