STATE OF WASHINGTON
DEPARTMENT OF ECOLOGY

Re: Further Action at a Property associated with a Site:

- Property Address: 26719 Highway 410 East, Buckley
- Facility/Site No.: 83113674
- Cleanup Site ID No.: 1131
- VCP Project No.: SW0814

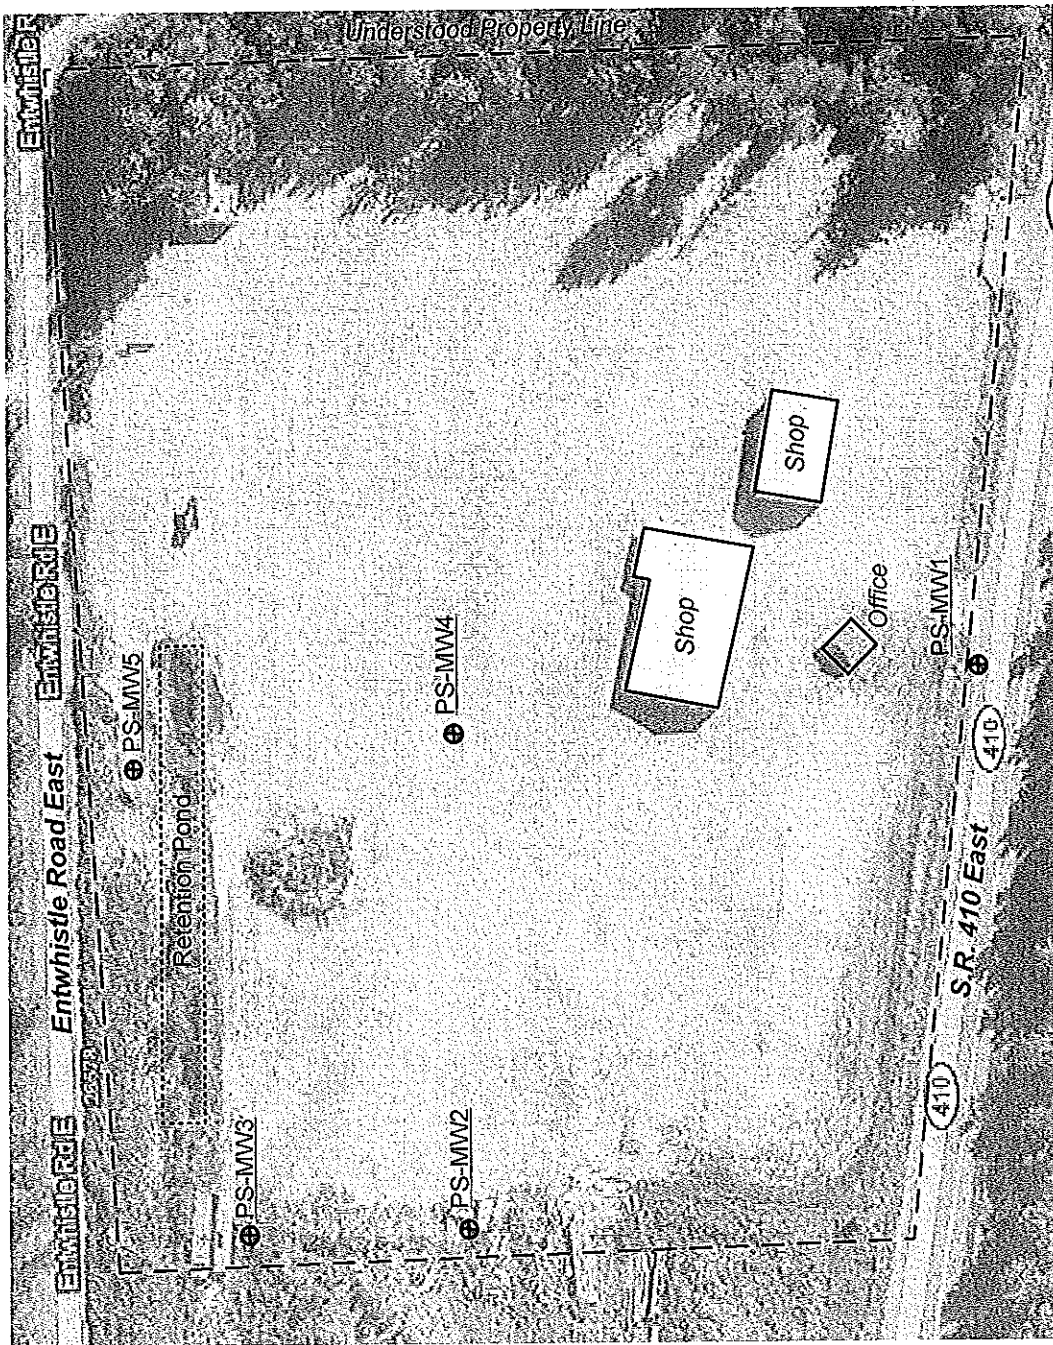
Monitoring Well Locations

Approximate Drawing Scale: 1" = 100'
