STATE OF WASHINGTON
DEPARTMENT OF ECOLOGY

Re: No Further Action at the following Site:

- **Site Name:** Chevron 9-1557
- **Site Address:** 220 Strander Boulevard, Tukwila, WA 98188
- **Facility/Site No.:** 43787415
- **VCP Project No.:** NW1561

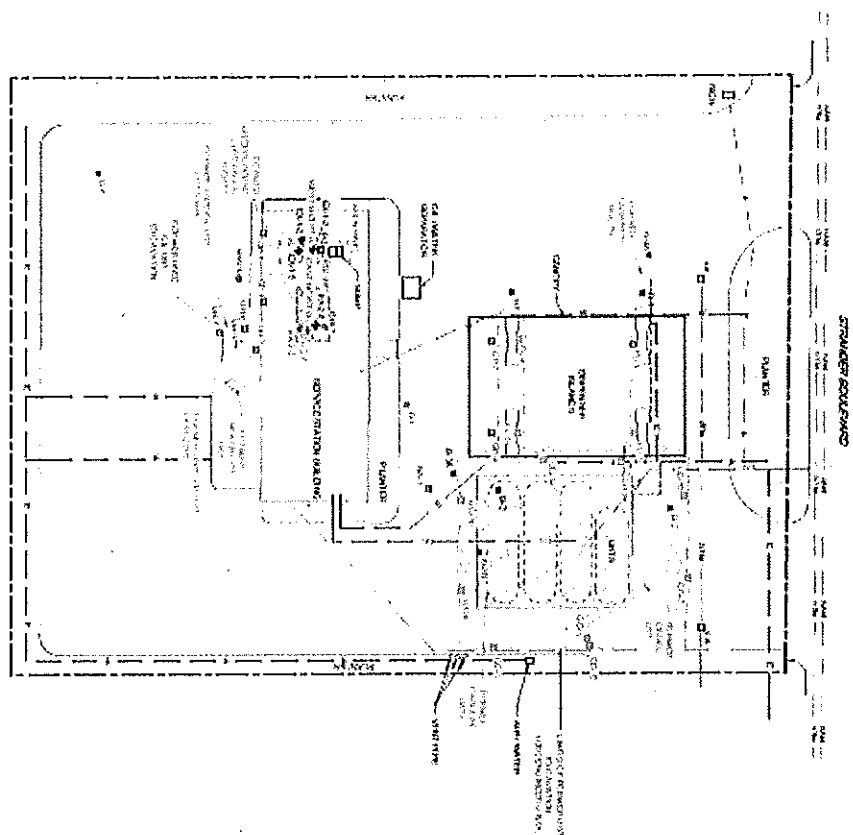
Figure 9
CURRENT SOIL CONDITIONS
CHEVRON SERVICE STATION 91557
220 STRANDER BOULEVARD
Tukwila, Washington
