Re: Opinion pursuant to WAC 173-340-515(5) on Proposed Remedial Action for the following Hazardous Waste Site:

- Name: John's Auto Wrecking
- Address: 411 93rd Avenue SE, Olympia, WA
- Facility/Site No.: 57665495
- VCP No.: SWO652

The Site is more particularly described in Enclosure A to this letter which includes a detailed Site diagram. The description of the Site is based solely on the information contained in the referenced documents.

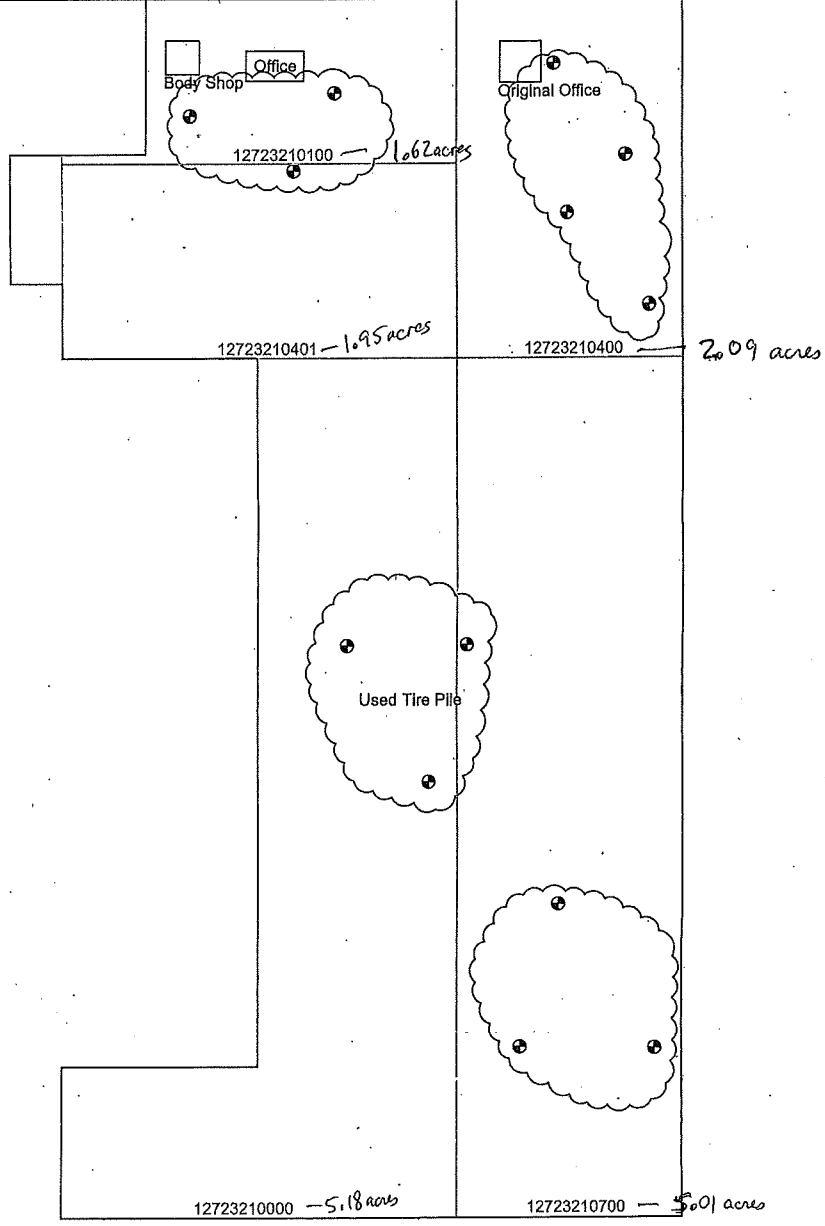
JOHN'S AUTO WRECKING
 06-110 Date: 8/20/03
 File: John's Auto Sheet 1 of 1

Body Shop
Office
12723210100 — 1.62 acres

Original Office
12723210400 — 1.95 acres

Proposed Work

The 15-acre site is located south of Tumwater and has been used as a wrecking yard supporting towing operations and related businesses for about 24 years. Site buildings/areas include a body/repair shop, possible battery storage area, former radiator shop, hazardous materials storage area, battery refurbishing shed, car crusher areas, and the car storage yard. A ditch (Hopkins Ditch) and a wetland are located in the southern portion of the property.
