**MAINTENANCE & REPAIR PLAN
LOT 7 OF THE SISTERS OF
THE HOLY NAMES
FINAL SHORT PLAT Z16-659FPLT
2752 WEST ELLIOTT COURT
SPOKANE, WASHINGTON**

ES-4332.01

PREPARED FOR
CATHOLIC HOUSING SERVICES OF EASTERN WASHINGTON

March 3, 2017
Revised March 7, 2017

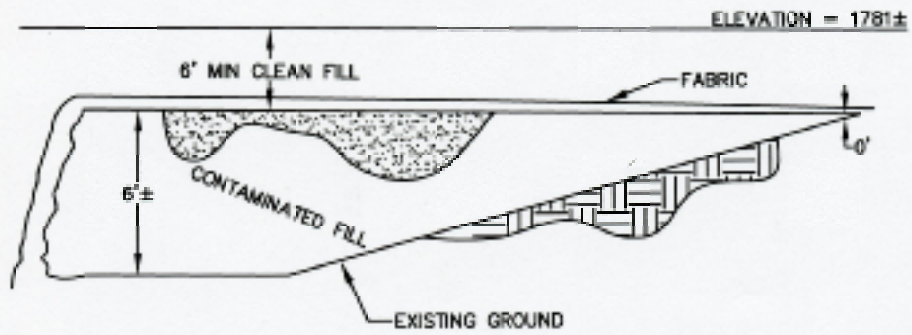
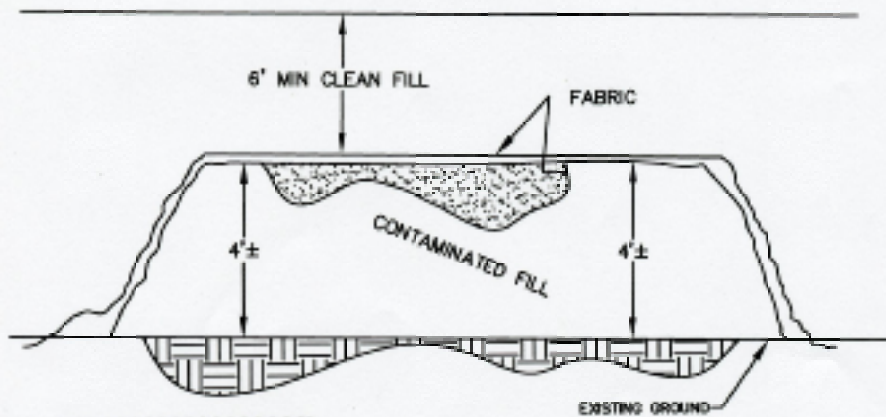
Drwn. MRS	Date 02/23/2017	Proj. No. 4332.01
Checked TWS	Date Feb. 2017	Plate 4

SECTION A-A

SECTION B-B

**CONTAMINATED FILL
APPROXIMATE
CROSS-SECTIONS**

CROSS-SECTIONS OF CONTAMINATED SOIL
Lot 7 of Short Plat 216-659FPLT
Spokane, Washington

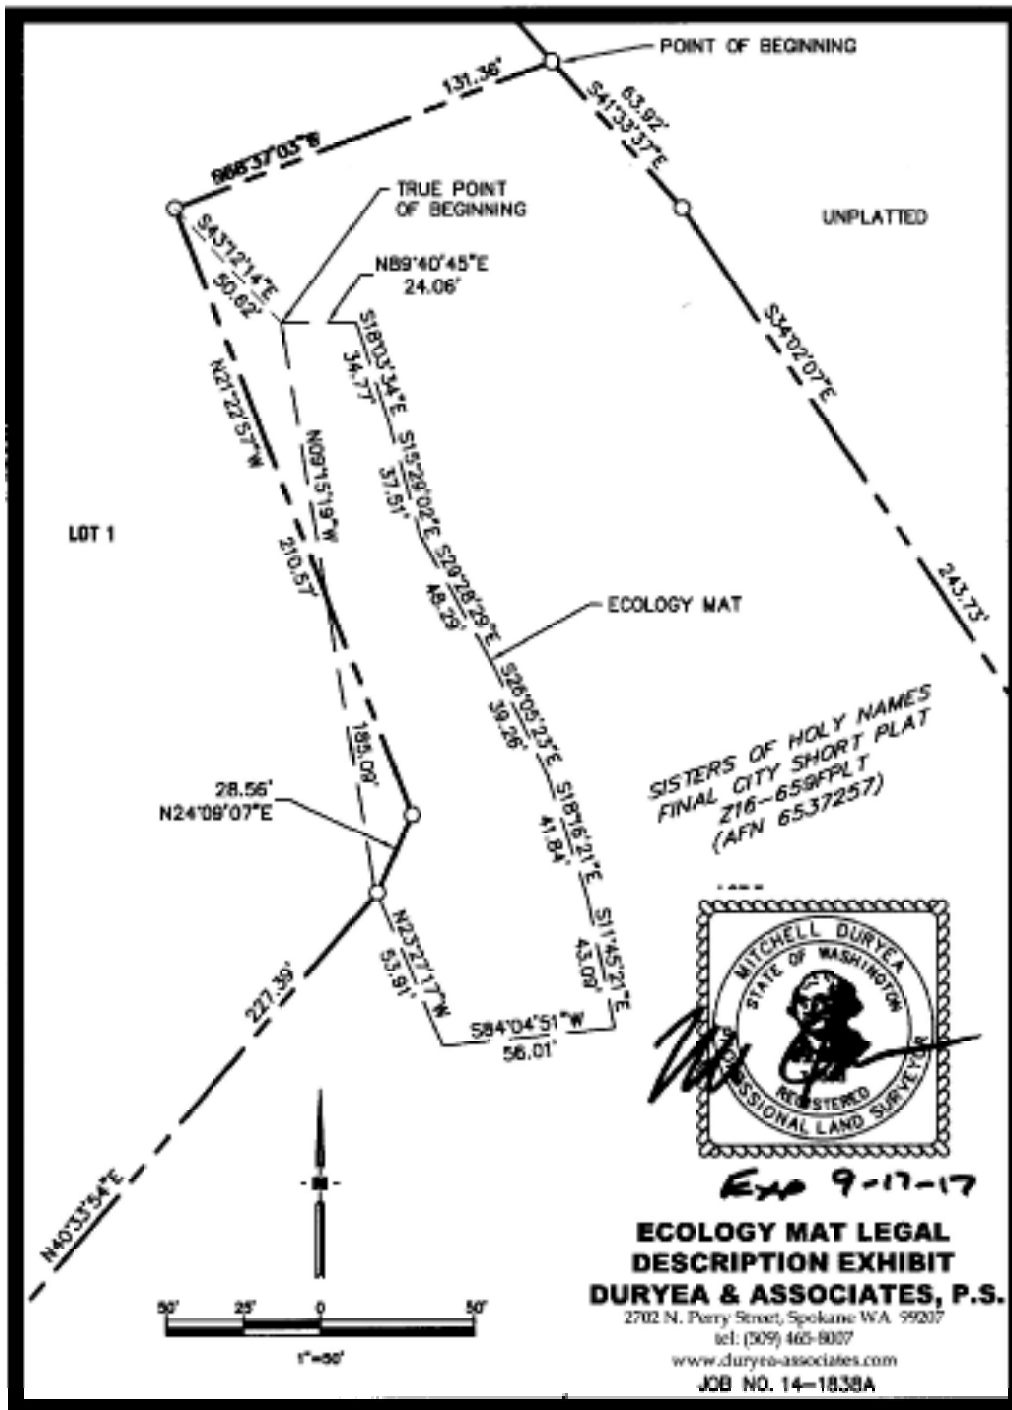
A portion of Lots 1 and 7 of Sisters of Holy Names Final City Short Plat Z16-659FPLT recorded September 22, 2016 under Auditor's File No. 6537257, Spokane County Records, and being more particularly described as follows:

BEGINNING at the North corner of said Lot 7, being hereinbove described; thence along the northwesterly line of said Lot 7 South 68°37'03" West 131.36 feet; thence leaving said northwesterly line of said Lot 7 South 43°12'14" East 50.62 feet to the TRUE POINT OF BEGINNING of this description; thence North 89°40'45" East 24.06 feet; thence South 18°03'34" East 34.77 feet; thence South 15°29'02" East 37.51 feet; thence South 29°28'29" East 48.29 feet; thence South 26°05'23" East 39.26 feet; thence South 18°16'21" East 41.84 feet; thence South 11°45'21" East 43.09 feet; thence South 84°04'51" West 56.01 feet; thence North 23°27'17" West 53.91 feet; thence North 09°15'19" West 185.09 feet to the said true point of beginning of this description, containing 0.257 acres of land, more or less.

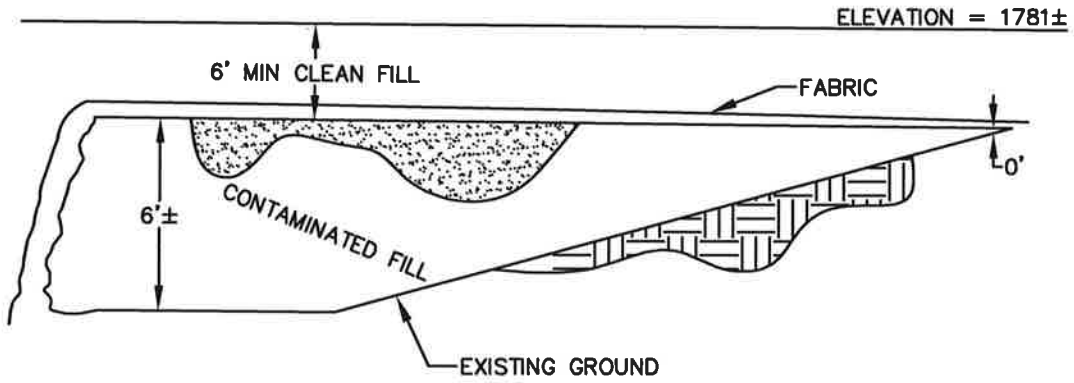
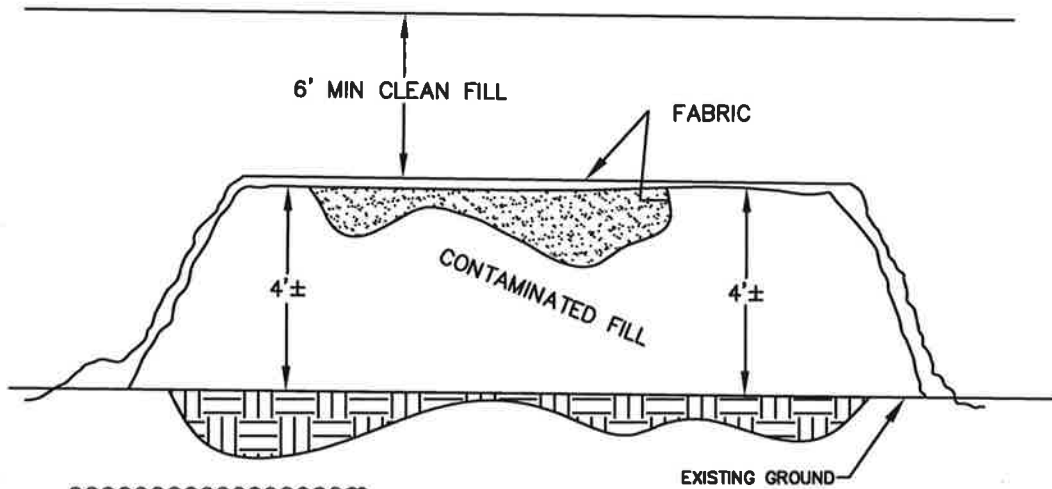
SECTION A-A

SECTION B-B

**CONTAMINATED FILL
APPROXIMATE
CROSS-SECTIONS**
