STATE OF WASHINGTON
DEPARTMENT OF ECOLOGY

Re: Opinion on Proposed Cleanup of a Property associated with a Site:

- **Property Address:** 21 10th Avenue South, 1006 Lake Street South and 6700 Lake Washington Blvd NE, Kirkland, Washington
- **Facility/Site No.:** 4595
- **VCP Project No.:** NW2850
- **Cleanup Site ID No.:** 12329

Site Diagrams

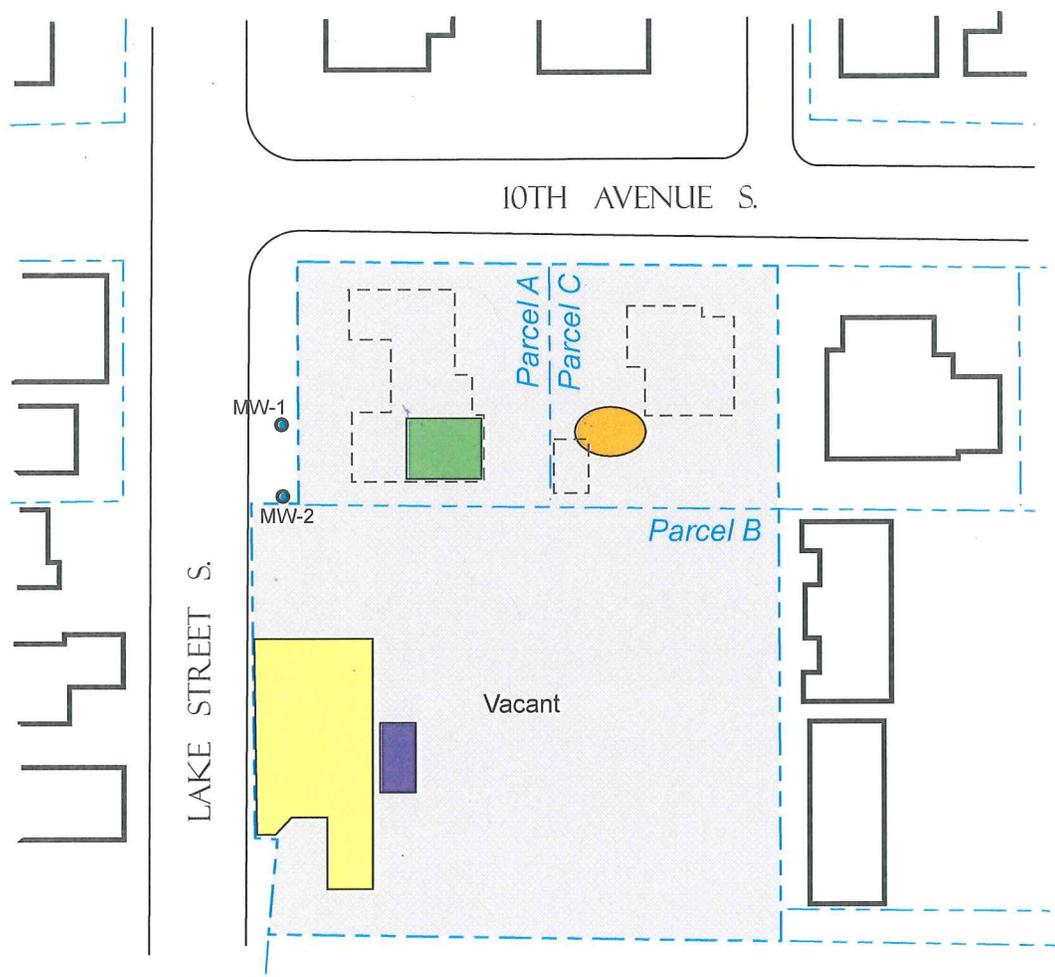
Earth Solutions NW LLC <small>Geotechnical Engineering, Construction Monitoring and Environmental Sciences</small>	
	Site Plan Potala Village Kirkland, Washington	
Drwn. GLS	Date 05/13/2014	Proj. No. 2880.05 & 07
Checked TWS	Date May 2014	Plate 2

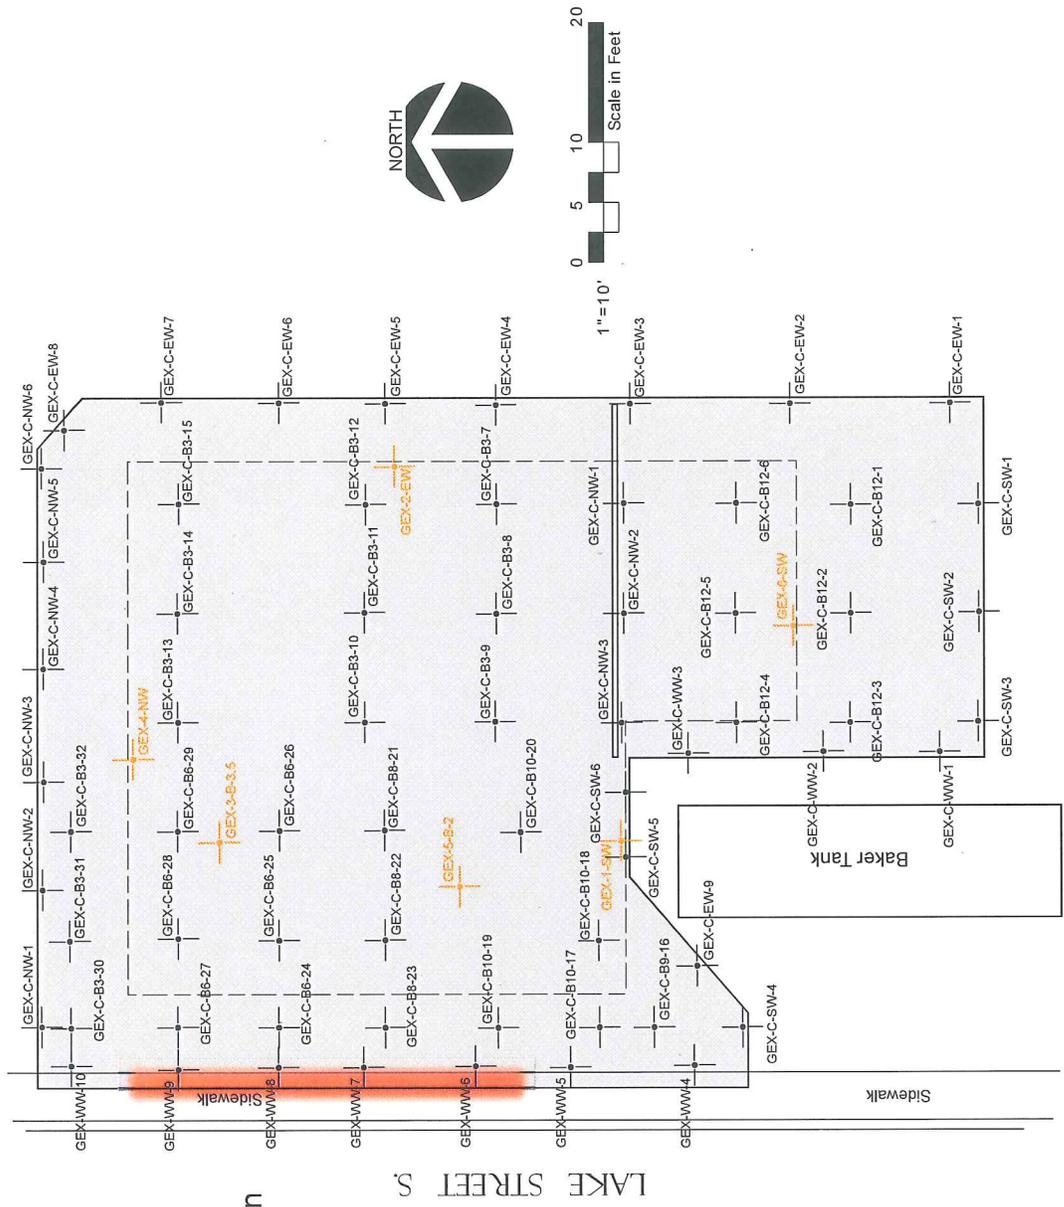
Area 4
Former Gasoline Service Station
Excavation

- LEGEND**
- Performance Soil Sample Location
 - Initial Excavation
 - Confirmation Soil Sample Location
 - Final Limits of Excavation
 - Area at Property Boundary Where Residual Petroleum Contamination Remains

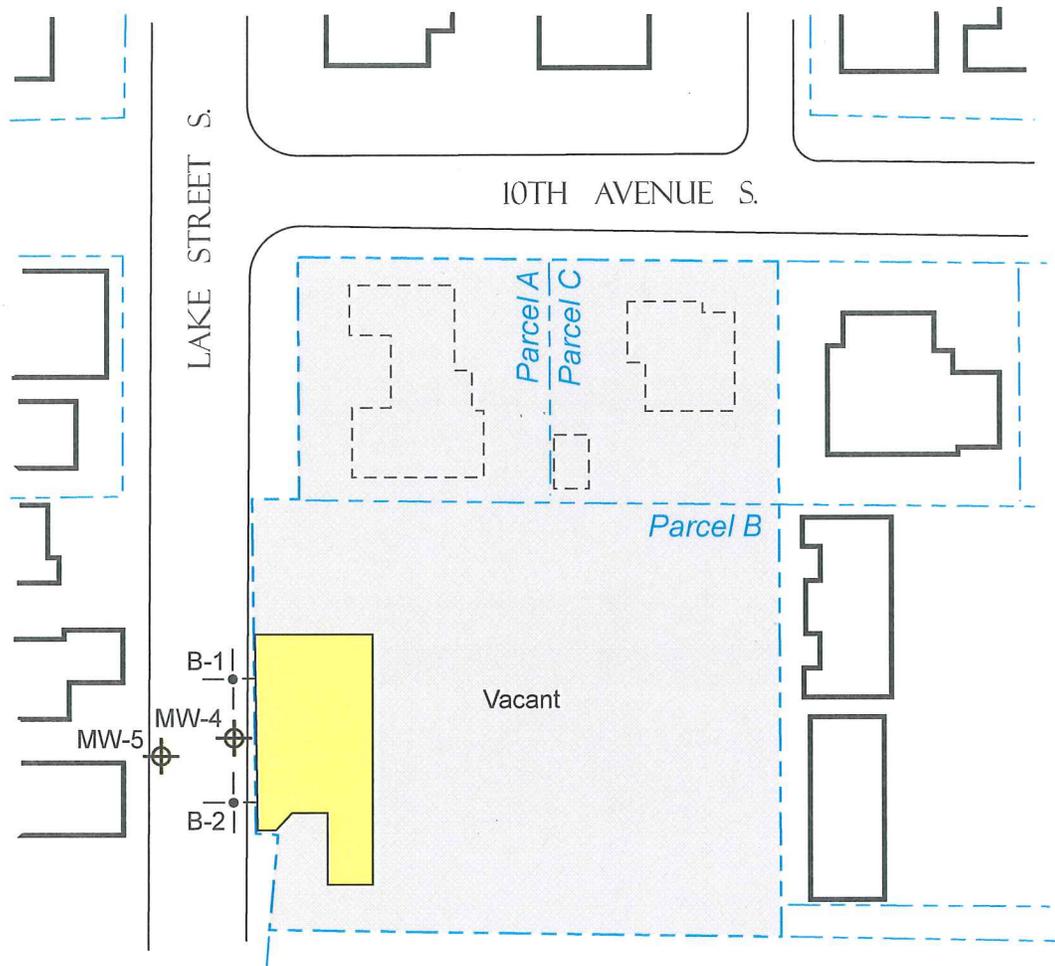
Drwn. GLS	Date 09/18/2014	Proj. No. 2880.07
Checked TWS	Date Sept. 2014	Plate 1

**Boring / Well Location Plan
Potlatch Village Kirkland
Kirkland, Washington**

Soil and ground water on the Property were first characterized at 1006 Lake Street South in 2006 and 2008 with soil borings, grab ground water samples and 3 monitoring wells. Later in 2013 and 2014, the results of soil samples collected in test pits were used to estimate the locations of contaminated soil on the Property. Two additional monitoring wells were installed west of 6700 Lake Washington Boulevard NE in 2014. No contamination related to the Site was found in any of the five Site monitoring wells.

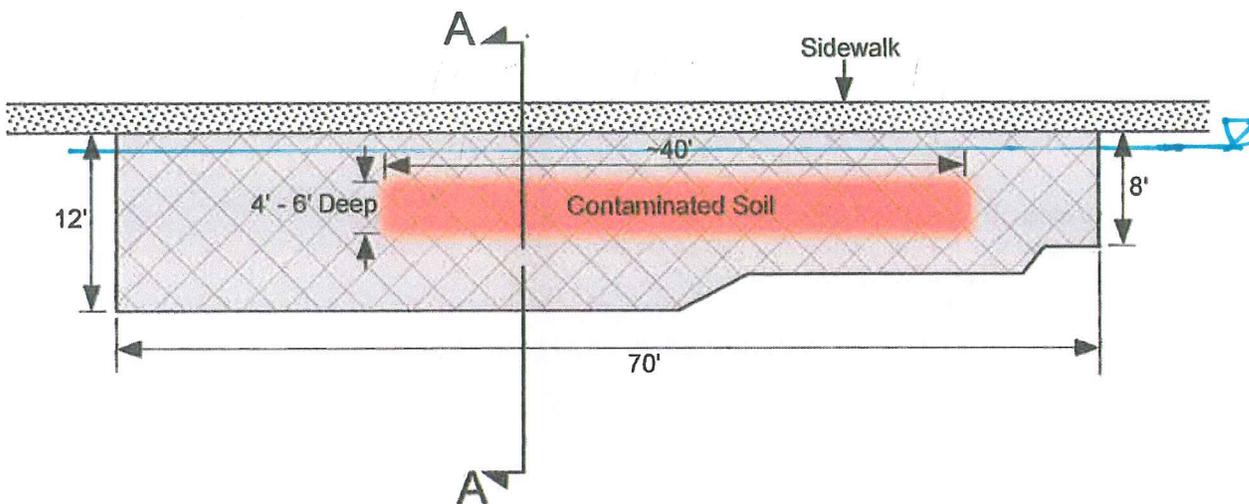
Earth Solutions NW LLC <small>Geotechnical Engineering Construction Monitoring and Environmental Sciences</small>	
As Built Cross Section of West Excavation Sidewall Potala Village Kirkland, Washington			
Drwn. MRS	Date 01/12/2017	Proj. No. 2880.07	
Checked TWS	Date Jan. 2017	Plate	1

Ecology recommended that an Environmental Covenant (EC) be placed on the Property in order to prevent the removal or damage to the volclay panels and the sheet drain. The EC will also require that any future building constructed on the Property have additional vapor barrier protection. Collection and analysis of indoor air samples will be required after building construction and to maintain the EC through the periodic review process.
