Subject: KCHA Response to Ecology's June 2016 Further Action Letter
Former Park Lake Homes Maintenance Shop Site
9800 8th Avenue SW
Seattle, Washington 98106
VCP Project No. NW3033
GeoEngineers File No. 1329-003-20

GeoEngineers prepared this letter on behalf of the King County Housing Authority (KCHA) to respond to Ecology's Further Action (FA) opinion letter dated June 6, 2016 for the former KCHA maintenance center facility ("Site") (Figure 1). Cleanup at the Site was completed in 2005, more than 10 years ago, and the Site was substantially redeveloped beginning in 2006 with infrastructure, housing, parking and common areas associated with KCHA's Greenbridge project <https://www.kcha.org/development/greenbridge/>. KCHA intends to own and manage the areas within the Site for the foreseeable future. Please see the attached Figure 2 which shows the current layout of the Site relative to the footprint of the Maintenance Center building, 2005 remedial excavations and post-cleanup excavations completed during redevelopment for the purposes of KCHA infrastructure (i.e., temporary stormwater pond and permanent water quality vault).

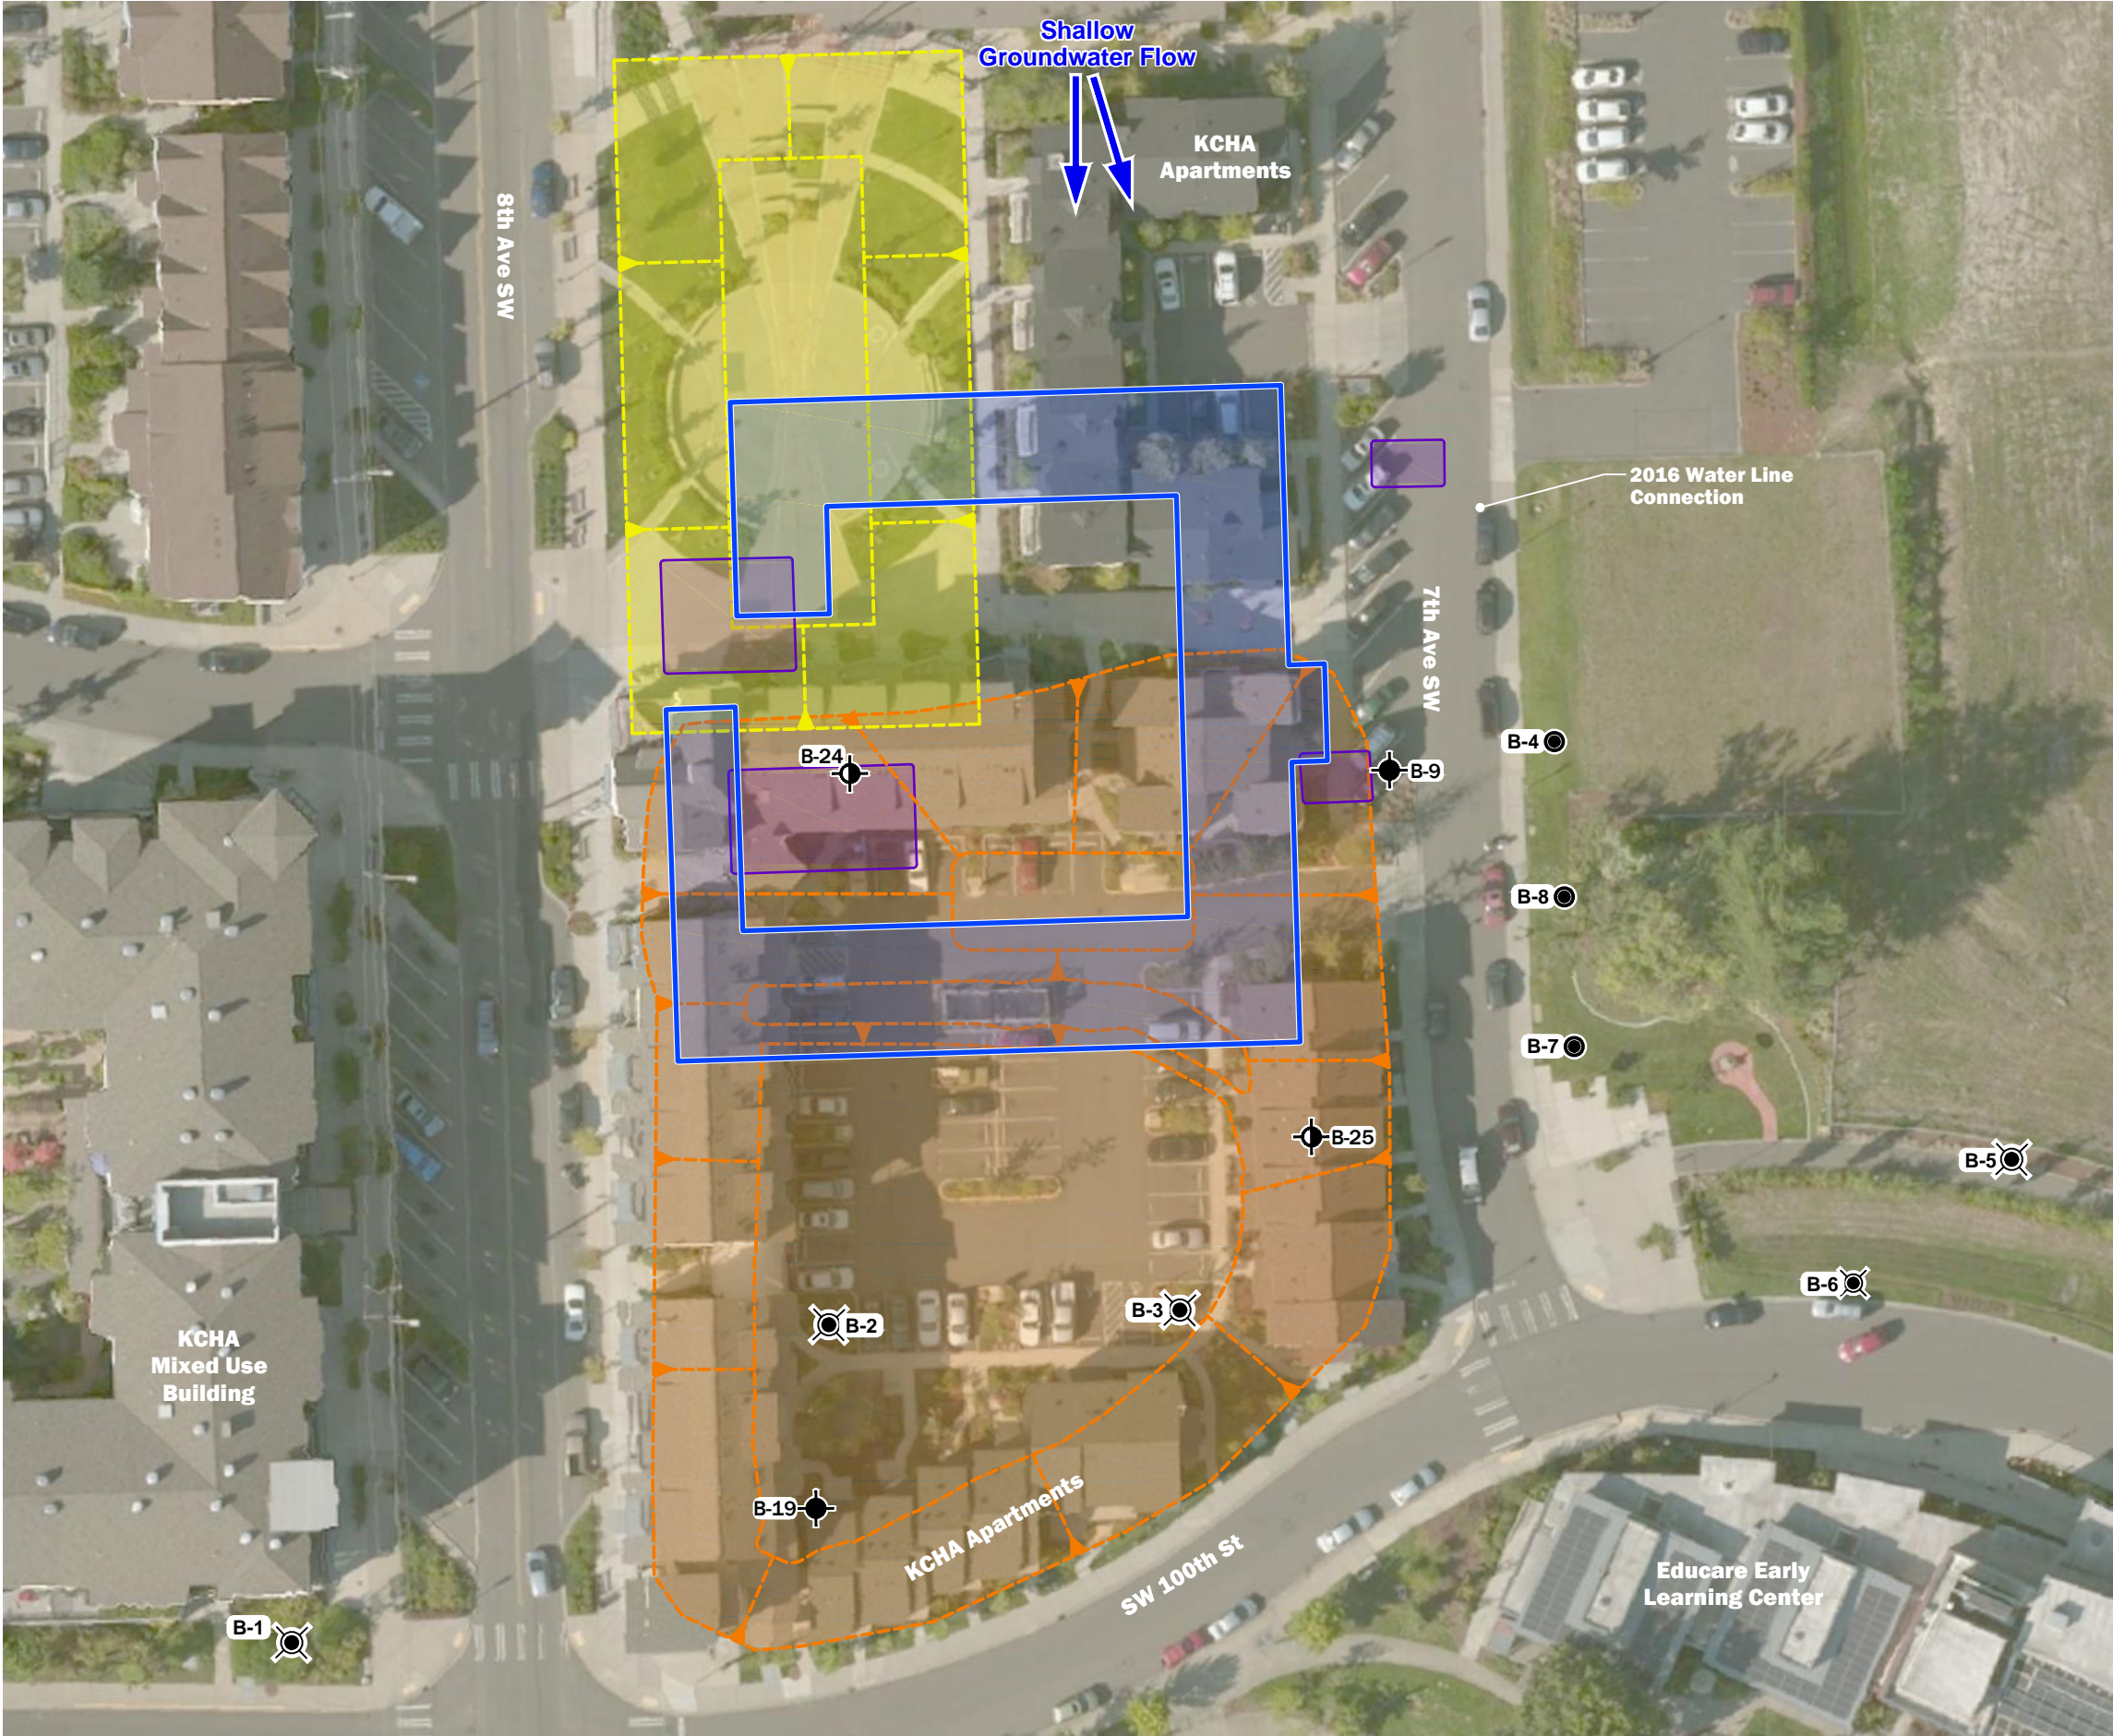
Site Plan Current Layout	
Former Park Lake Homes Maintenance Center Seattle, Washington	
GEOENGINEERS	Figure 2

- Direct Push Boring
No Groundwater Encountered
(GeoEngineers, 2015)
- Direct Push Temporary Groundwater
Monitoring Well (GeoEngineers, 2015)
- Geotechnical Boring by GeoEngineers, 2004
- Geotechnical Boring by GeoEngineers, 2003
- Approximate Footprint of Former Park Lake
Homes Maintenance Center Building
- Approximate Location of
Removed UST
- Approximate Location of 2005
Remedial Excavations - MTCA
Cleanup at Maintenance Center
- Approximate Boundary of Backfilled
CV4 Stormwater Pond Excavation
- Excavation for Water Quality Vault

- **Soil cleanup confirmation sampling at the limits of the Maintenance Center remedial excavations complied with MTCA cleanup levels.** Based on GeoEngineers' 2005 field observations, field screening data, and verification sampling results, the contaminated soil was successfully removed. Furthermore, there is no evidence of contamination in areas beyond those originally characterized as contaminated. Specifically, none of the past geotechnical explorations completed in the vicinity of the former Maintenance Center between 2003 and 2004 (B-9, B-19, B-24, B-25 see attached logs) indicated evidence of contaminated soil. It is also relevant to note that an excavation completed in Summer 2016 for a water line tie-in directly east of the easternmost 2005 remedial excavation EX-3 was completed to approximately 8 feet below-grade did not show evidence of contaminated soil (Figure 2).

- After the 2005 cleanup action, the majority of **soil underlying the former Maintenance Center was subsequently removed to depths up to 16 feet below original grade** for the temporary CV4 construction stormwater pond (later backfilled, area shown in orange shading in Figure 2) and for the permanent CV3 water quality vault (area shown in yellow shading in Figure 2). No evidence of contaminated soil was reported by KCHA representatives or contractors, or by GeoEngineers during geotechnical construction observation, during soil removal in both of these large areas. The significant quantity of soil removed should eliminate Ecology concerns that there are unexplored areas or possible remaining soil contamination associated with the former Maintenance Center.

- **Favorable groundwater quality** was represented by the 2015 groundwater samples (GeoEngineers 2015) obtained from locations proximate to the former maintenance center (B-4, B-7 and B-8, Figure 2). Gasoline-, diesel- and heavy oil-range petroleum hydrocarbons and volatile organic compounds (VOCs) were not detected except for one detection of diesel-range hydrocarbons in B-8 at a concentration less than the MTCA Method A cleanup level. Consequently, there is no reason to suspect that deeper groundwater beneath the Site (if present) might be contaminated.
