**REMEDIAL INVESTIGATION
WORK PLAN**

**FORMER CASCADE LAUNDRY
205 PROSPECT STREET
WHATCOM COUNTY PARCEL 380330111249
BELLINGHAM, WASHINGTON 98225
ECOLOGY FS ID: 21786898**

May 24, 2016

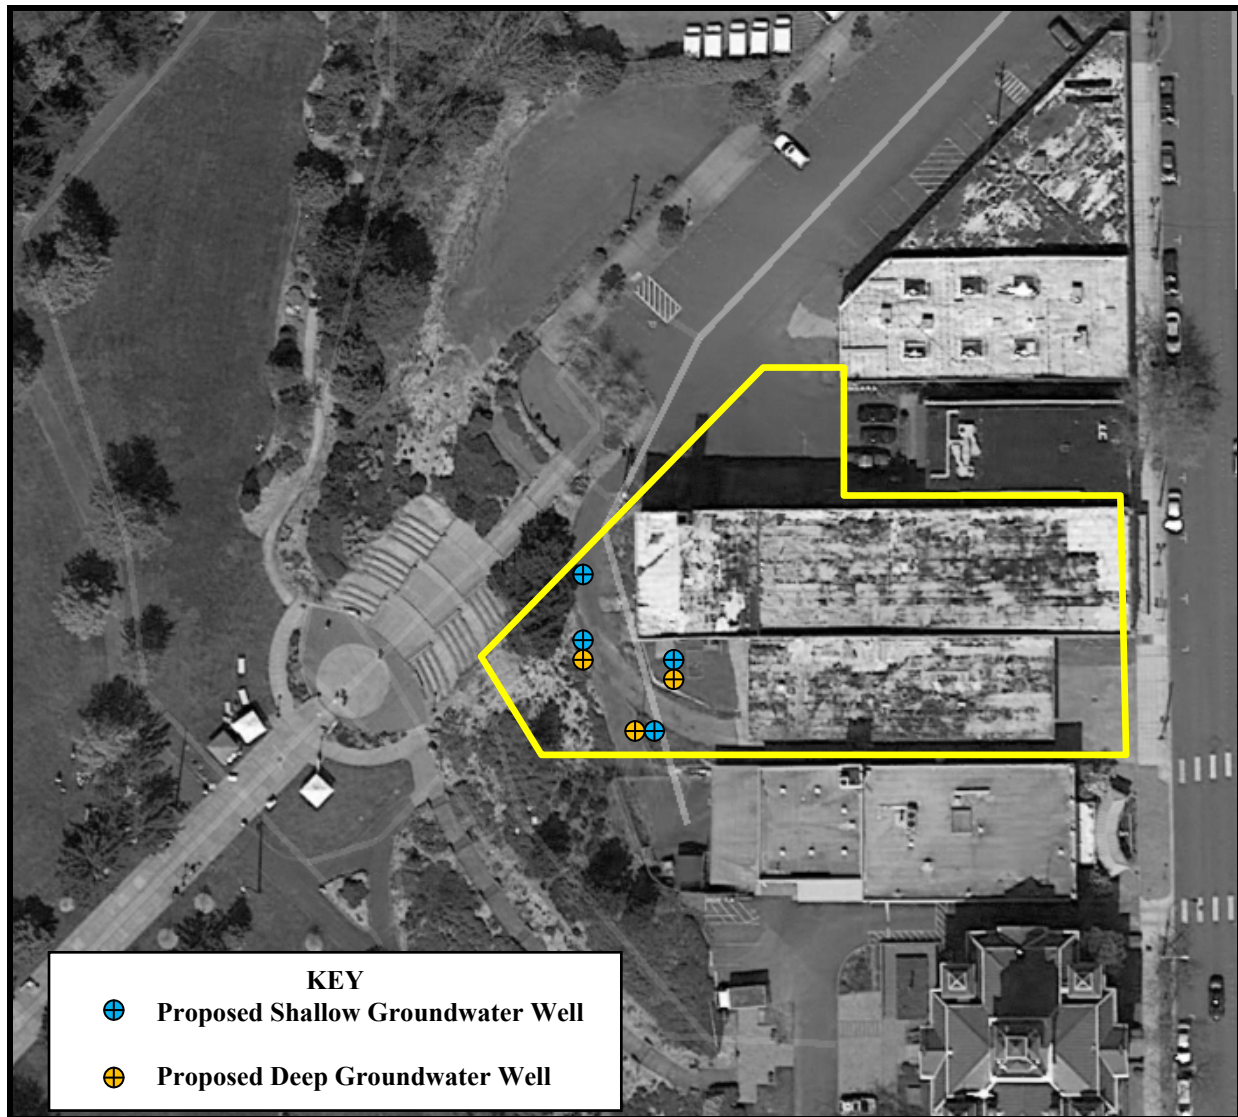
The recommended monitoring well locations are provided in Figure 6, below

Location of proposed groundwater monitoring wells on the Cascade Laundry site

We recommend that four shallow groundwater monitoring wells be installed on the Cascade Laundry property. The wells should be drilled and screened within the first groundwater zones encountered. Wells will be installed around the exterior of the site where previous groundwater contamination has been identified, or groundwater contamination is potentially present.

To evaluate the regional groundwater table for contamination, we recommend that three deep monitoring wells be installed on the site. The purpose of the deep monitoring wells is to evaluate the vertical extent of groundwater contamination at the site. These monitoring wells should be installed into the area's aquifer, located approximately 45 feet below the Cascade Laundry's ground surface. Wells should be screened for 20 feet from the top of the aquifer.
