MEMORANDUM

SUBJECT: Proposed Sampling and Assessment Approach
Seaport Landing
Aberdeen, Washington.

1 Introduction

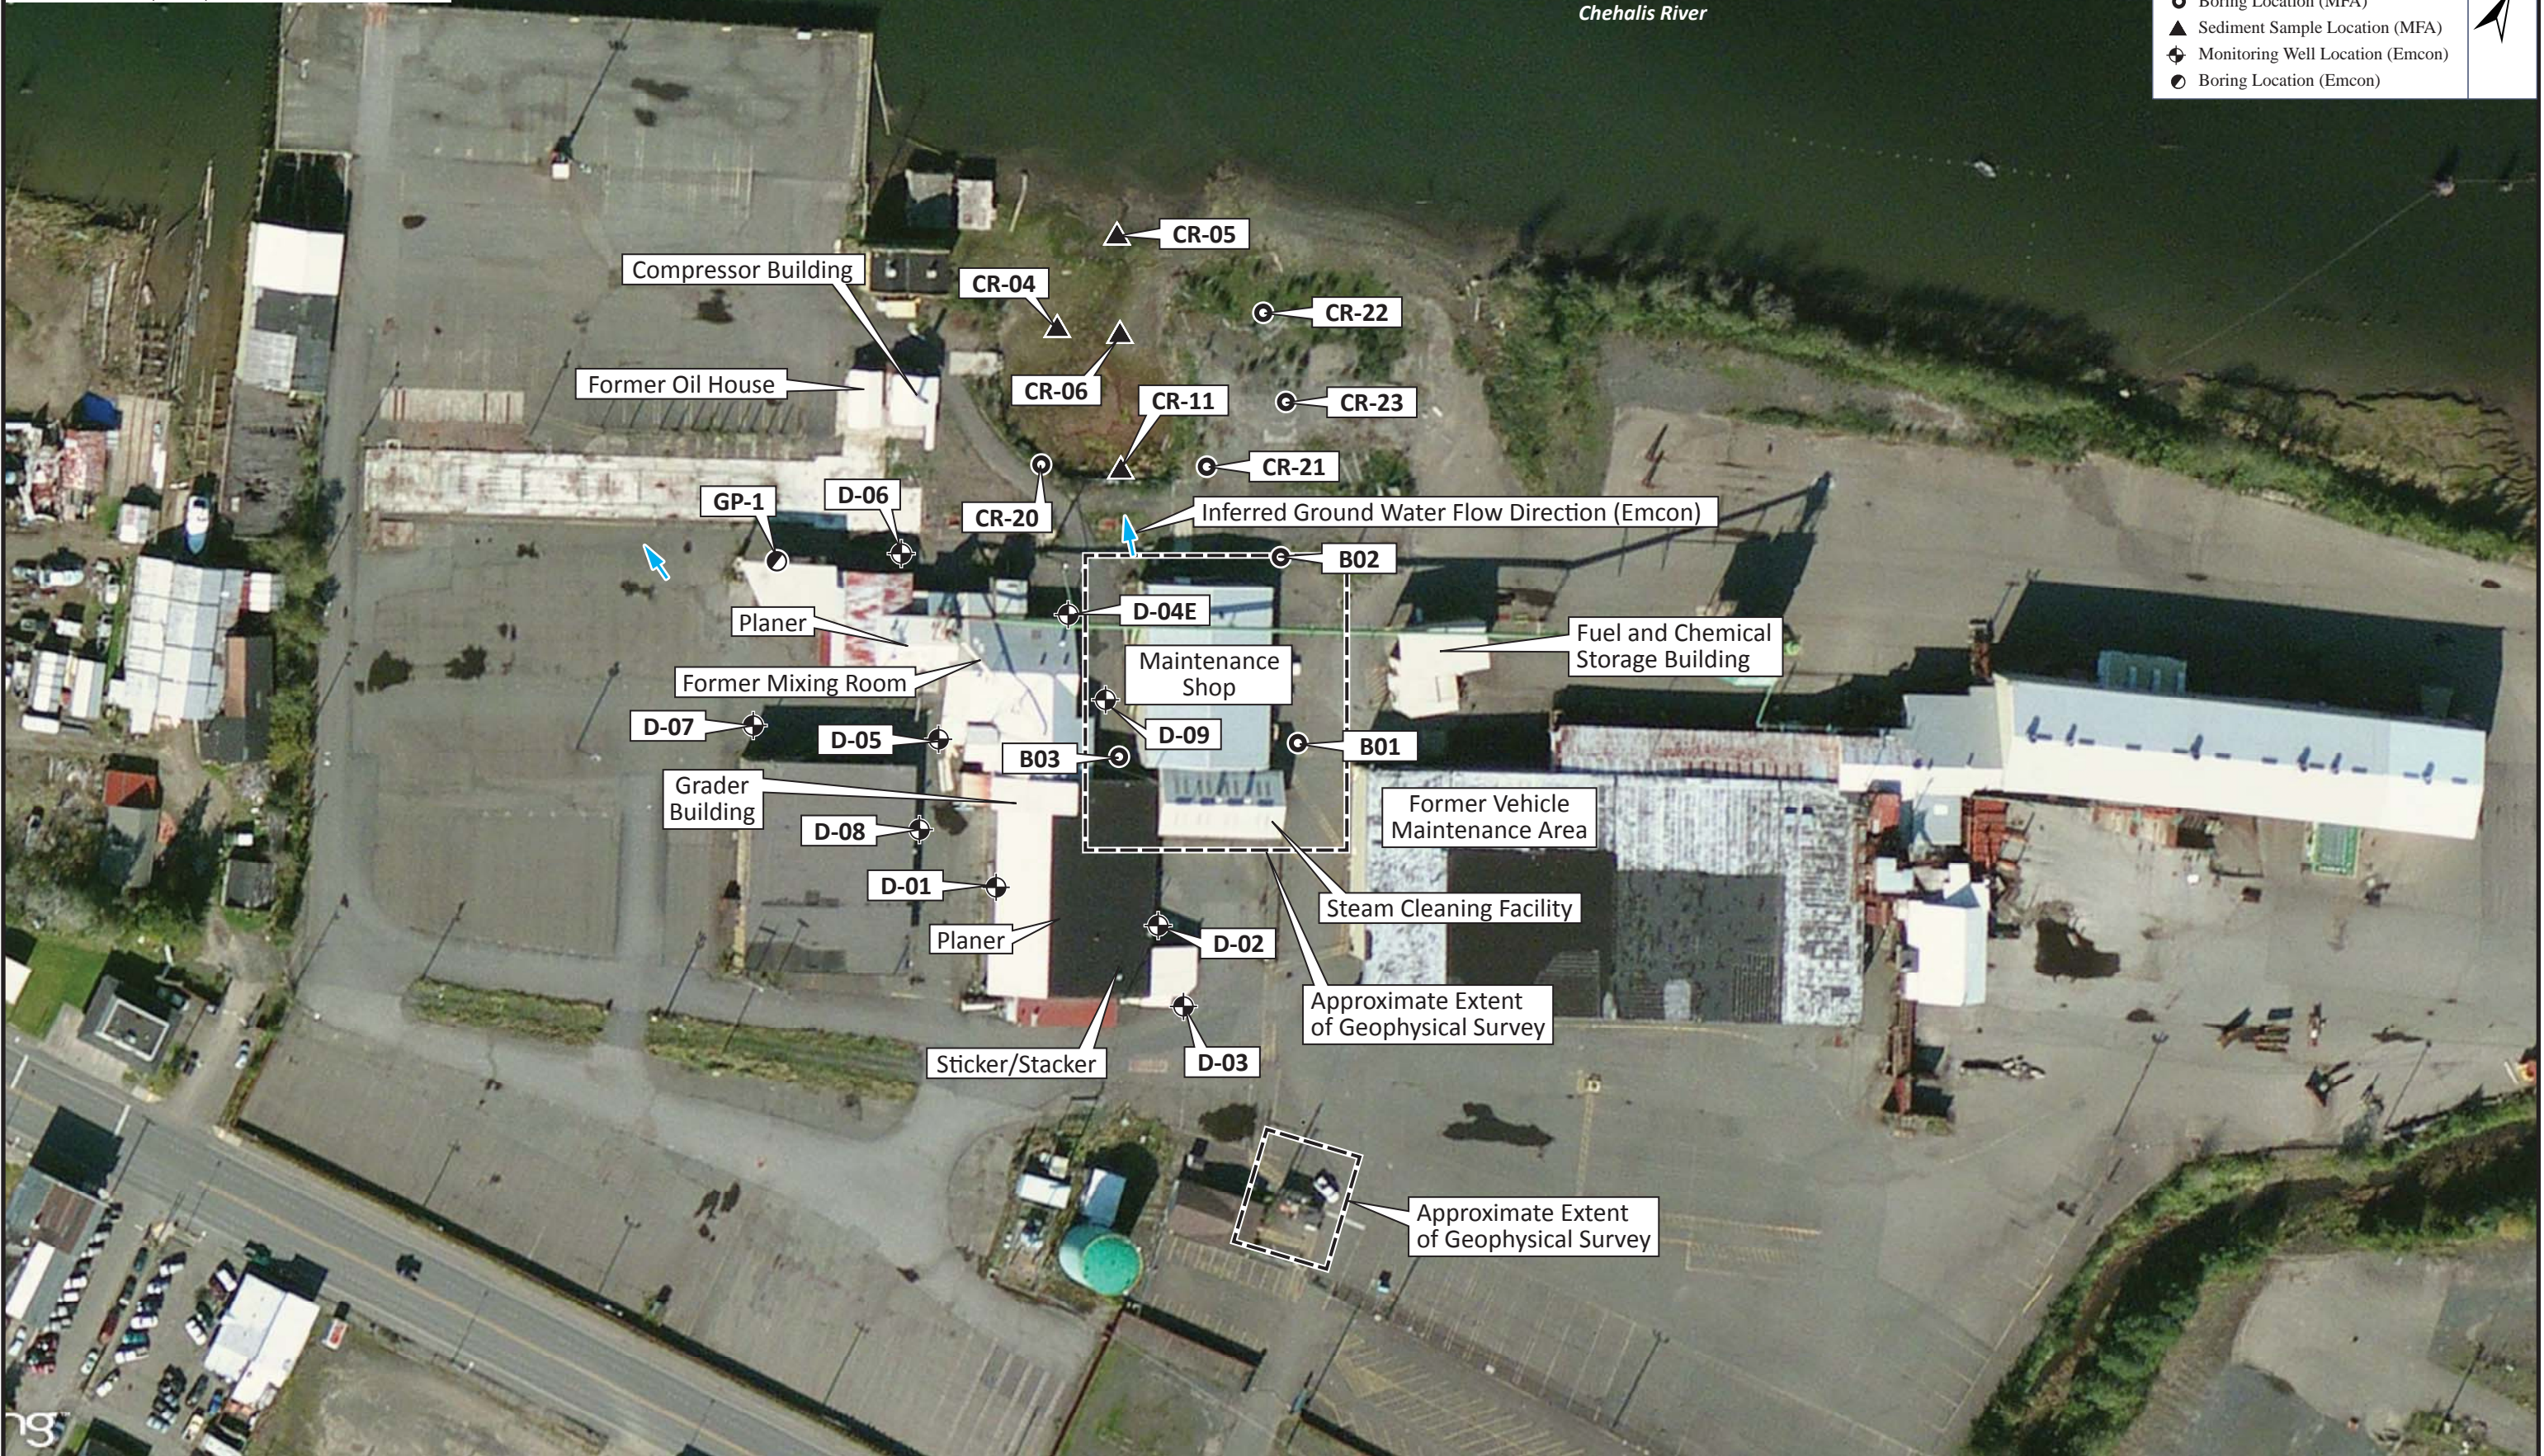
Key:

- Boring Location (MFA)
- ▲ Sediment Sample Location (MFA)
- ⊕ Monitoring Well Location (Emcon)
- Boring Location (Emcon)

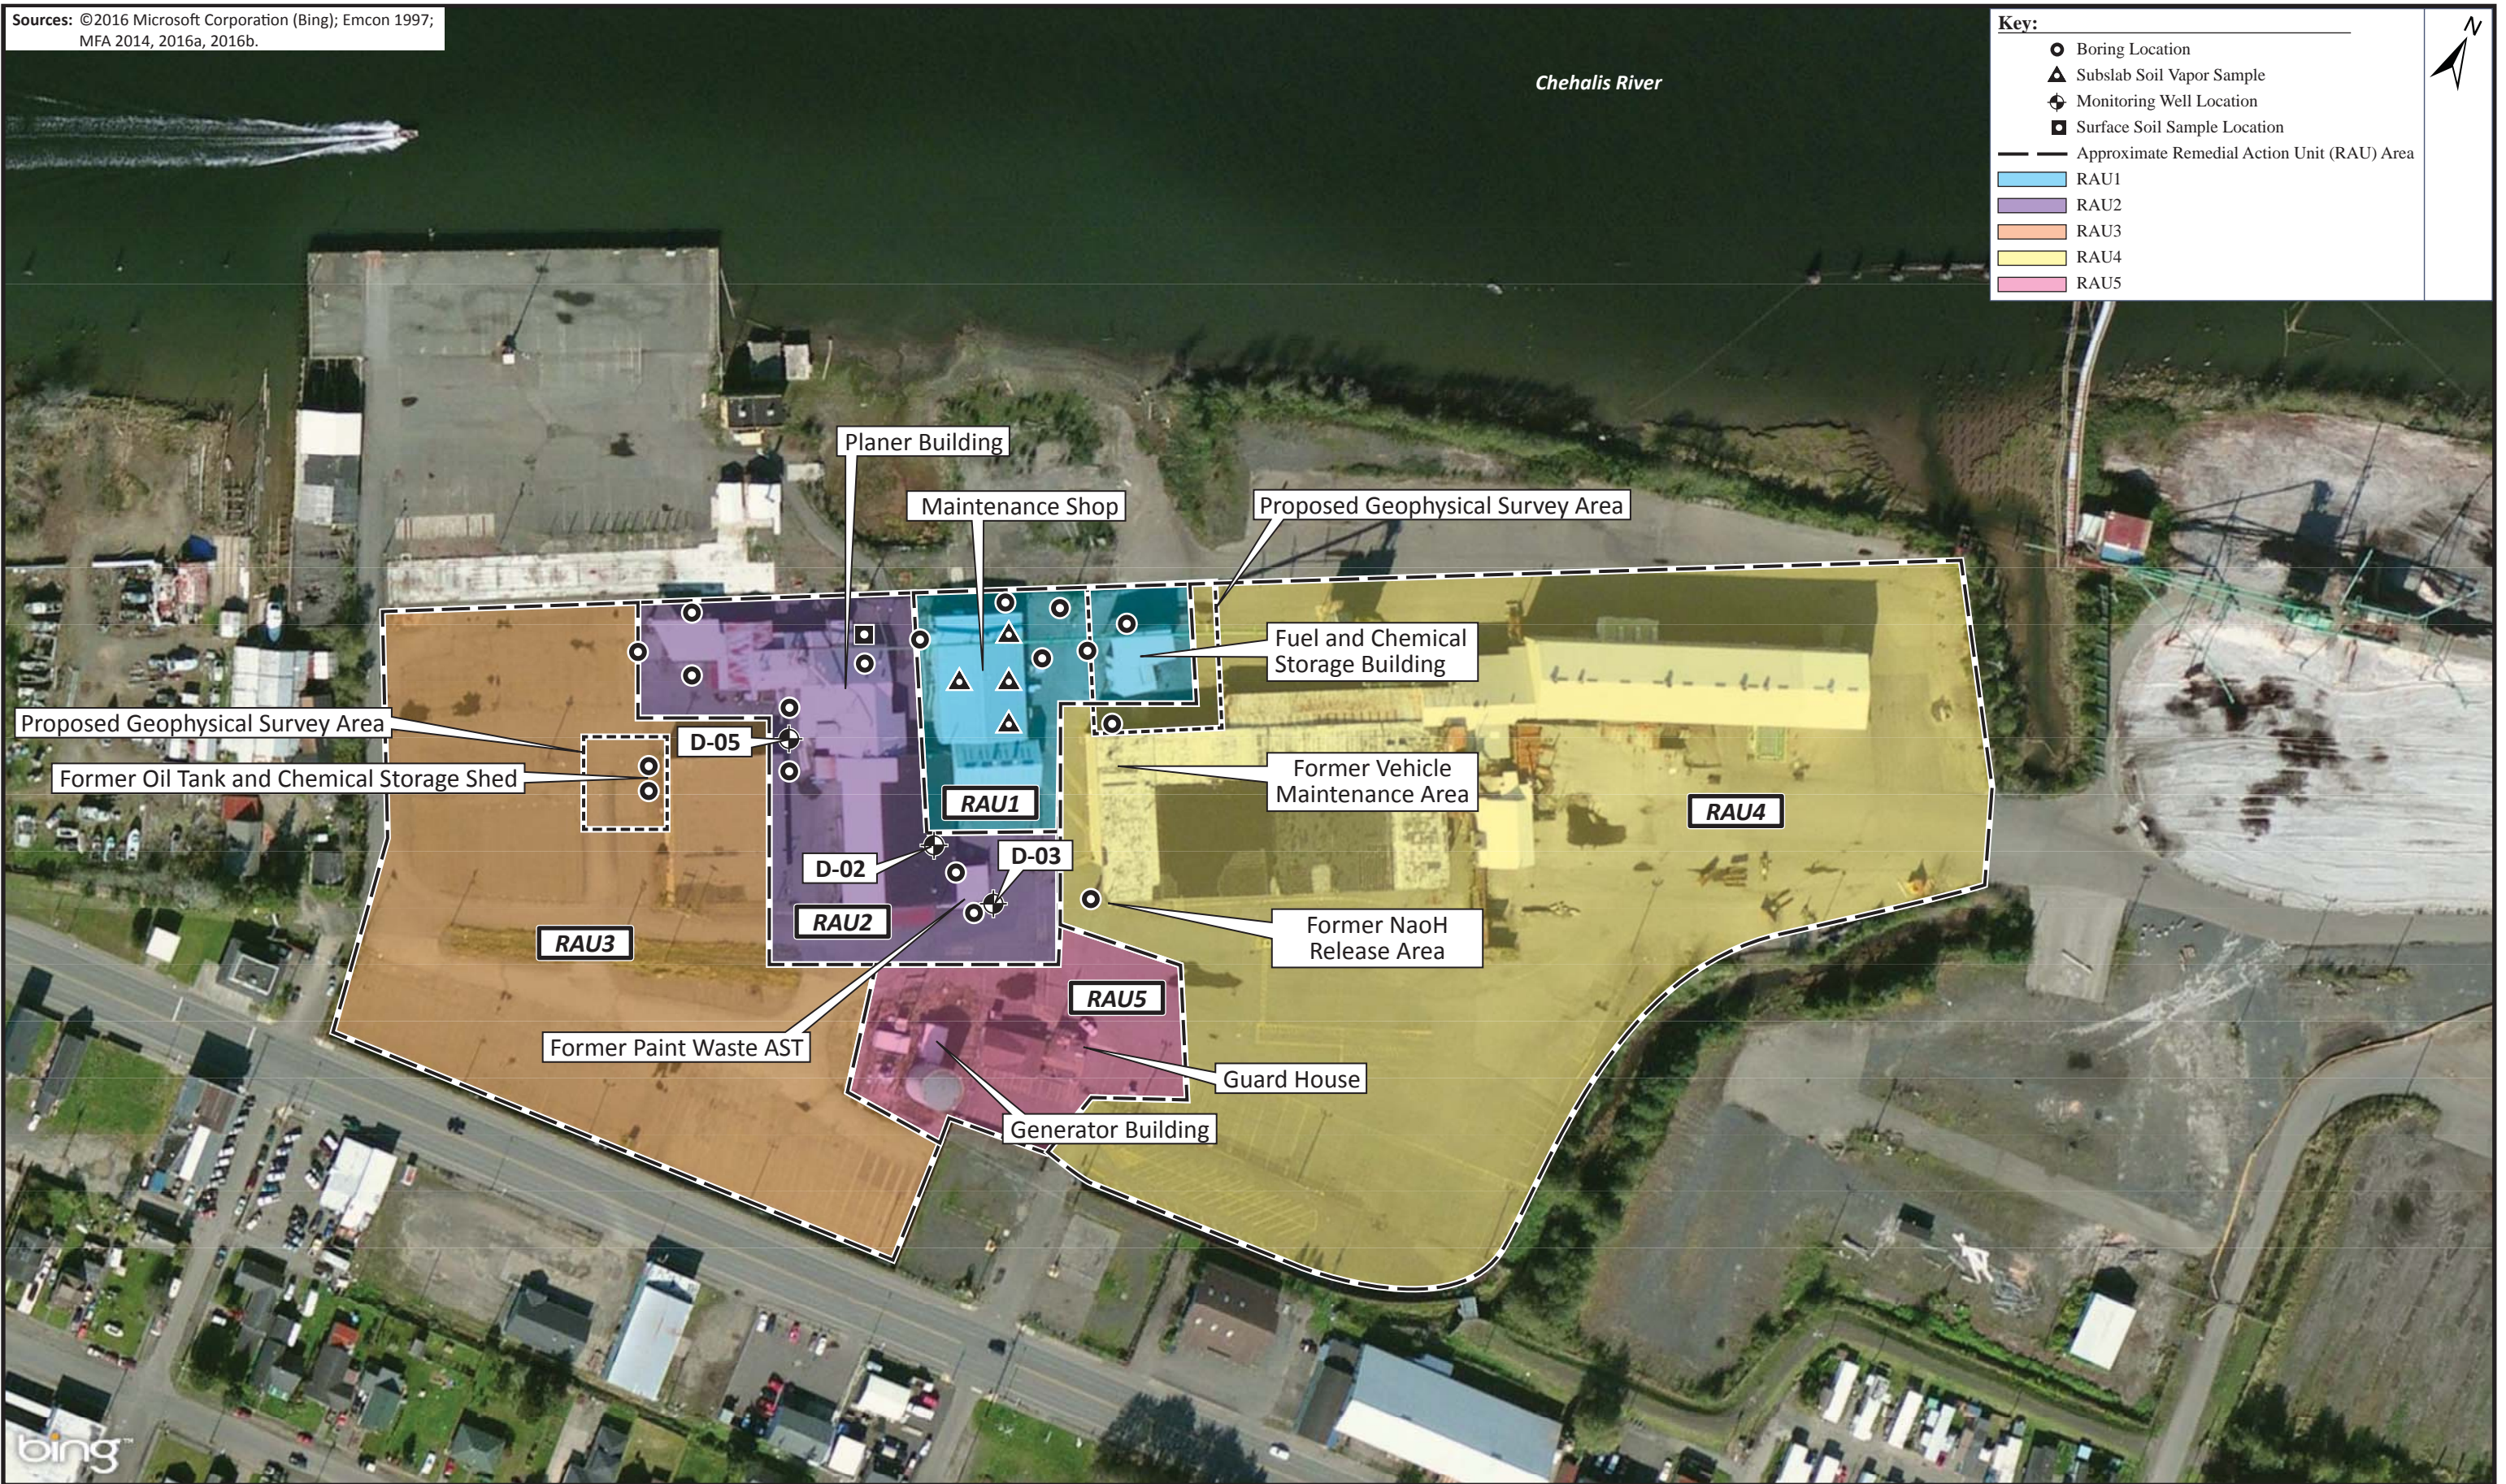
Key:

- Boring Location
- ▲ Subslab Soil Vapor Sample
- ⊕ Monitoring Well Location
- Surface Soil Sample Location
- Approximate Remedial Action Unit (RAU) Area
- RAU1
- RAU2
- RAU3
- RAU4
- RAU5
