220 Occidental Ave South, Seattle, WA 98104

March 28, 2017

**Re: Preliminary Determination of Liability for Release of Hazardous Substances at  
Weyerhaeuser Everett Mill E Site**

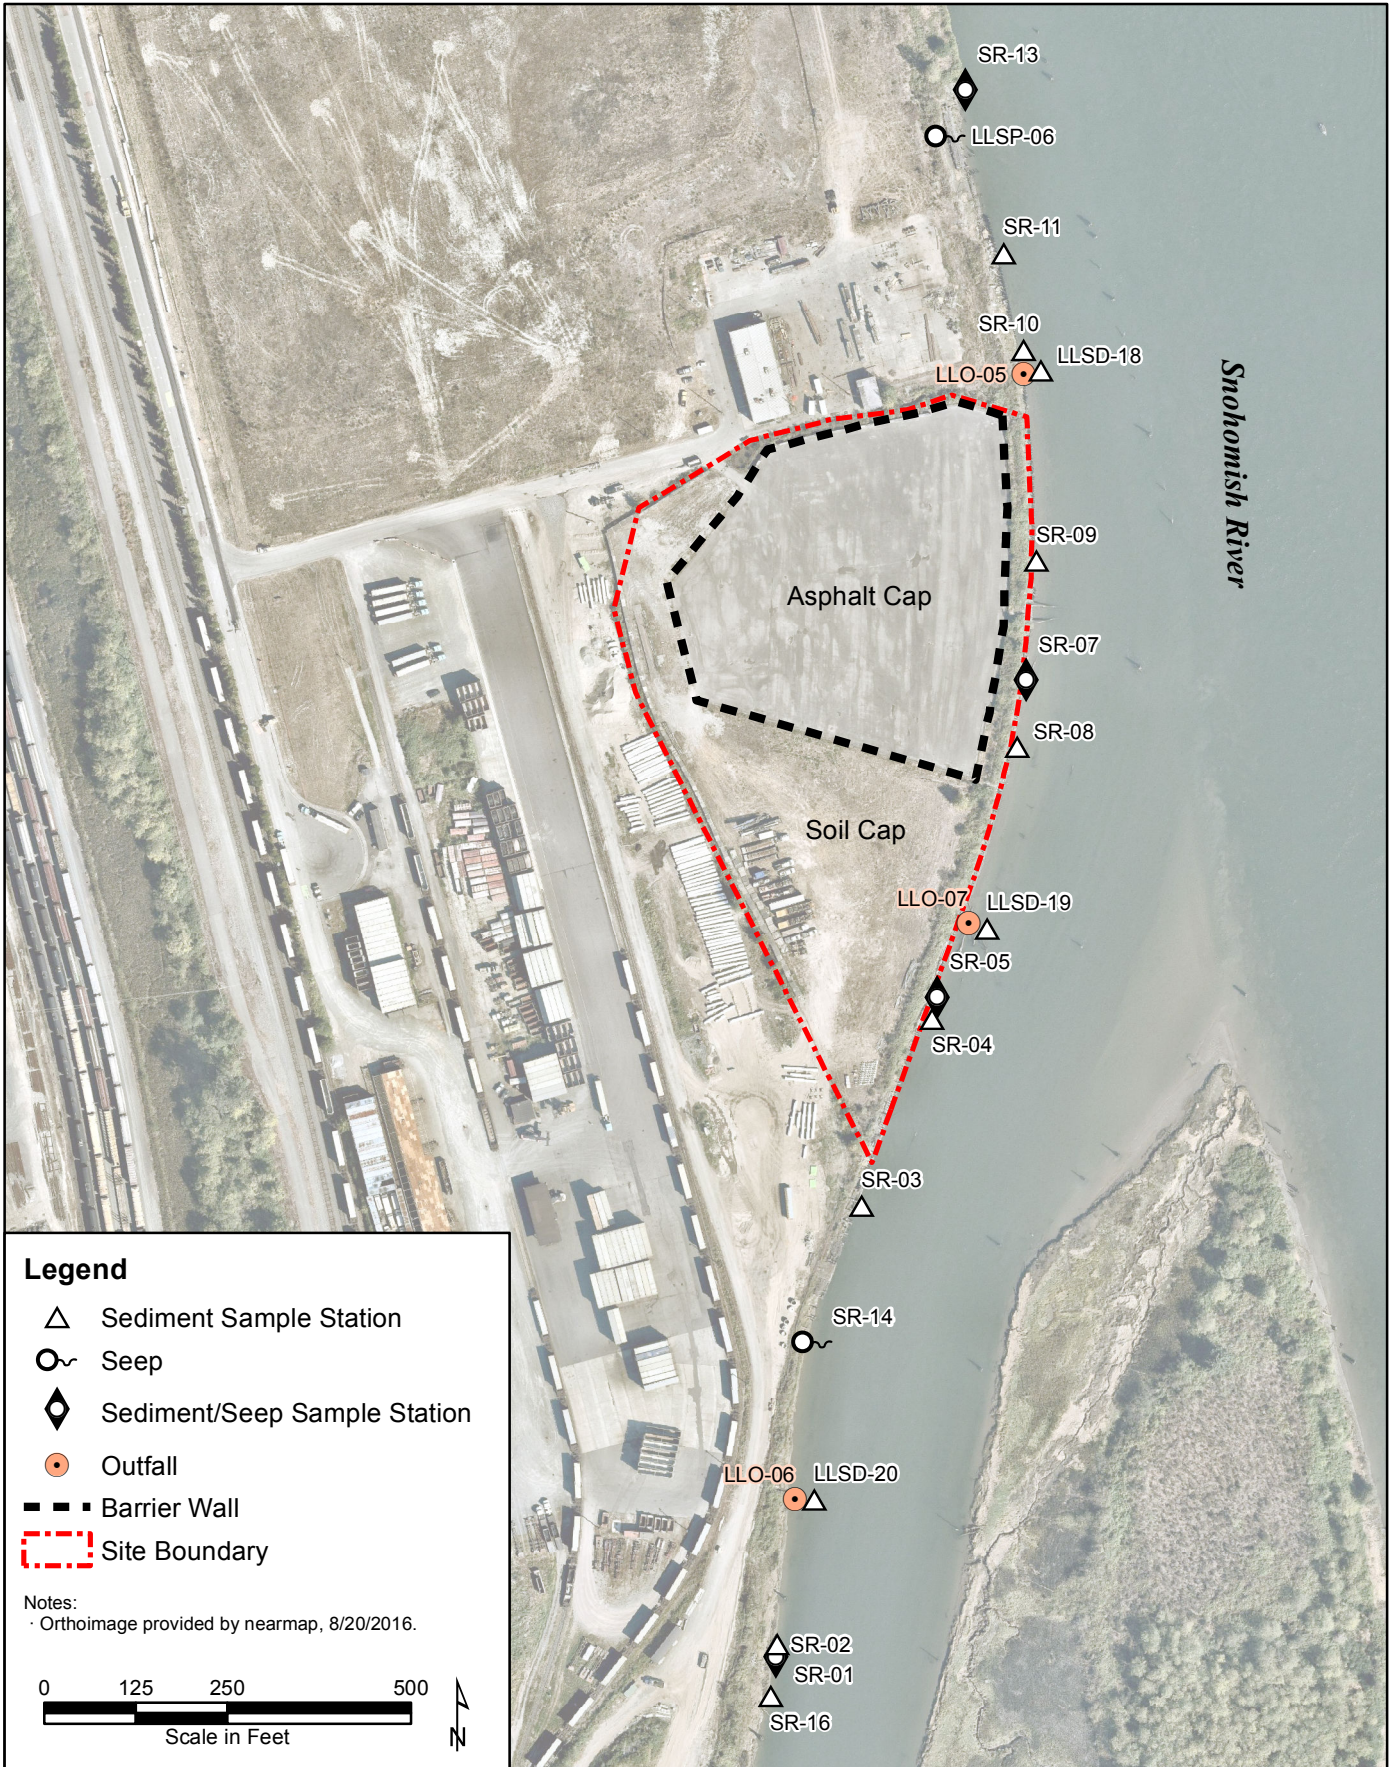
Finally, Weyerhaeuser and Floyd|Snider investigated every likely source of documents that might provide information about the pipe and Outfall LLO-07. Weyerhaeuser reviewed its own property records, and Floyd|Snider reviewed documents from the City of Everett, Snohomish County, Washington state archives and Sanborn maps. No record of this pipe and Outfall LLO-07 were found. The documentary record thus provides no credible evidence that the pipe and Outfall LLO-07 originate on the Site or that its purpose is to drain the Site. Stormwater features on the Site and in the immediate vicinity are shown on Figure 3 for reference.

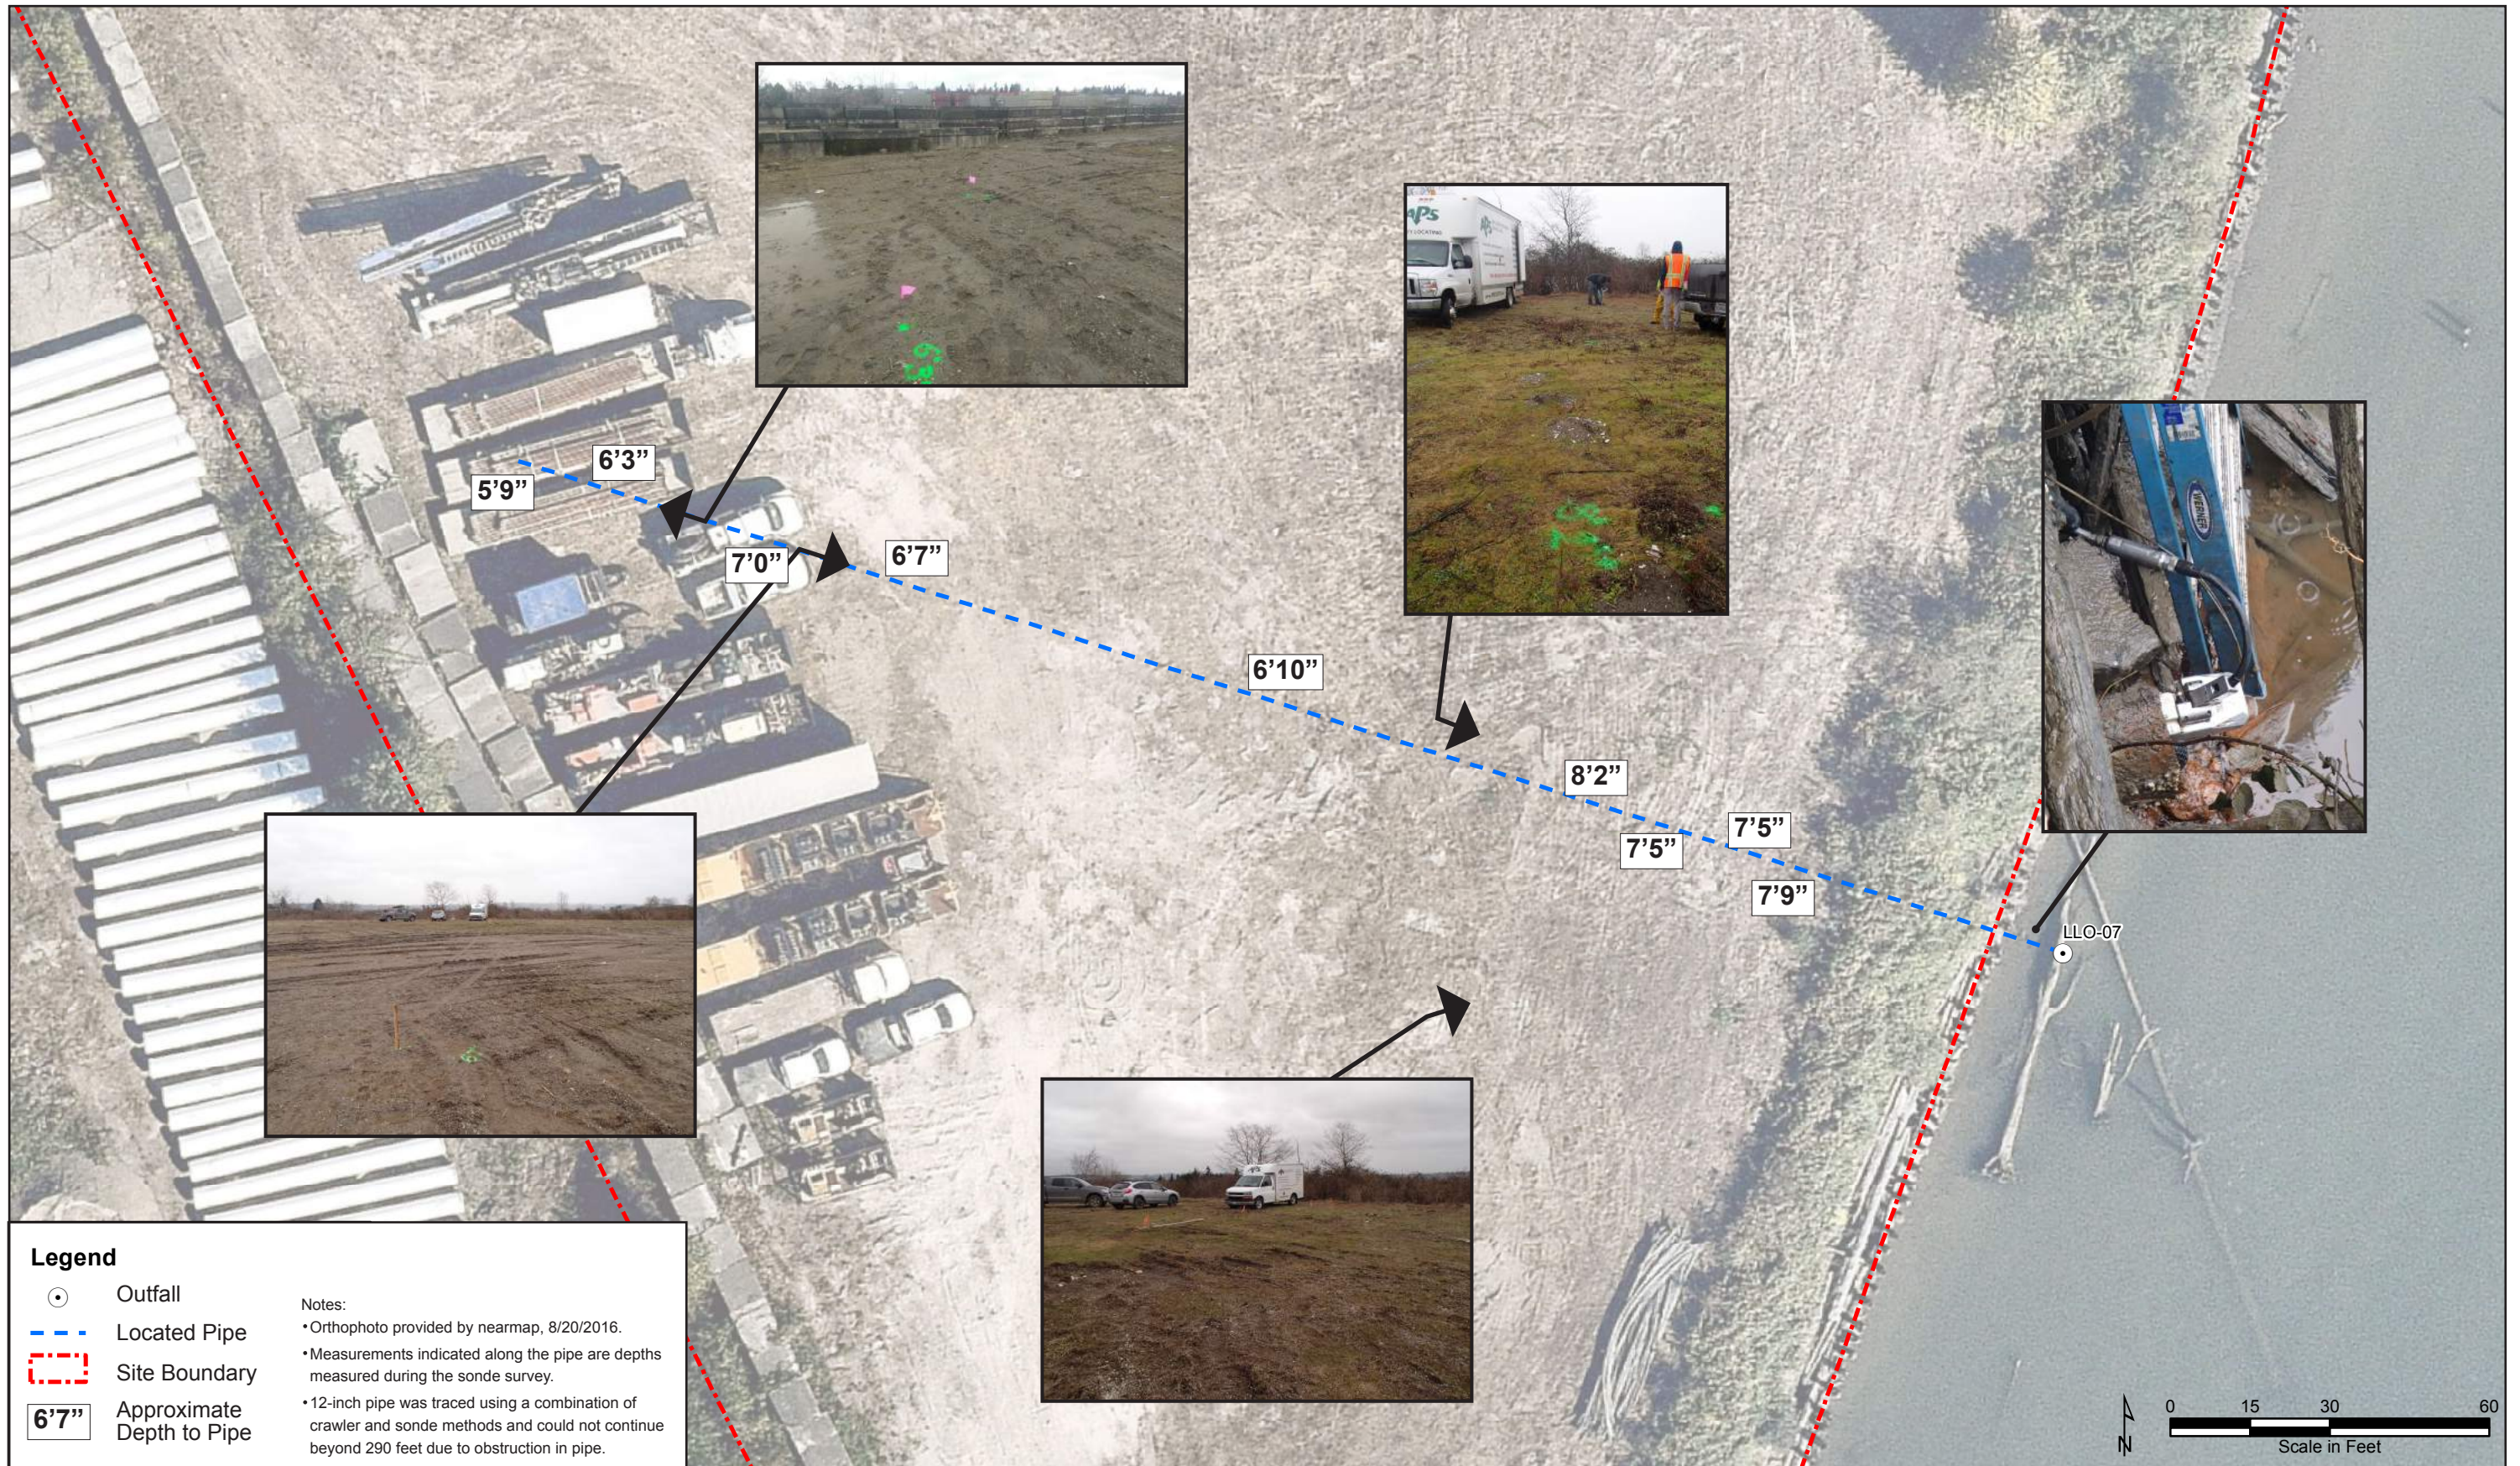
- Outfall
- - - Located Pipe
- - - Site Boundary
- 6'7" Approximate Depth to Pipe

Thus, our field work examined the pipe to the extent possible using all reasonable methods of in-pipe technology. The results all strongly indicate that the pipe continues on for the final forty feet to the Site and property boundary and beyond. Further, reasonable inferences from known data (pipe depth, pitch and discharge flow) all strongly and mutually support the conclusion that the pipe originates well beyond the Site and property boundary and that the pipe drains a much larger area than the soil cap area of the Site. And, there are no features of any kind observed at the Site, including any stormwater features, to indicate that this pipe drains any portion of the Site.

As discussed above, Floyd|Snider explored Outfall LLO-07 and its pipe alignment across 90% of the soil cap and to within 40 feet of the Site boundary and property line. These inside-the-pipe investigations, along with field observations along the alignment of the pipe, did not indicate any damage or loss of integrity to the pipe. During the field survey work, the Floyd|Snider and Pacific Topsoils team observed no surface indications that the pipe has lost integrity, such as excessive ponding, depressions or sinkholes. There is no evidence that indicates the pipe is not fully intact as it traverses the Site.
