Re: November 28, 2017 Further Action opinion letter  
Site Name: Gibraltar Senior Living  
Site Address: 10816 18<sup>th</sup> Ave. E., Tacoma, Pierce County, WA 98445  
Facility/Site ID No.: 6607  
Cleanup Site No.: 12686  
VCP Project No.: SW1472

I represent Gibraltar Senior Living, a senior living facility located at the above-referenced address in Pierce County, Washington ("Property" or "Site"). I am writing in response to your November 28, 2017 further action opinion letter, specifically to inquire into the necessity for additional site characterization triggered by an off-property detection of petroleum hydrocarbon contamination that is, in all likelihood, not related to contamination on the Site.

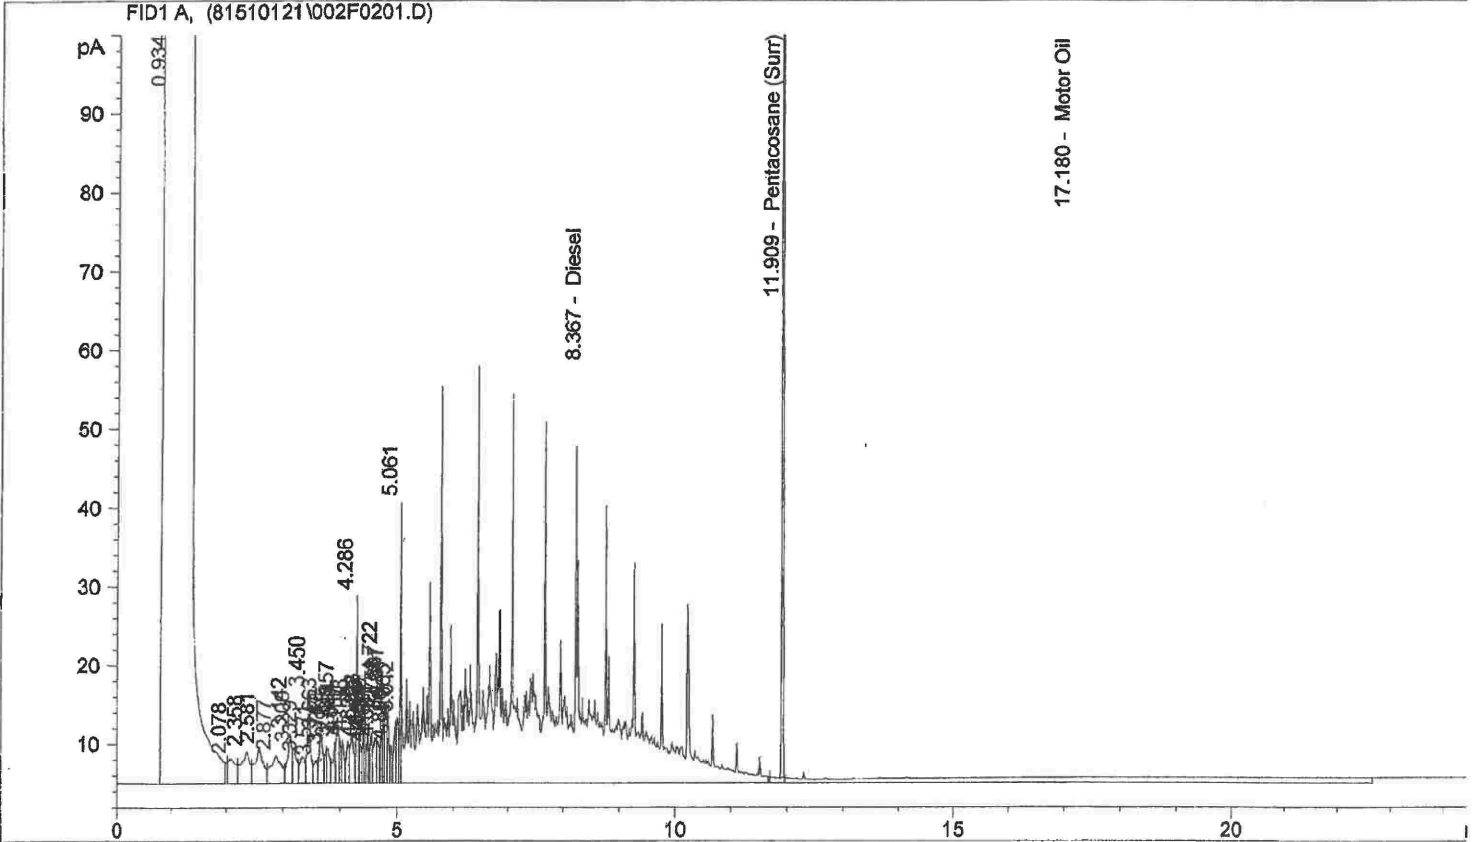
Sample Name: DSL STD W358-8

Instrument #81      Data File: C:\HPCHEM\1\DATA\81510121\002F0201.D  
 Operator:    DLC  
 Method:     C:\HPCHEM\1\METHODS\FDMO0914.M  
 Injection Date & Time: 10/12/2015 7:33:19 AM      10/12/2015 7:33:19 AM  
 Report Creation:      10/12/2015                      9:51:19 AM

Ret. Time	Signal	Compound Name	Response	Amount ug/mL
8.367	FID1 A,	Diesel	2973.699	256.742
11.909		Pentacosane (Surr)	269.305	11.091
17.180		Motor Oil	416.519	38.357

103%  
 111%    ± 15% OK

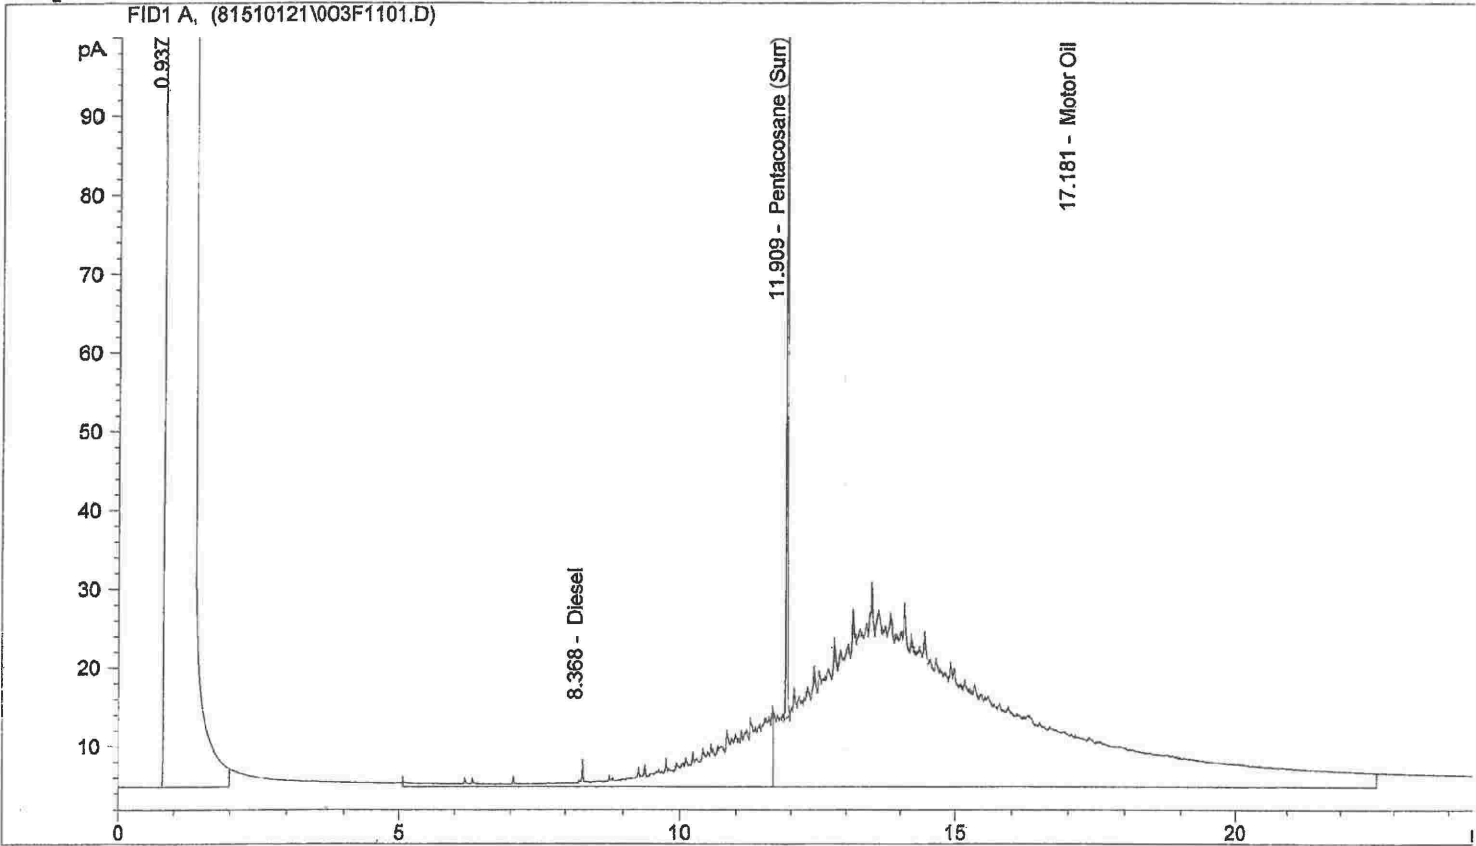
Sample Name: MO STD W358-9

Instrument #81      Data File: C:\HPCHEM\1\DATA\81510121\003F1101.D  
 Operator:    DLC  
 Method:     C:\HPCHEM\1\METHODS\FDMO0914.M  
 Injection Date & Time: 10/12/2015 1:43:55 PM      10/12/2015 1:43:55 PM  
 Report Creation:      10/12/2015                      2:17:01 PM

Ret. Time	Signal	Compound Name	Response	Amount ug/mL
8.368	FID1 A,	Diesel	764.839	66.034
11.909		Pentacosane (Surr)	266.076	10.958 110%
17.181		Motor Oil	5418.986	499.026 100% ±15% OK
