STATE OF WASHINGTON
DEPARTMENT OF ECOLOGY

February 27, 2018

Re: Opinion on Proposed Cleanup of the following Site:

- **Site Name:** Kelly Moore Paint Company
- **Site Address:** 5410 Airport Way South, Seattle, WA 98108
- **Facility/Site No.:** 2163
- **VCP Project No.:** NW2305
- **Cleanup Site ID:** 5064

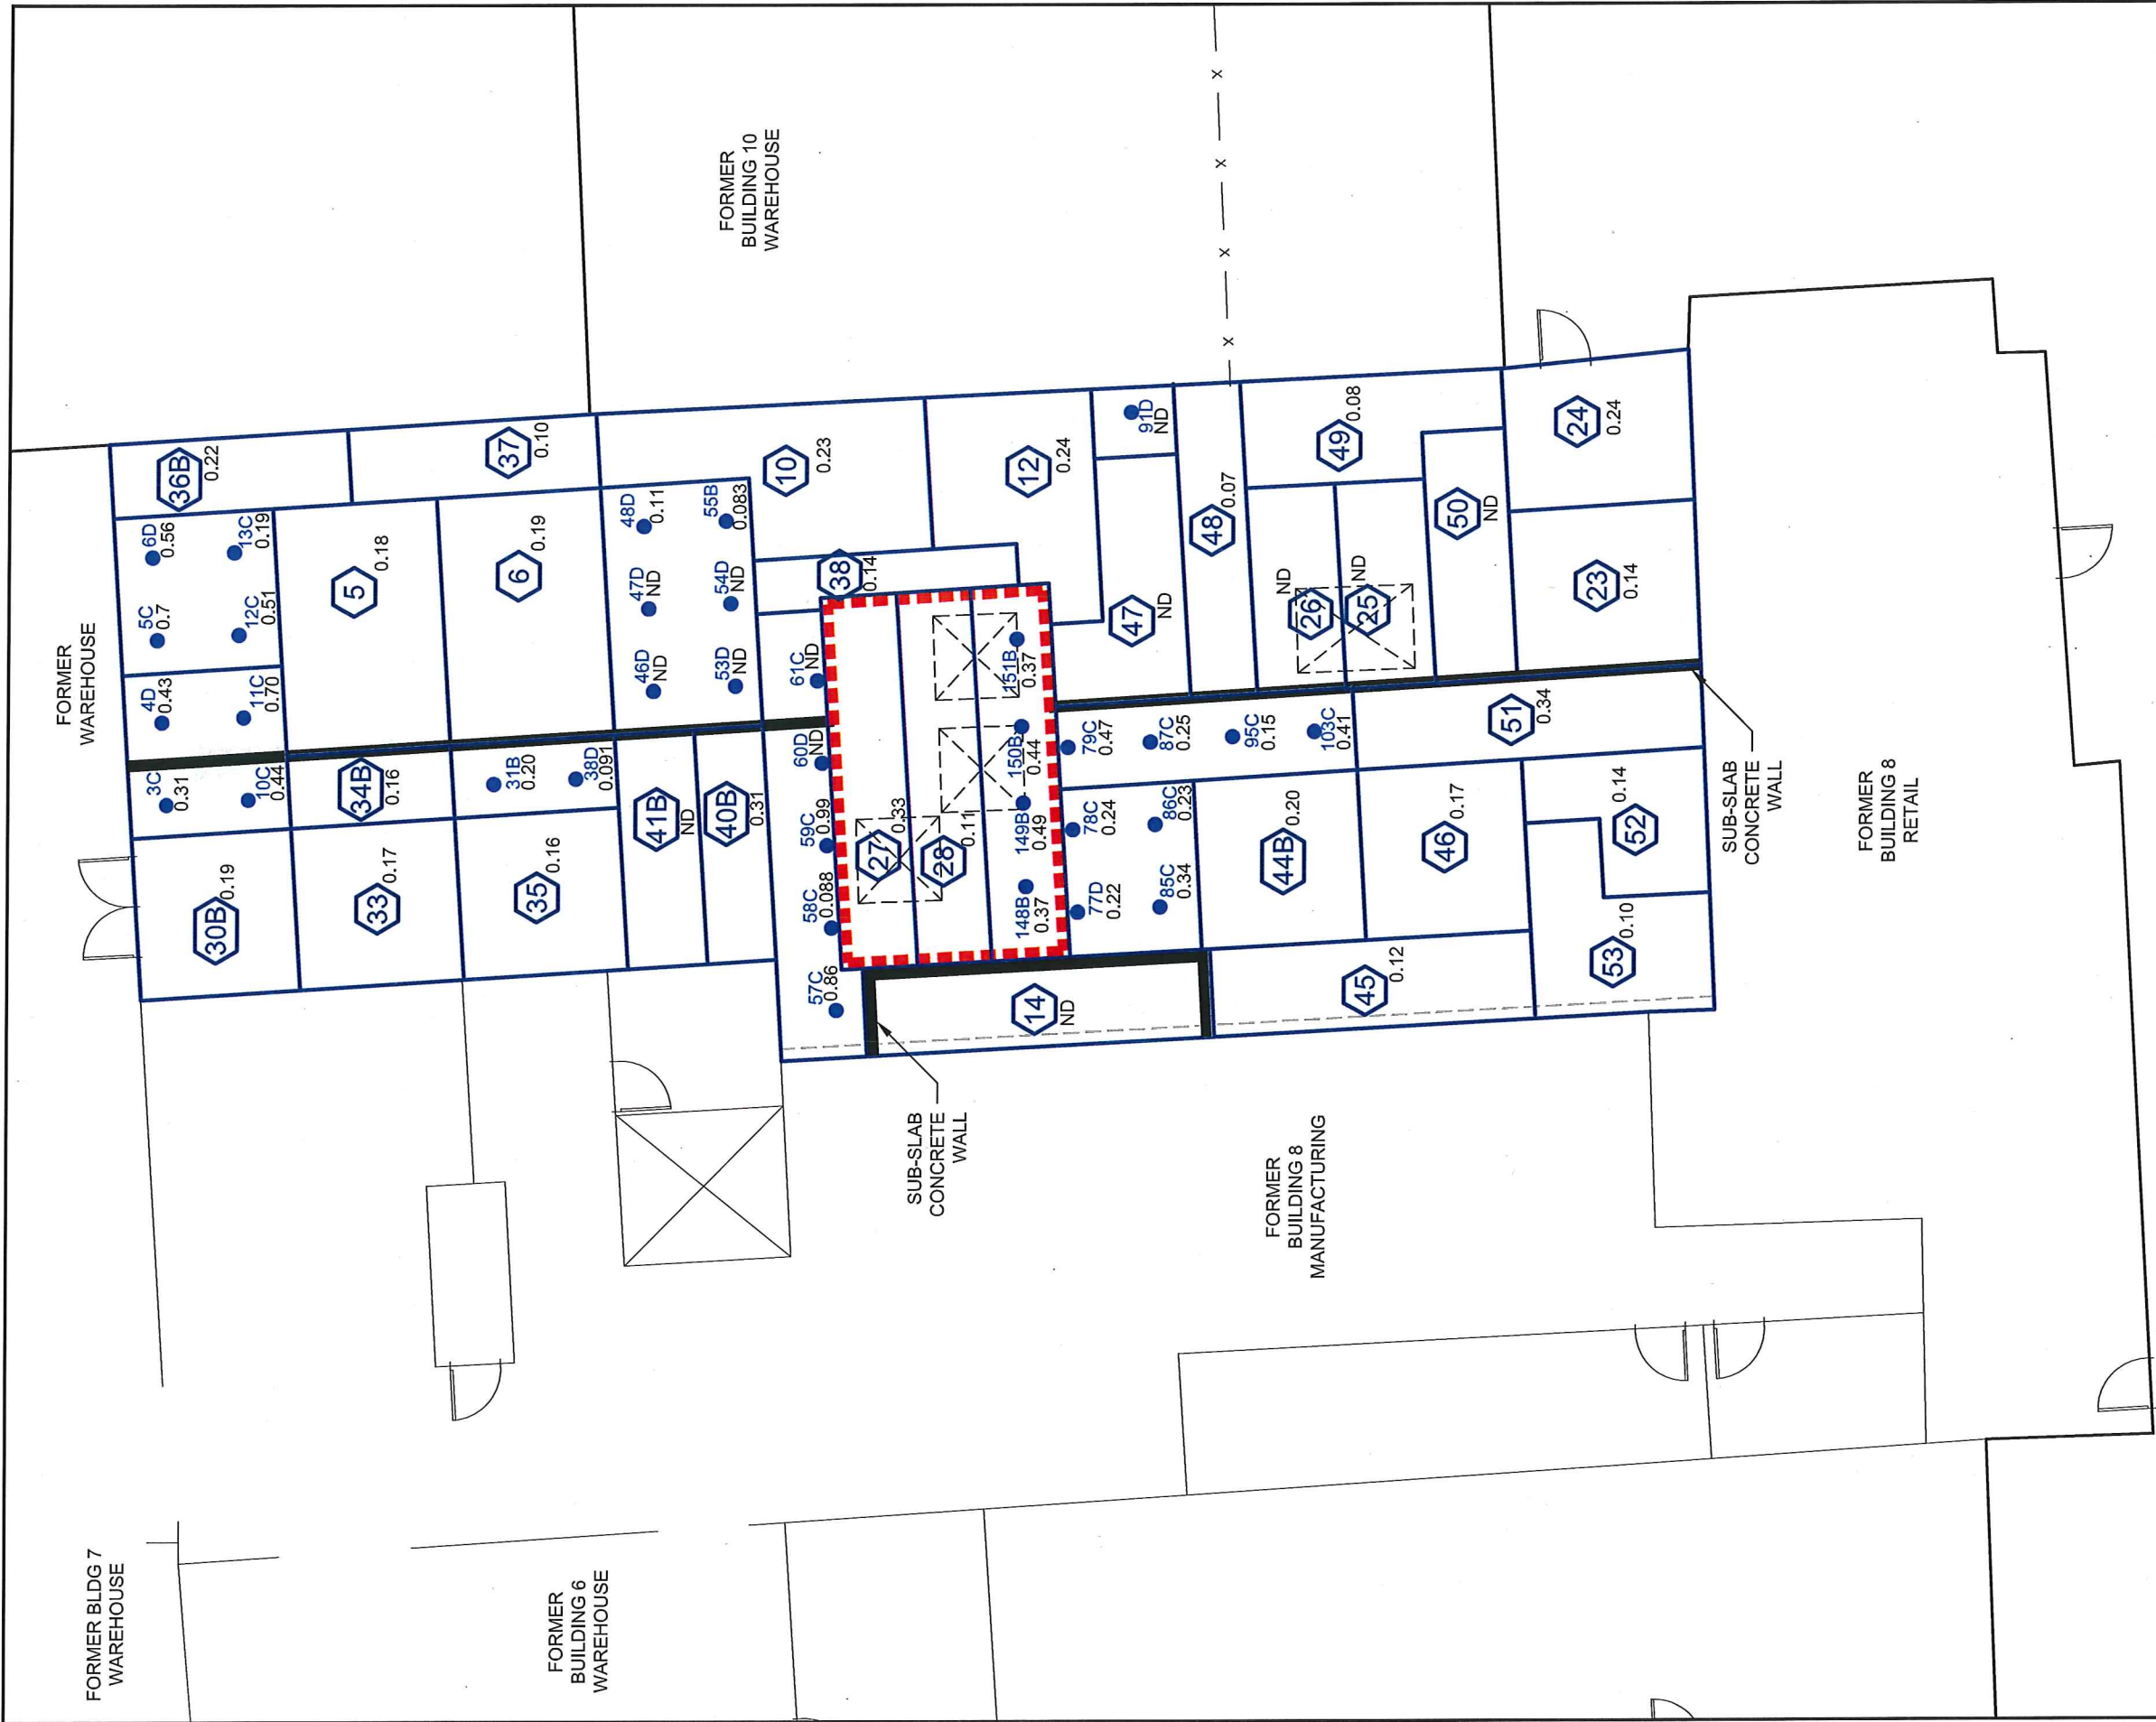
Enclosure A: Figure 8

EXPLANATION

- PCB PRIMARY SAMPLE LOCATION WITH PCB CONCENTRATION IN mg/kg
- COMPOSITE SAMPLE AREA AND DESIGNATION WITH PCB CONCENTRATION IN mg/kg

EXTENT OF SCALE PIT EXCAVATION

FORMER FLOOR SCALE PIT

amec foster wheeler	PROJECT	5410 Airport Way South Seattle, Washington		DATE	MAY 2015
	Amec Foster Wheeler Environment & Infrastructure, Inc. 600 University Street, Suite 600 Seattle, WA 98101		TITLE	BUILDING 8 EXCAVATION FINAL PCB SAMPLE RESULTS	SCALE	1" = 10'	
					PROJECT NO.	16110	
			FIGURE			4
