STATE OF WASHINGTON
DEPARTMENT OF ECOLOGY

Re: Opinion pursuant to WAC 173-340-515(5) on Proposed Remedial Action for the following Hazardous Waste Site:

- **Site Name:** Cowman Campbell Paints
- **Site Address:** 5221 Ballard Avenue NW, Seattle, WA
- **Facility/Site No.:** 30774595
- **VCP Project No.:** NW3030
- **Cleanup Site ID No.:** 8651

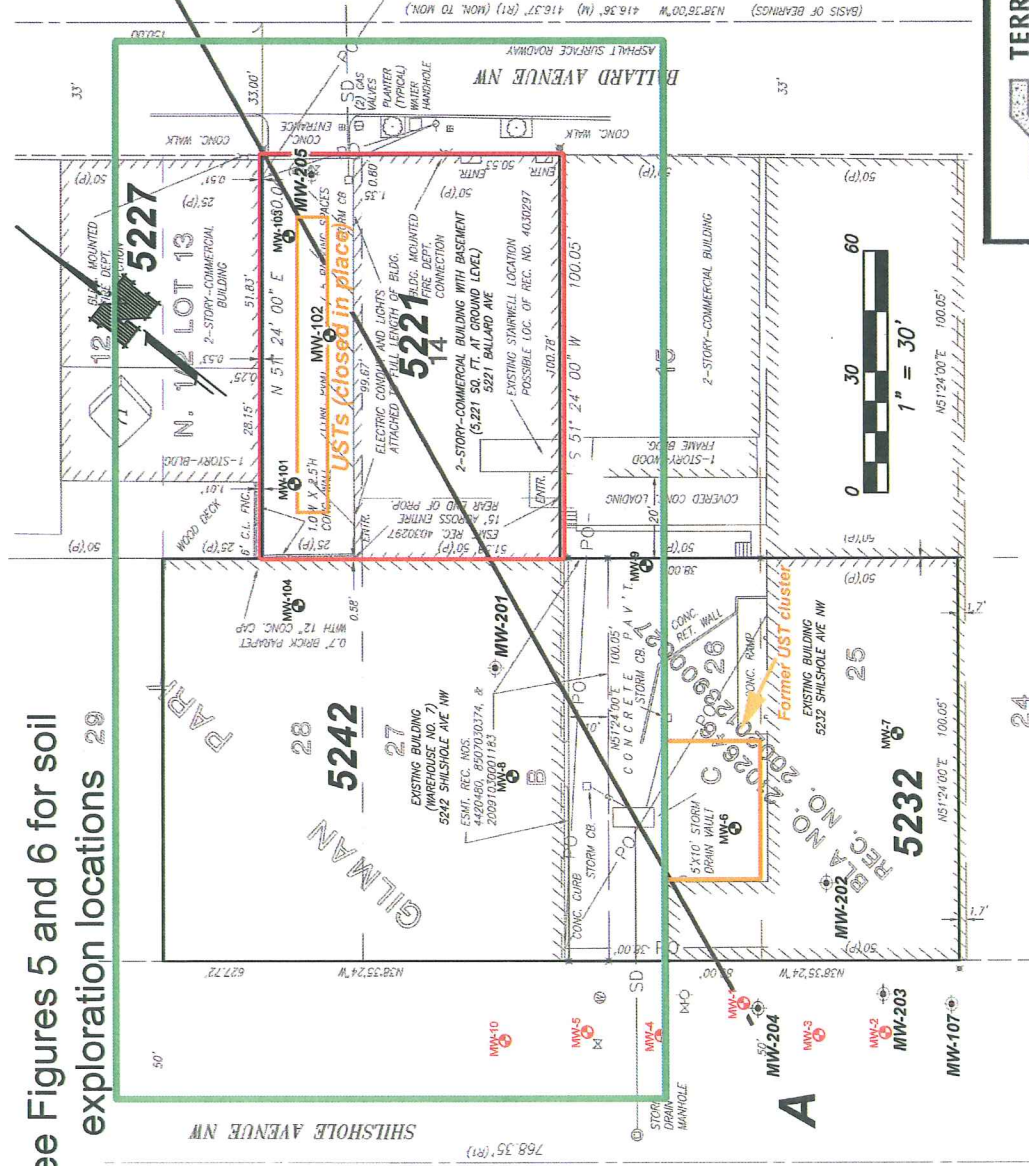
Proj. No. T-6552 Date Oct 2015 Figure 3

MW prefix indicates that the boring was completed as a monitoring well. Monitoring wells shown in red have been abandoned.

Monitoring Well Location Plan
5221 Ballard Ave NW
Seattle, Washington

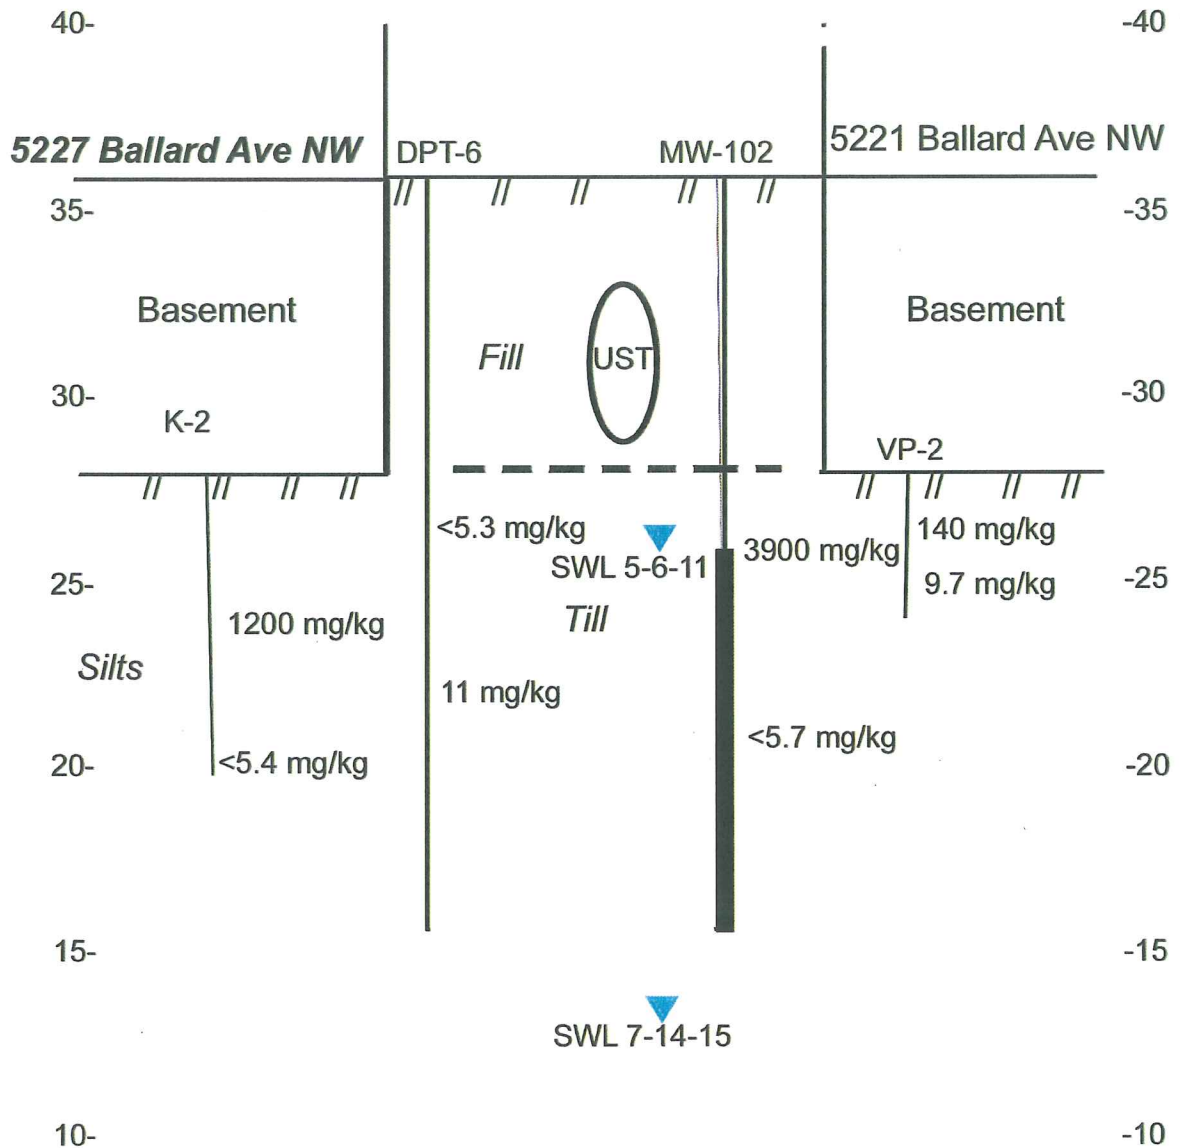
Horizontal Scale 1"=10 feet
 Vertical Scale 1" = 5'
 Cross Section View is looking north
