TECHNICAL MEMORANDUM

RE: Response to Comments on Remedial Investigation Checklist
Meeker Former Gas Station Site
105 Washington Ave N., Kent, WA
Cleanup Site ID: 2782
Facility/Site ID: 44681713
VCP Project ID: NW3167

EPI Project Number: 65112.5

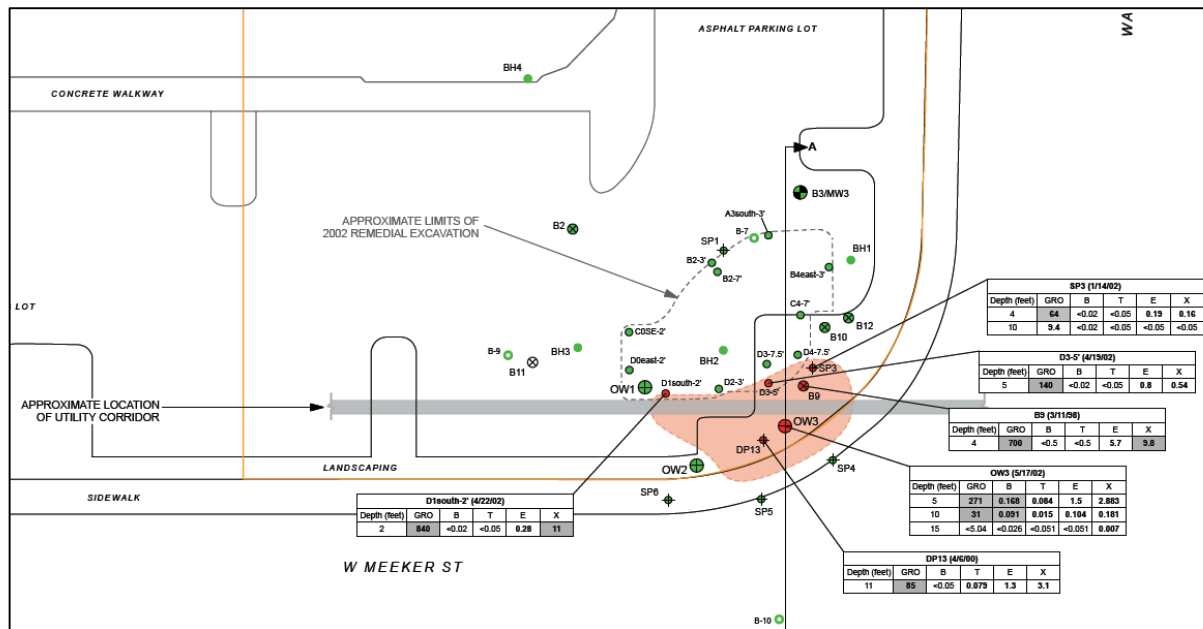
(Image Source: RI/FS/CAP, September 1, 2017)

EPI believes that the Site is sufficiently characterized. All contaminated soil was removed to the maximum extent practicable in 2002. After the soil removal, sampling was performed at all possible locations. The following image illustrates the area of contaminated soil that was removed in 2002 and all post-excavation sampling locations.

The sampling locations were selected based on existing data and were limited by the presence of dense utilities, natural gas lines, and other buried infrastructure associated with the major arterial intersection, including traffic-related sensors beneath the adjacent roadway to the east. As illustrated in the above image, the off-site extent of remaining impacted media is well defined to the south and southeast and no additional characterization is possible or necessary. EPI would like to discuss any perceived data gaps with the Ecology Site Manager, when assigned.
