Lower Duwamish Waterway Source Control Status Report January 2014 through December 2016

June 2018

Publication No. 17-09-266

Toxics Cleanup Program
Northwest Regional Office
Washington State Department of Ecology
Bellevue, Washington

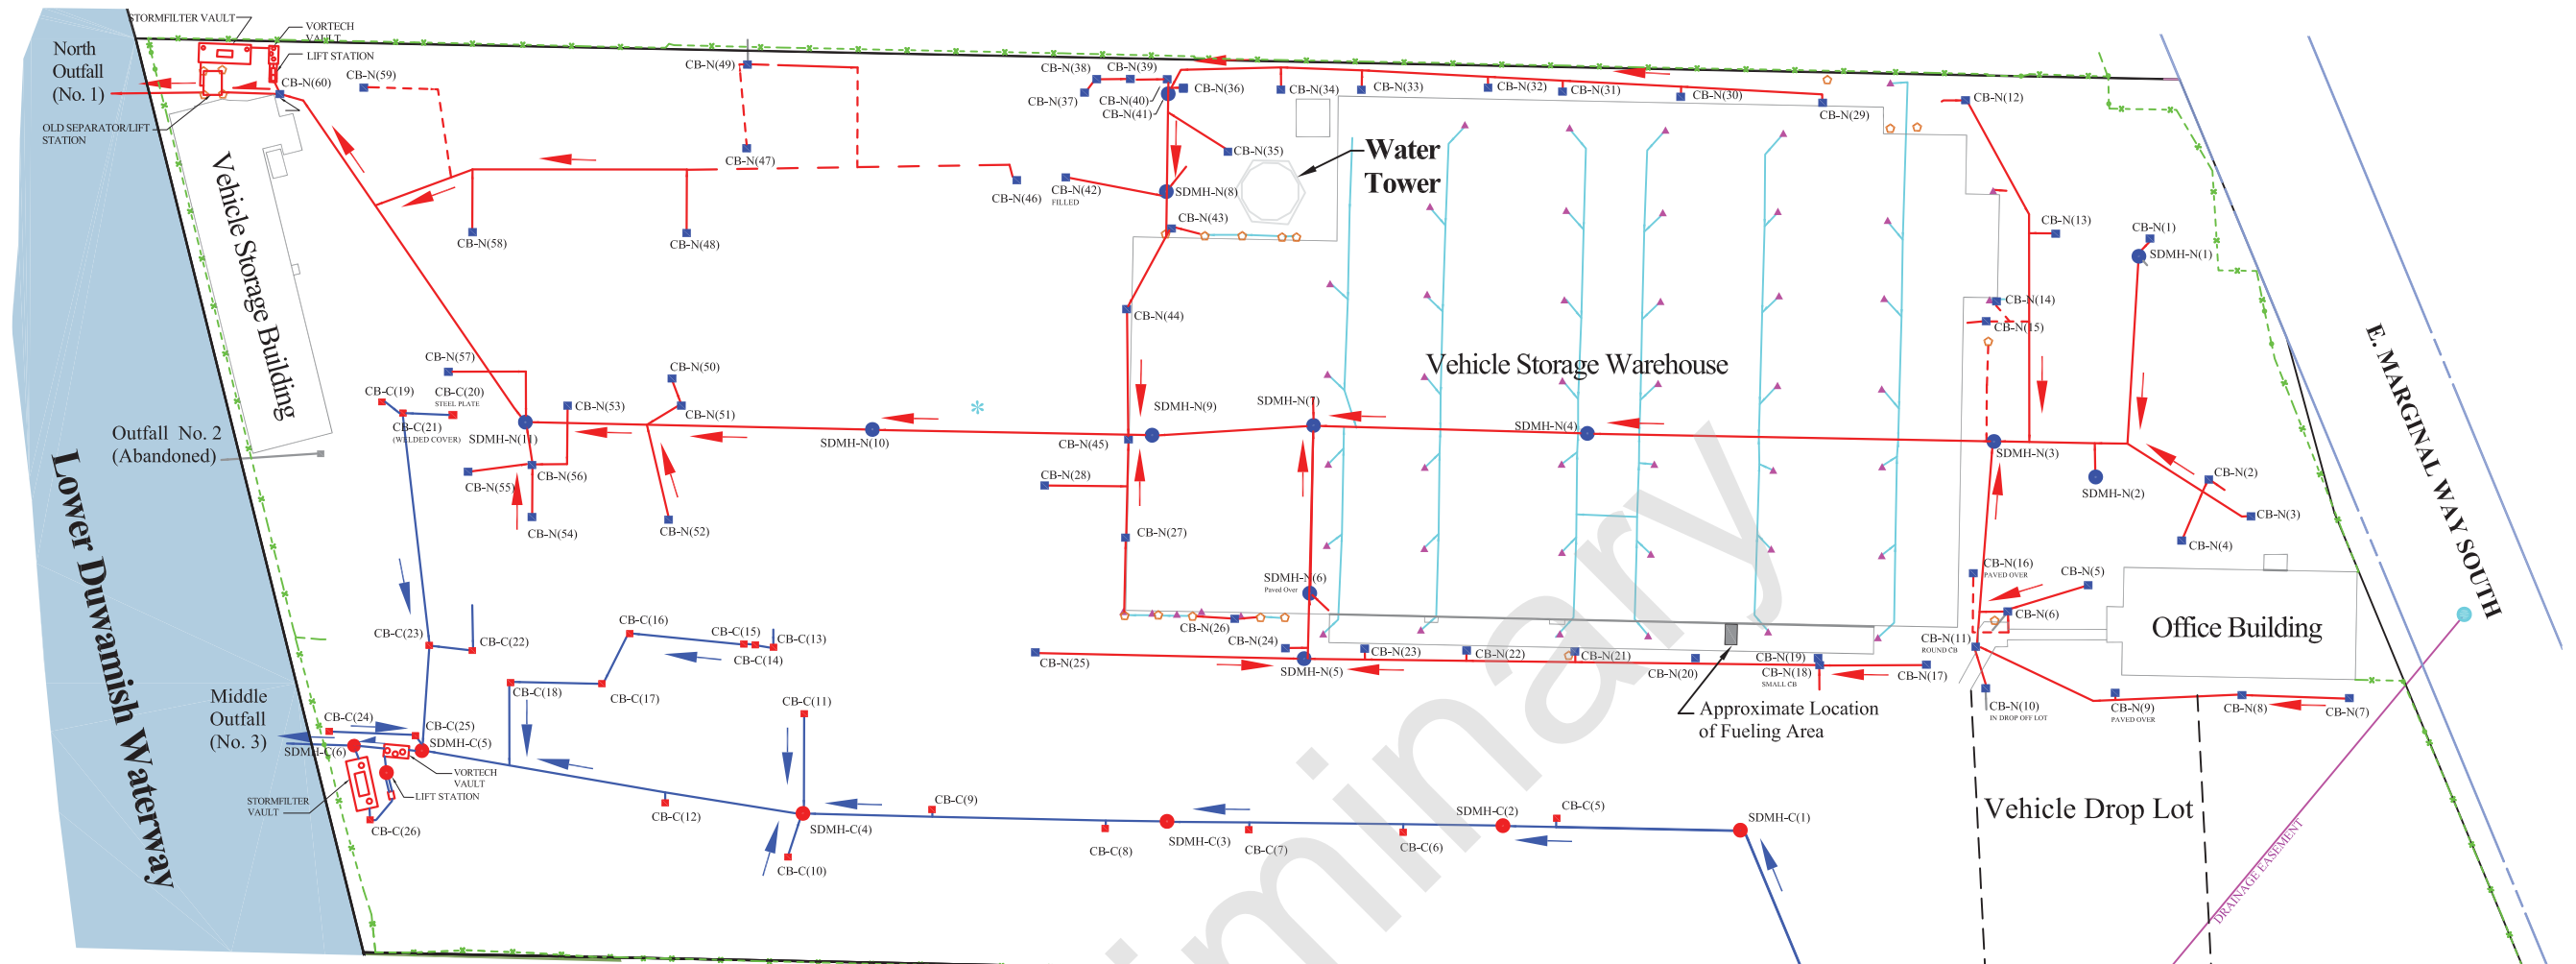
OUTFALL NO. 1 STORM DRAIN PIPES		OUTFALL NO. 1 BASIN CONVEYANCE /ROUTE
	OUTFALL NO. 1 CATCH BASINS		OVERFLOW ROUTE ^a
	OUTFALL NO. 1 STORM DRAIN MANHOLES		OUTFALL NO. 3 BASIN CONVEYANCE ROUTE
	OUTFALL NO. 3 STORM DRAIN PIPES		DOWNSPOUTS
	OUTFALL NO. 3 CATCH BASINS		ROOF DRAIN INLET
	OUTFALL NO. 3 STORM DRAIN MANHOLES		ROOF DRAIN PIPES
	EASEMENT STORM DRAIN PIPES		EAST MARGINAL WAY RIGHT OF WAY
	EASEMENT STORM DRAIN MANHOLES		FENCE LINE
	ABANDONED STORM DRAIN PIPES		PROPERTY LINE
	PRESUMED ALIGNMENT OF STORM DRAIN PIPES ^b		APPROXIMATE LOCATION OF A WELL - NON STORM WATER RELATED STRUCTURE

^a DURING SEVERE STORM EVENTS, THIS ROUTE MAY BE USED IN CONJUNCTION WITH THE NORMAL FLOW ROUTE
^b BASED ON HISTORICAL INFORMATION OR FIELD OBSERVATIONS OF PIPES WITHIN DRAINAGE STRUCTURES, DYE/SMOKE TESTING, AND VIDEO SURVEILLANCE. WORK IS ONGOING TO CONFIRM THESE CONNECTIONS.

Note:
 Base map, utilities, and all survey related information has been obtained from Barghausen Consulting Engineers, Incorporated As-built storm drainage and water quality improvements plans, dated 7/19/08. The base map has been updated based on field observations by Insurance Auto Auctions and Windward Environmental staff. The storm drain system on north parcel is owned by Merrill Creek Holdings LLC. The storm drain system on the south parcel is owned by Container Properties LLC.

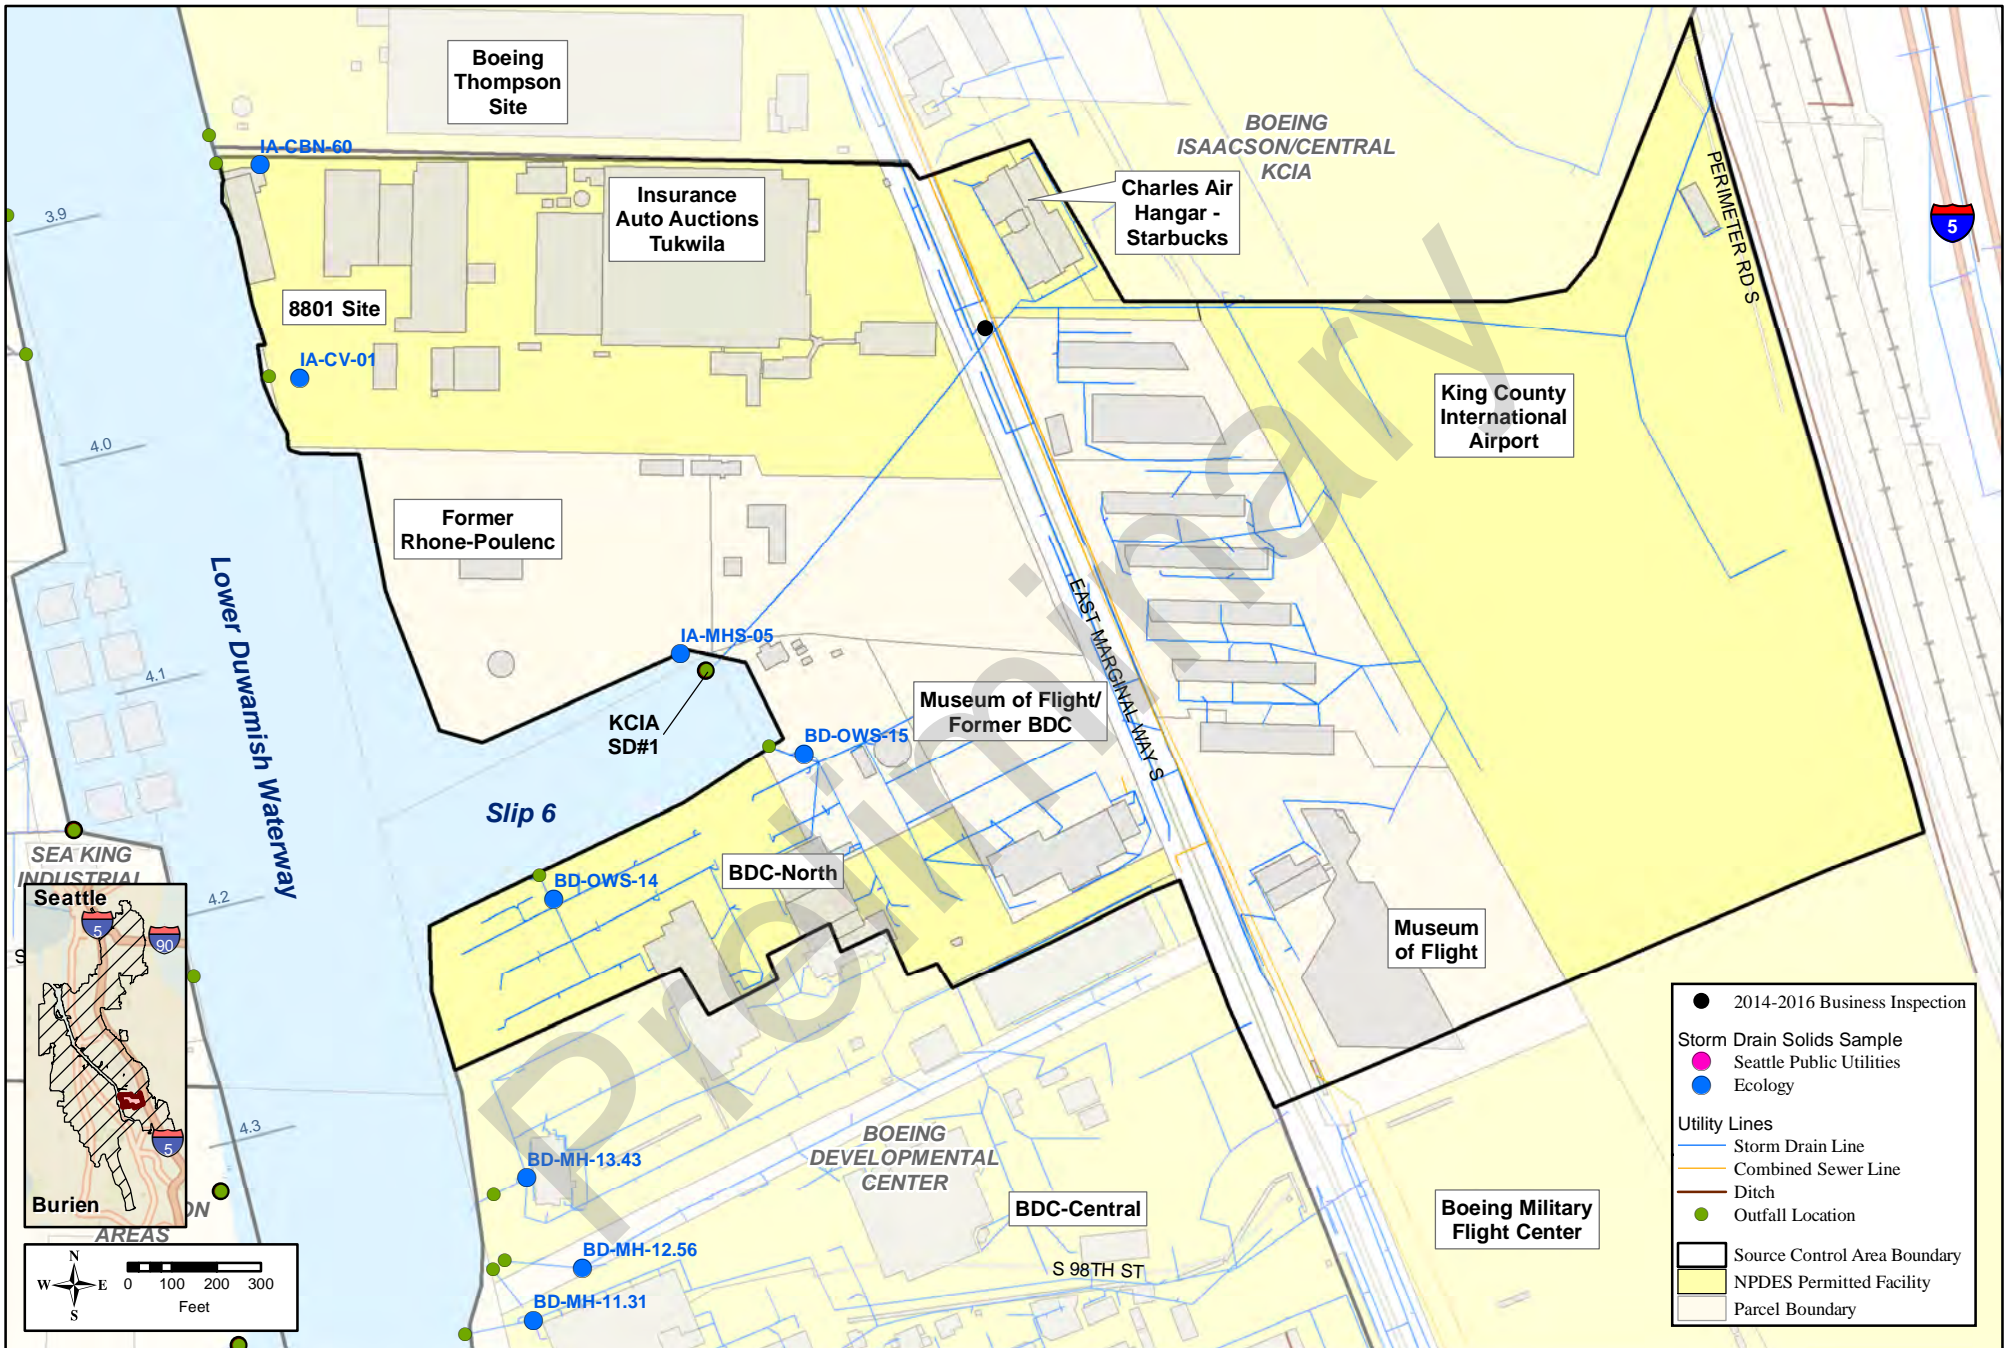
**Figure 1. RM 3.9-4.3 East
(Slip 6)
Source Control Area**

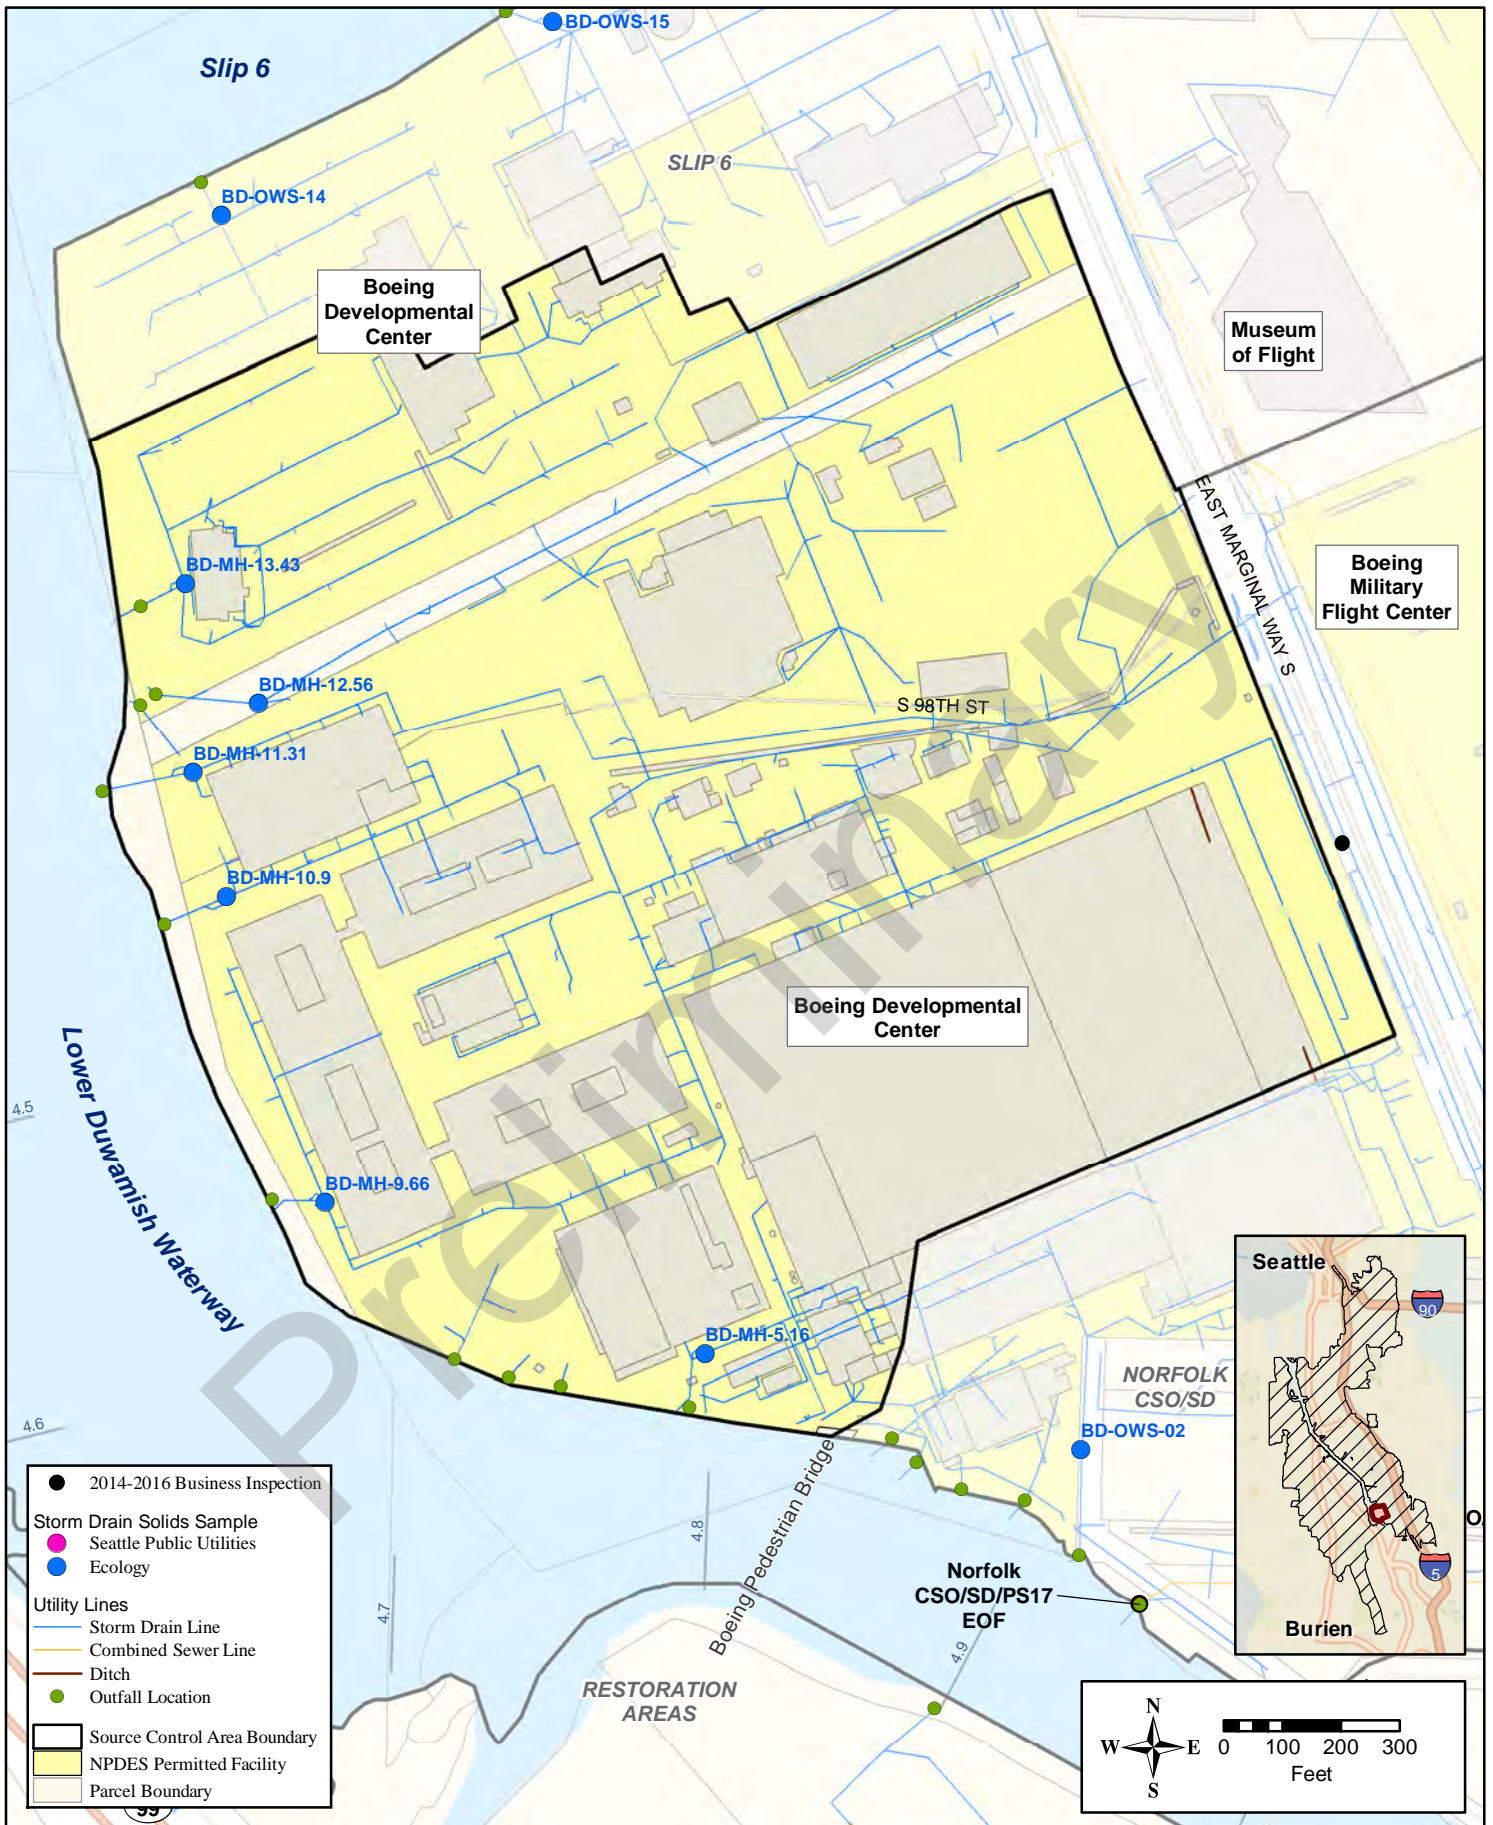
**Figure 2. RM 4.3-4.9 East
(Boeing Developmental Center)
Source Control Area**

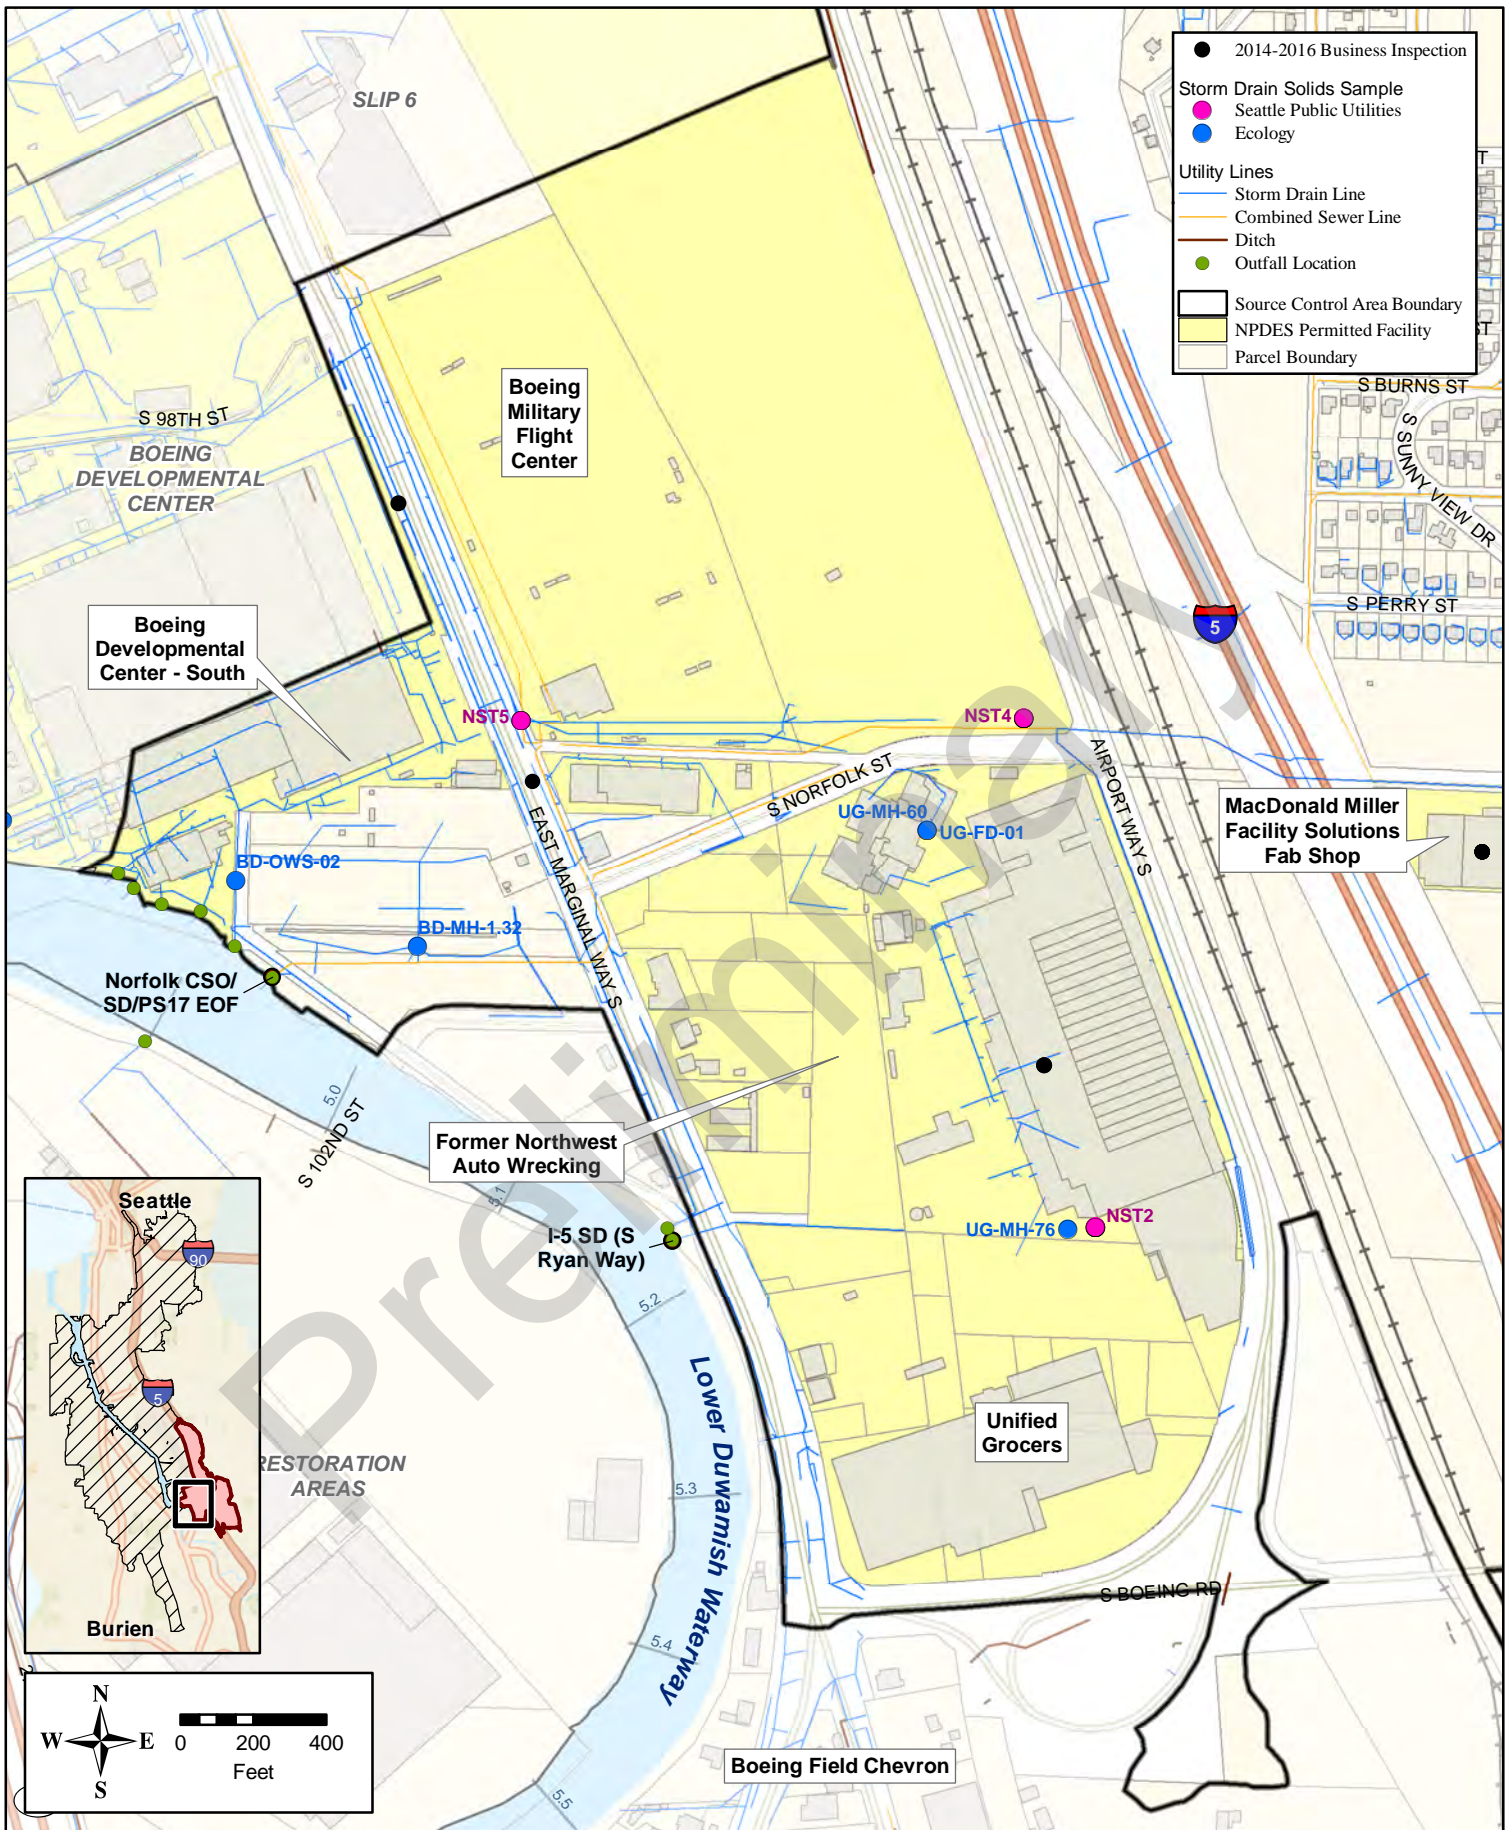
**Figure 3. RM 4.9 East
(EEA-7: Norfolk CSO/SD)
Source Control Area**

Property Name	Boeing Developmental Center
	RM 4.9. Outfalls DC1, DC2, DC3, DC4, DC16, DC17, and the associated drainage areas, are included in this portion of the BDC property (Figure 3).
Historical Activities	<p>The Monsanto Fund purchased the northern 38 acres of the BDC property at an unknown time and leased portions of the property. The area included warehouse and office buildings, winery buildings, a granary, and a trucking company. The Port of Seattle purchased the property and took over the leases in 1976; the northeastern five acres (two separate parcels) were leased by the Port to Kenworth Truck Company and Transport Pool Granary for storage (Ecology 2008 [0080]).</p> <p>The Port sold the property to The Boeing Company in 1985. Boeing has operated on portions of this property since 1956. Historical activities include manufacturing of airplanes and missiles, including metal machining, electroplating, chemical milling, conversion coating, painting, parts cleaning, and assembly activities (Ecology 2008 [0080]).</p>

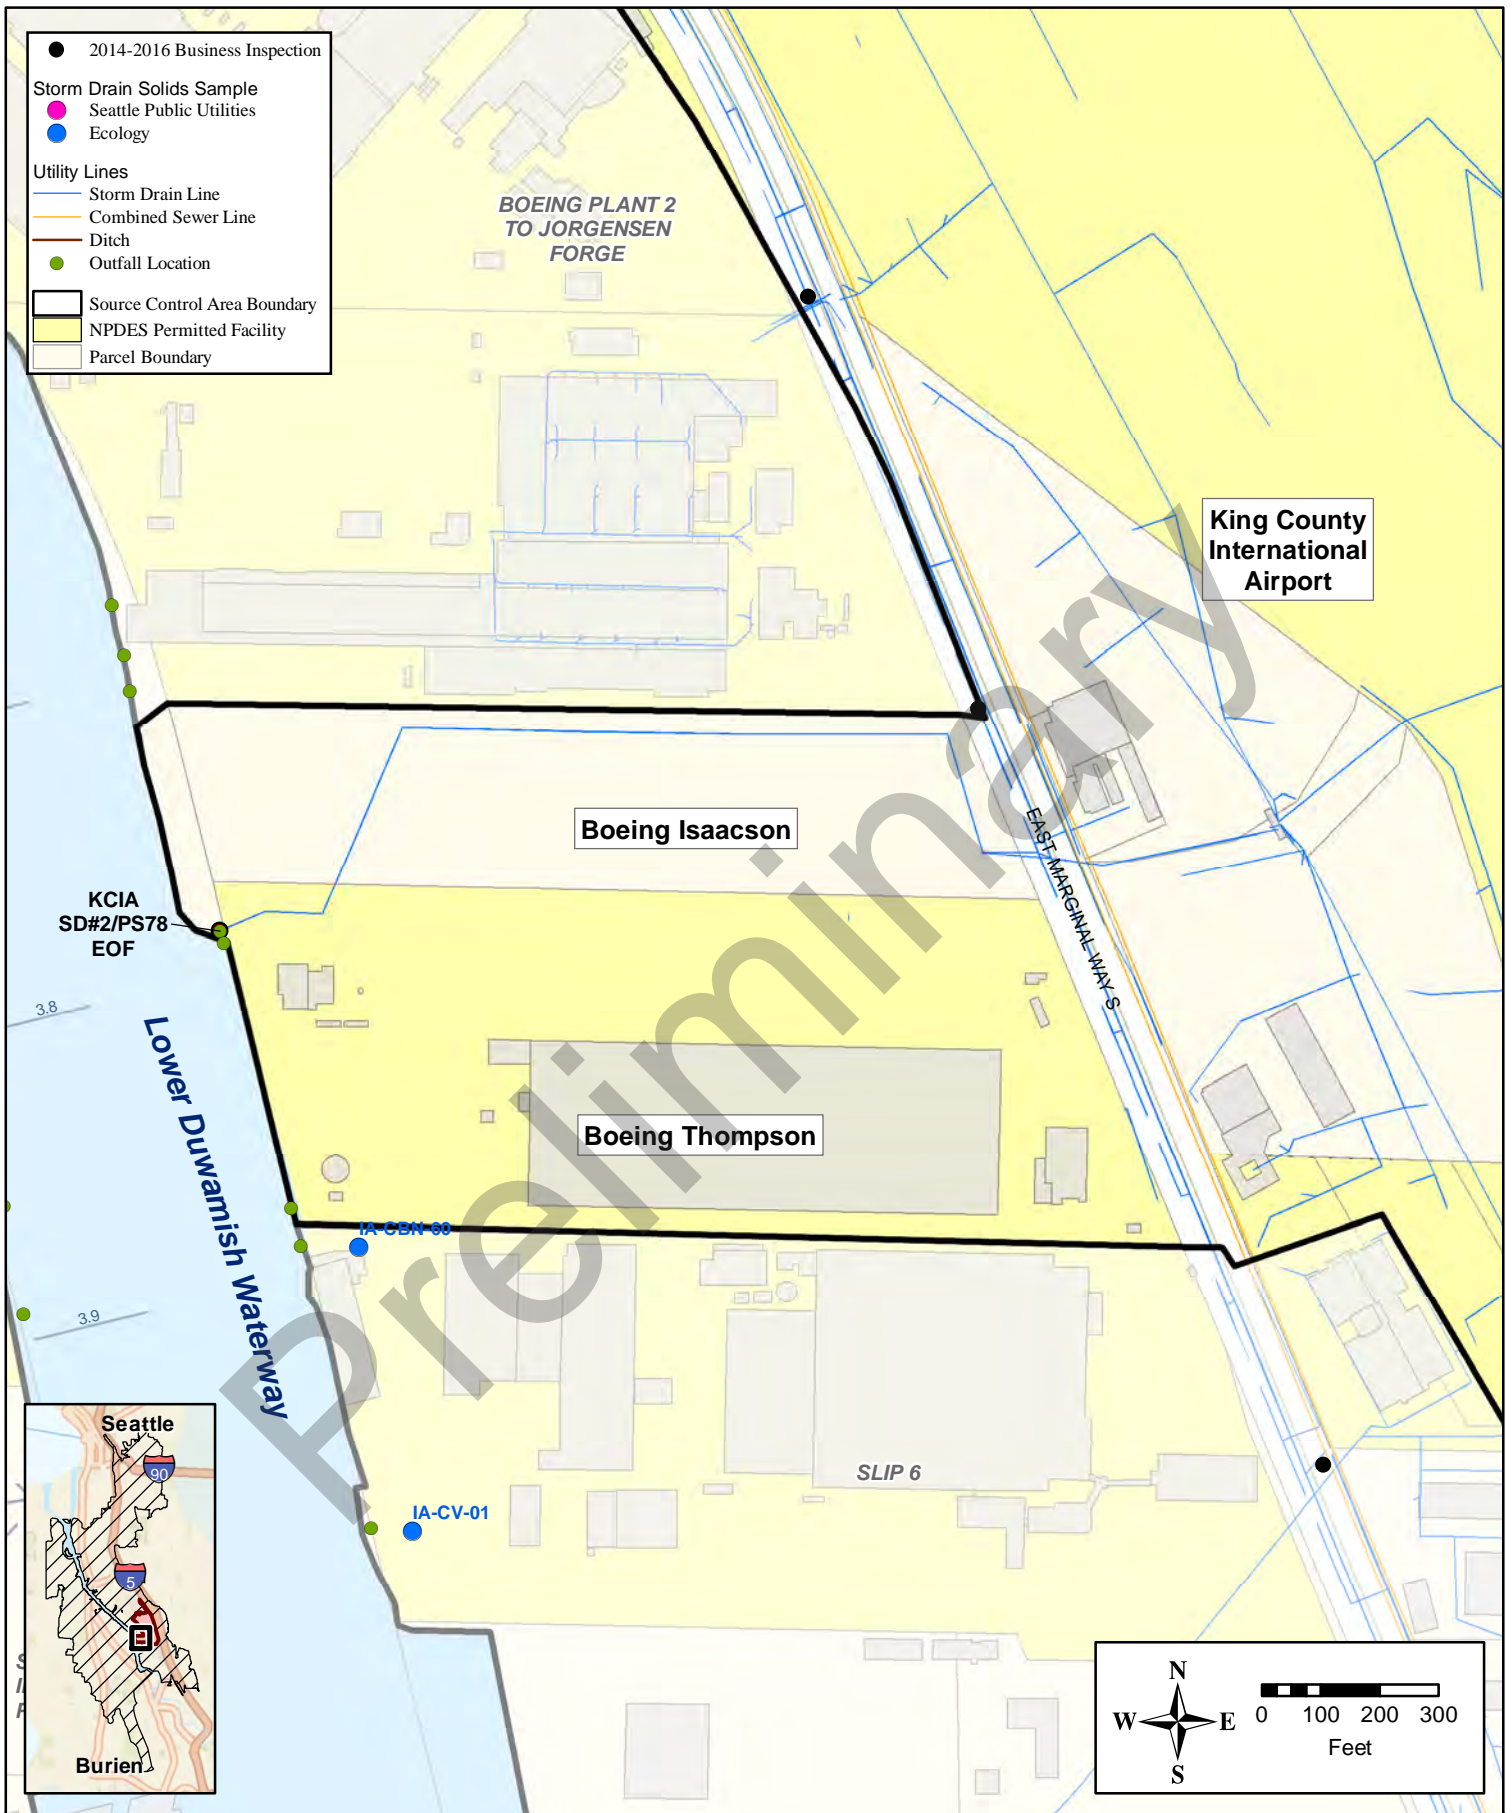
**Figure 1. RM 3.7-3.9 East
(EAA-6: Boeing Isaacson/Central KCIA)
Boeing Thompson and Isaacson Properties**

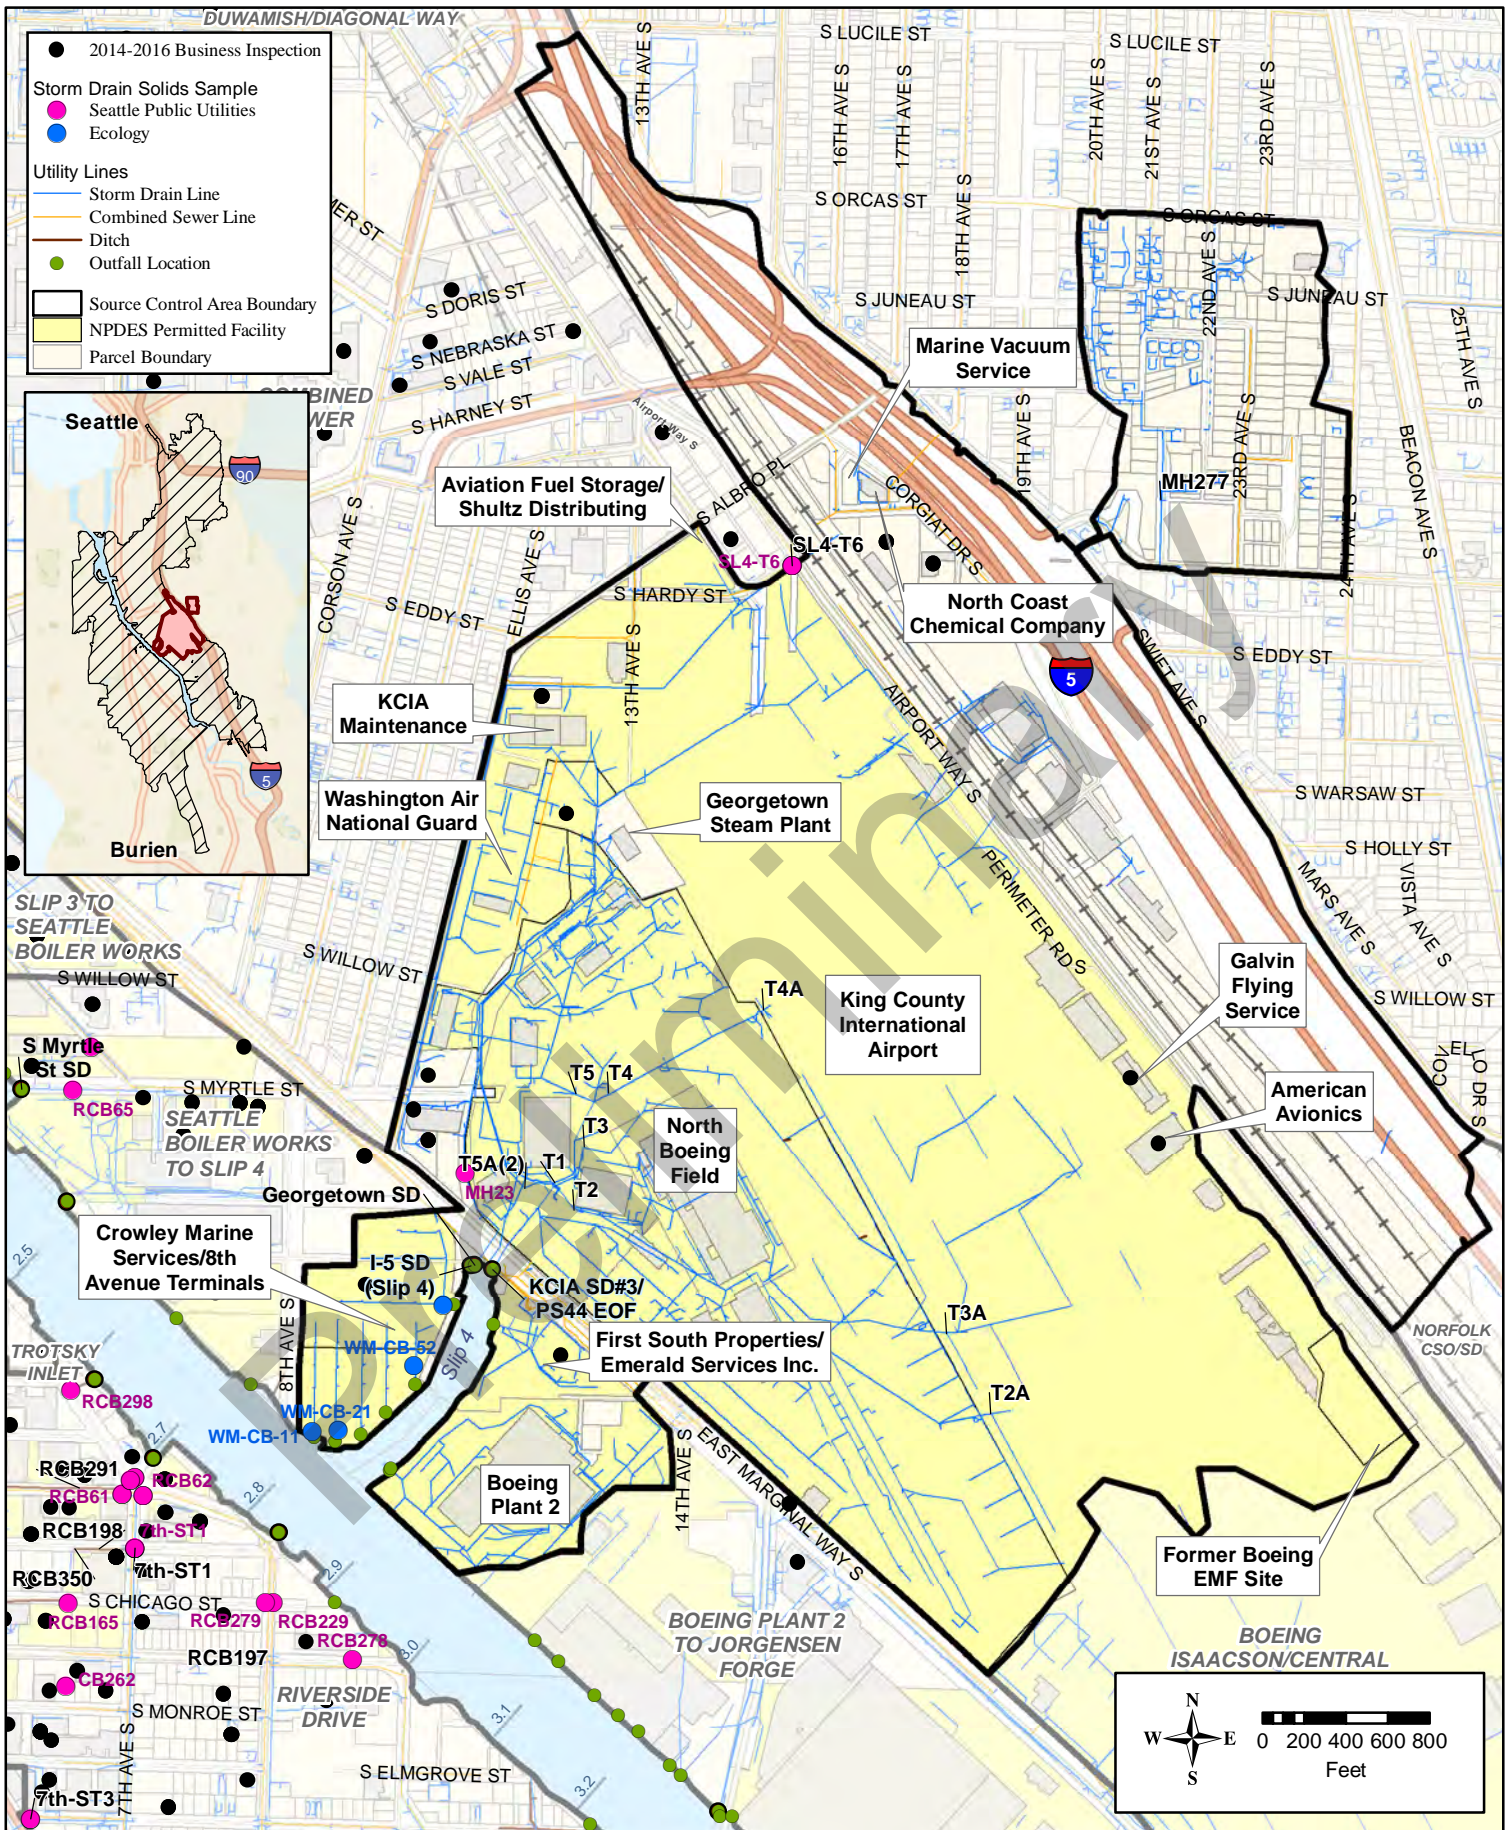
**Figure 1. RM 2.8 East
(EAA-3: Slip 4)
Source Control Area**

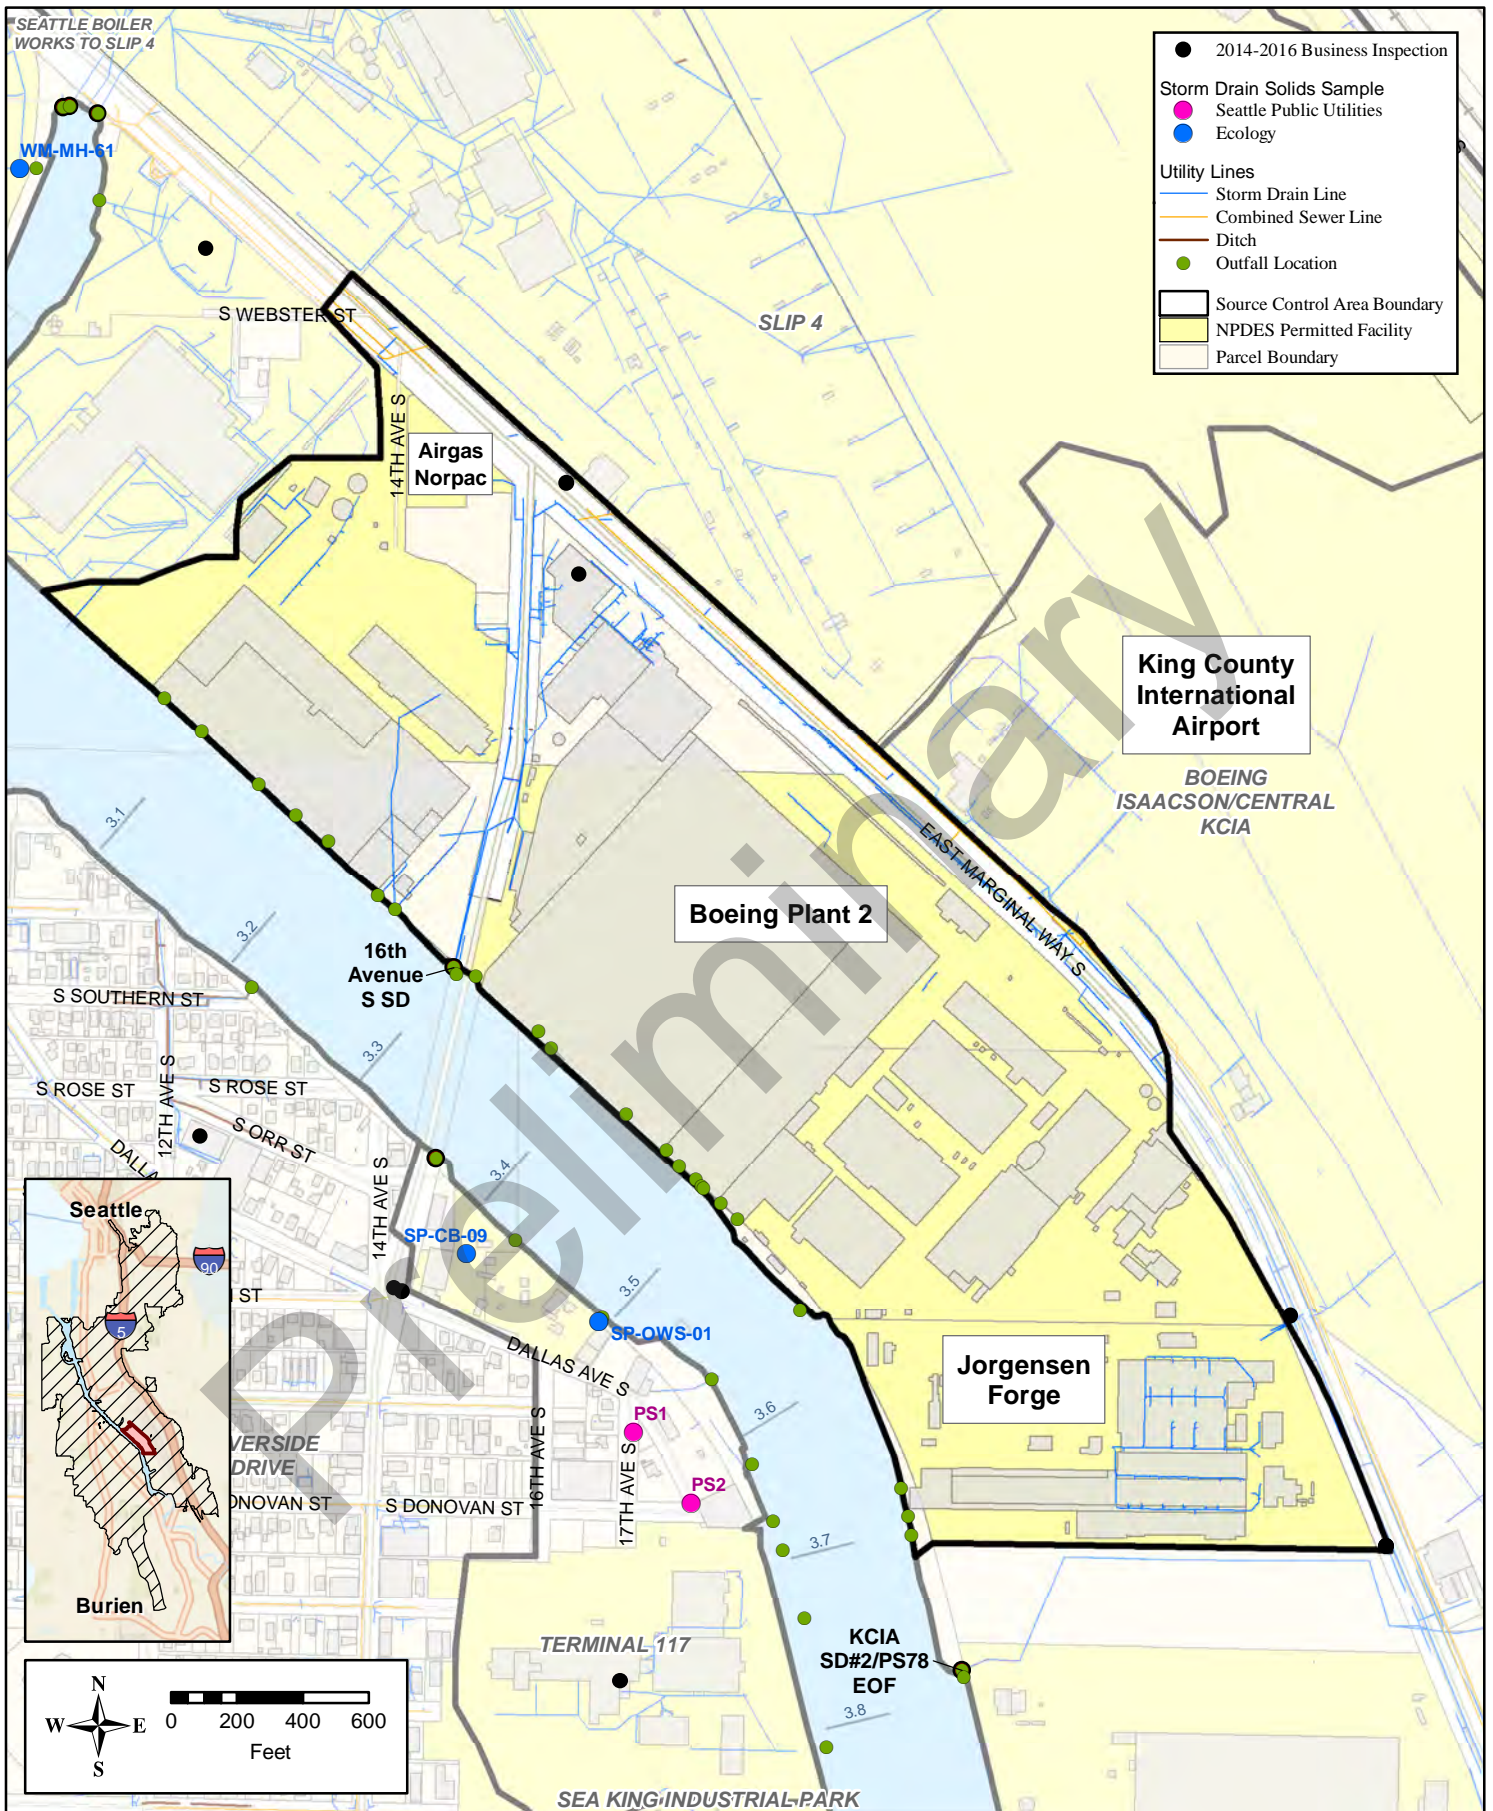
**Figure 2. RM 2.8-3.7 East
(EAA-4: Boeing Plant 2 to Jorgensen Forge)
Source Control Area**

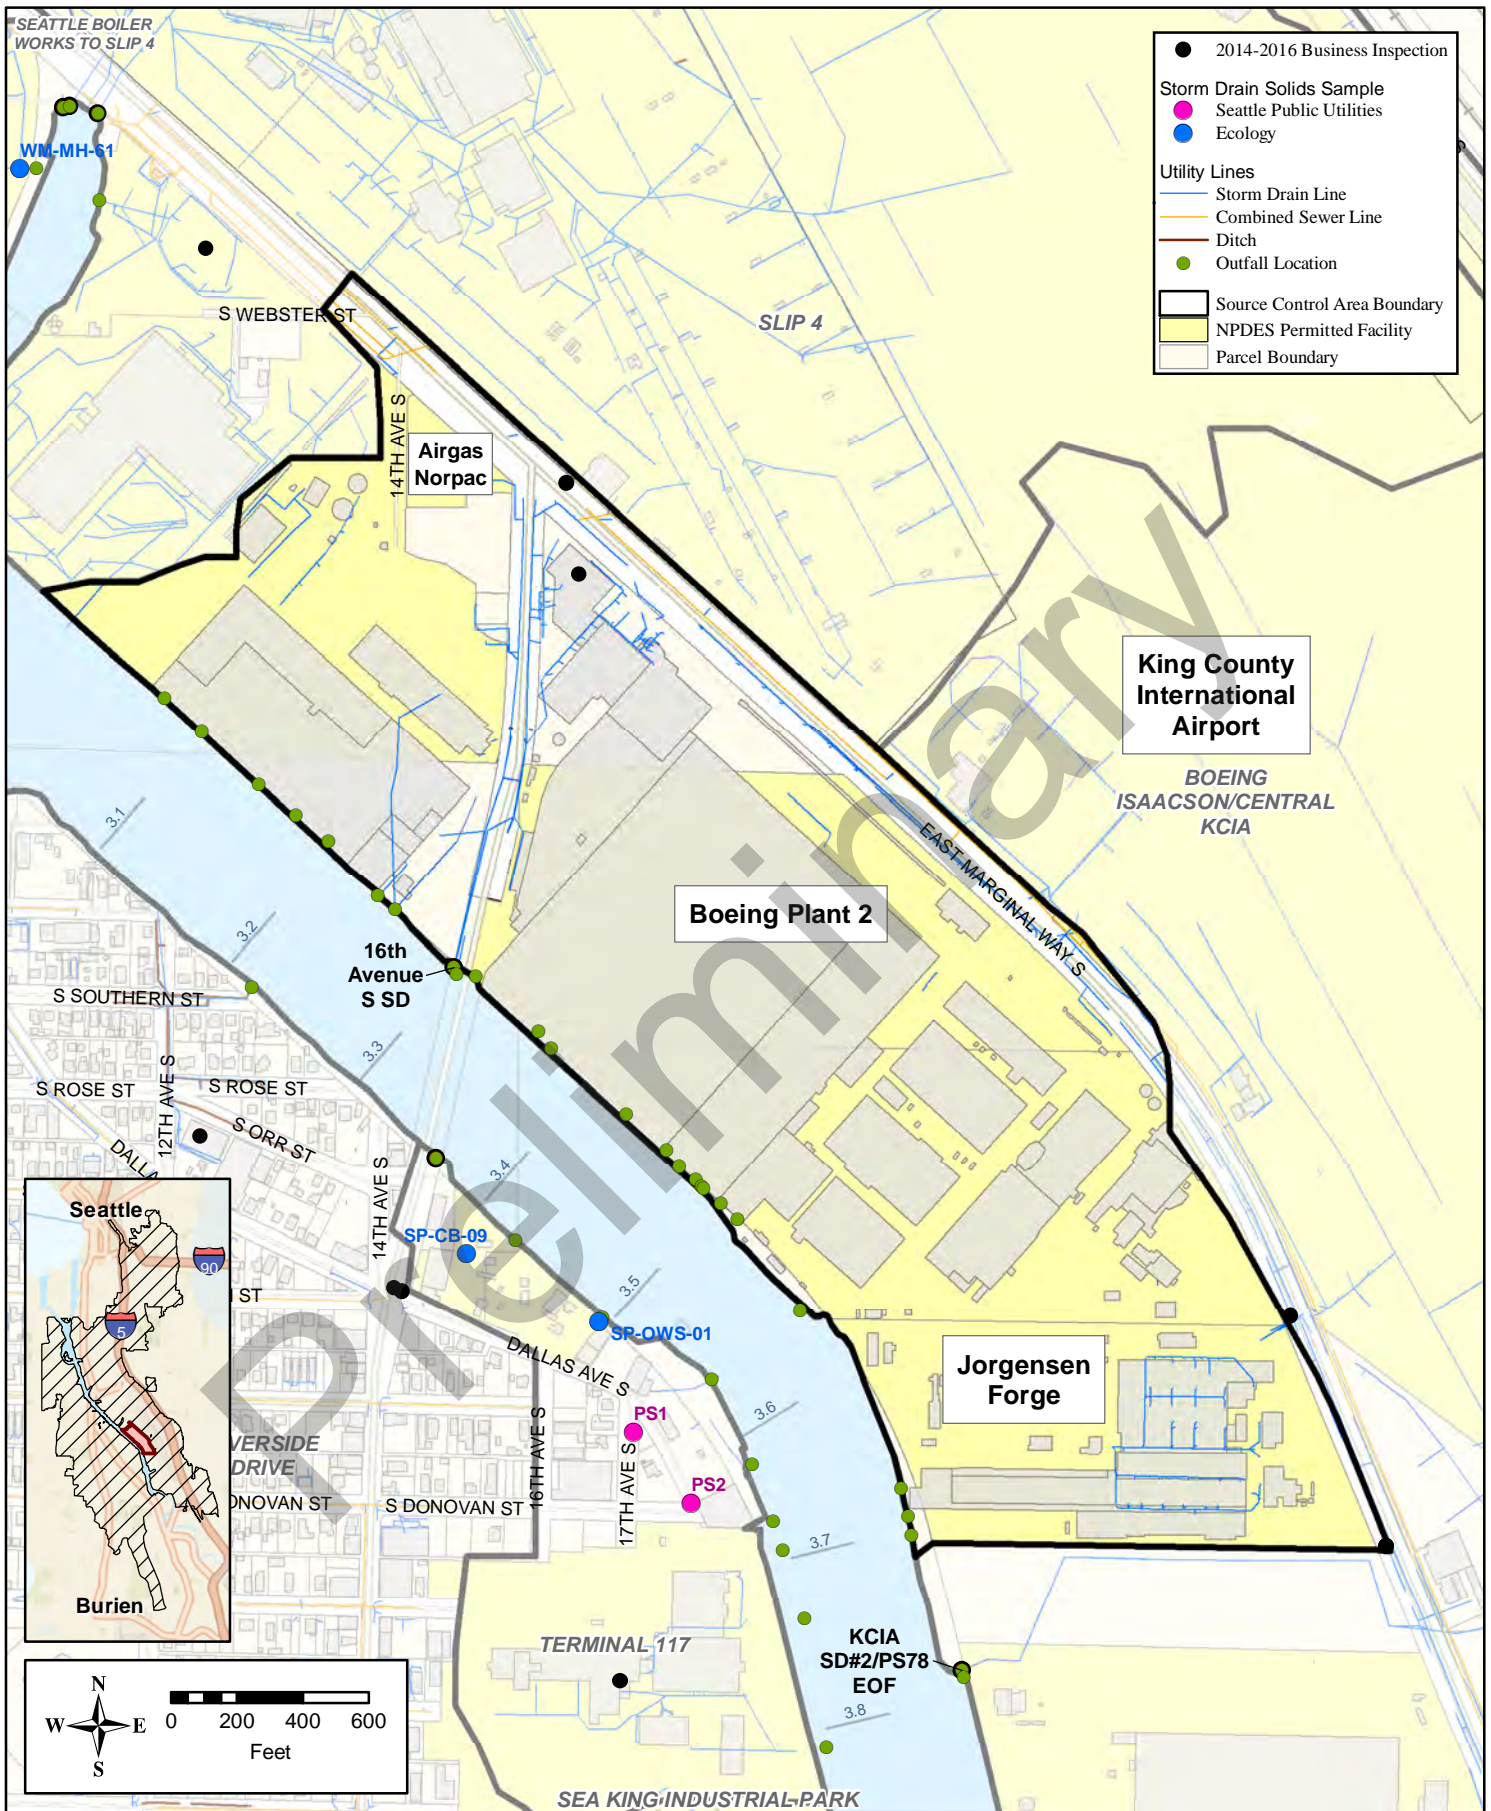
**Figure 1. RM 2.8-3.7 East
(EAA-4: Boeing Plant 2 to Jorgensen Forge)
Source Control Area**
