Lower Duwamish Waterway Source Control Status Report January 2014 through December 2016

June 2018

Publication No. 17-09-266

Toxics Cleanup Program
Northwest Regional Office
Washington State Department of Ecology
Bellevue, Washington

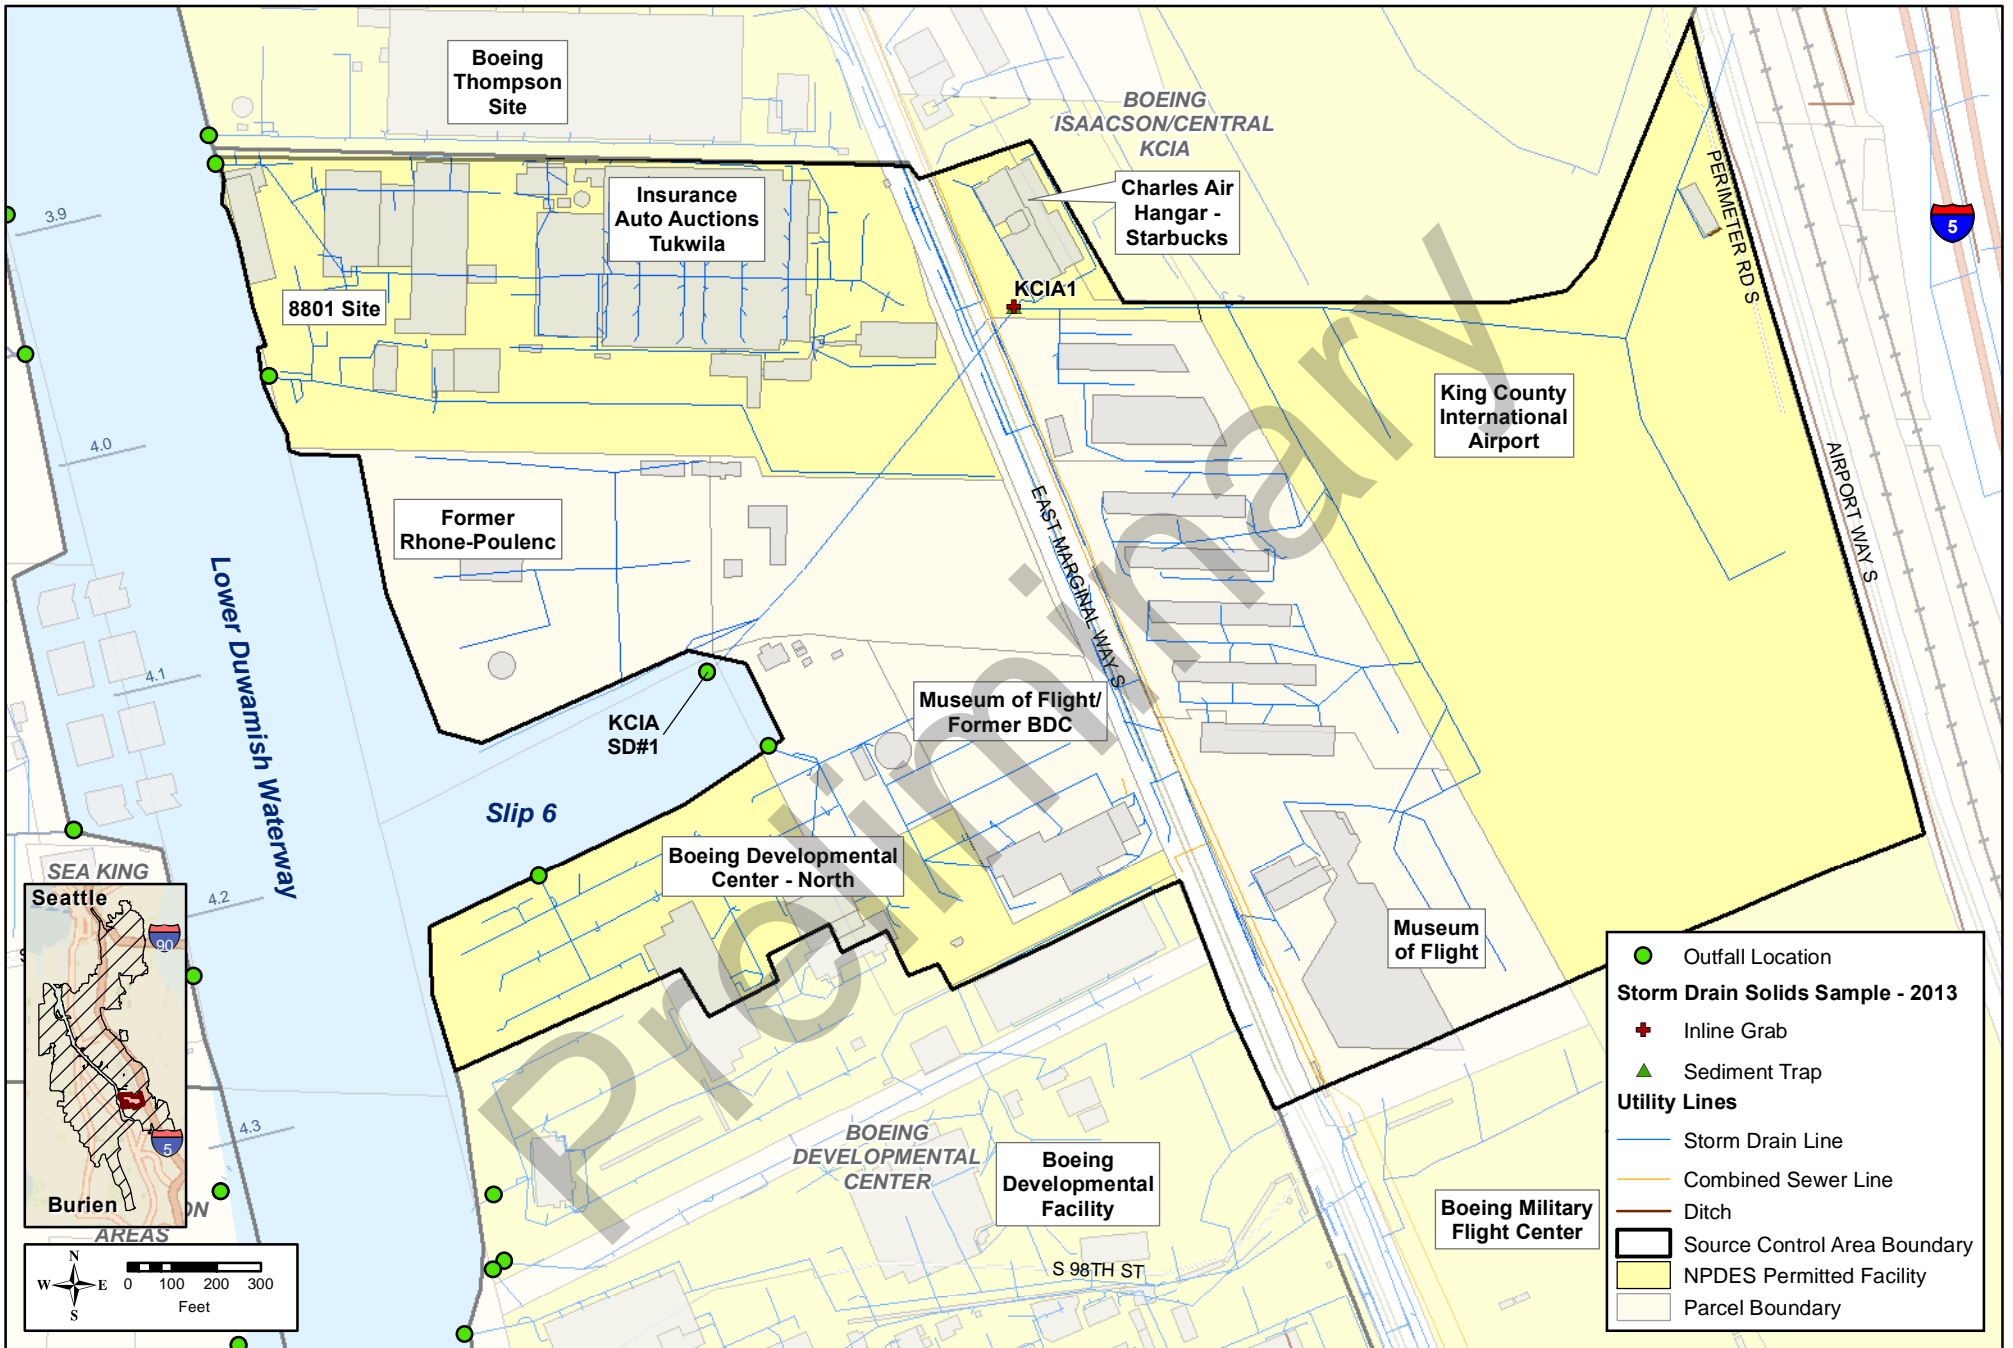
**Figure 1. RM 3.9-4.3 East
(Slip 6)
Source Control Area**

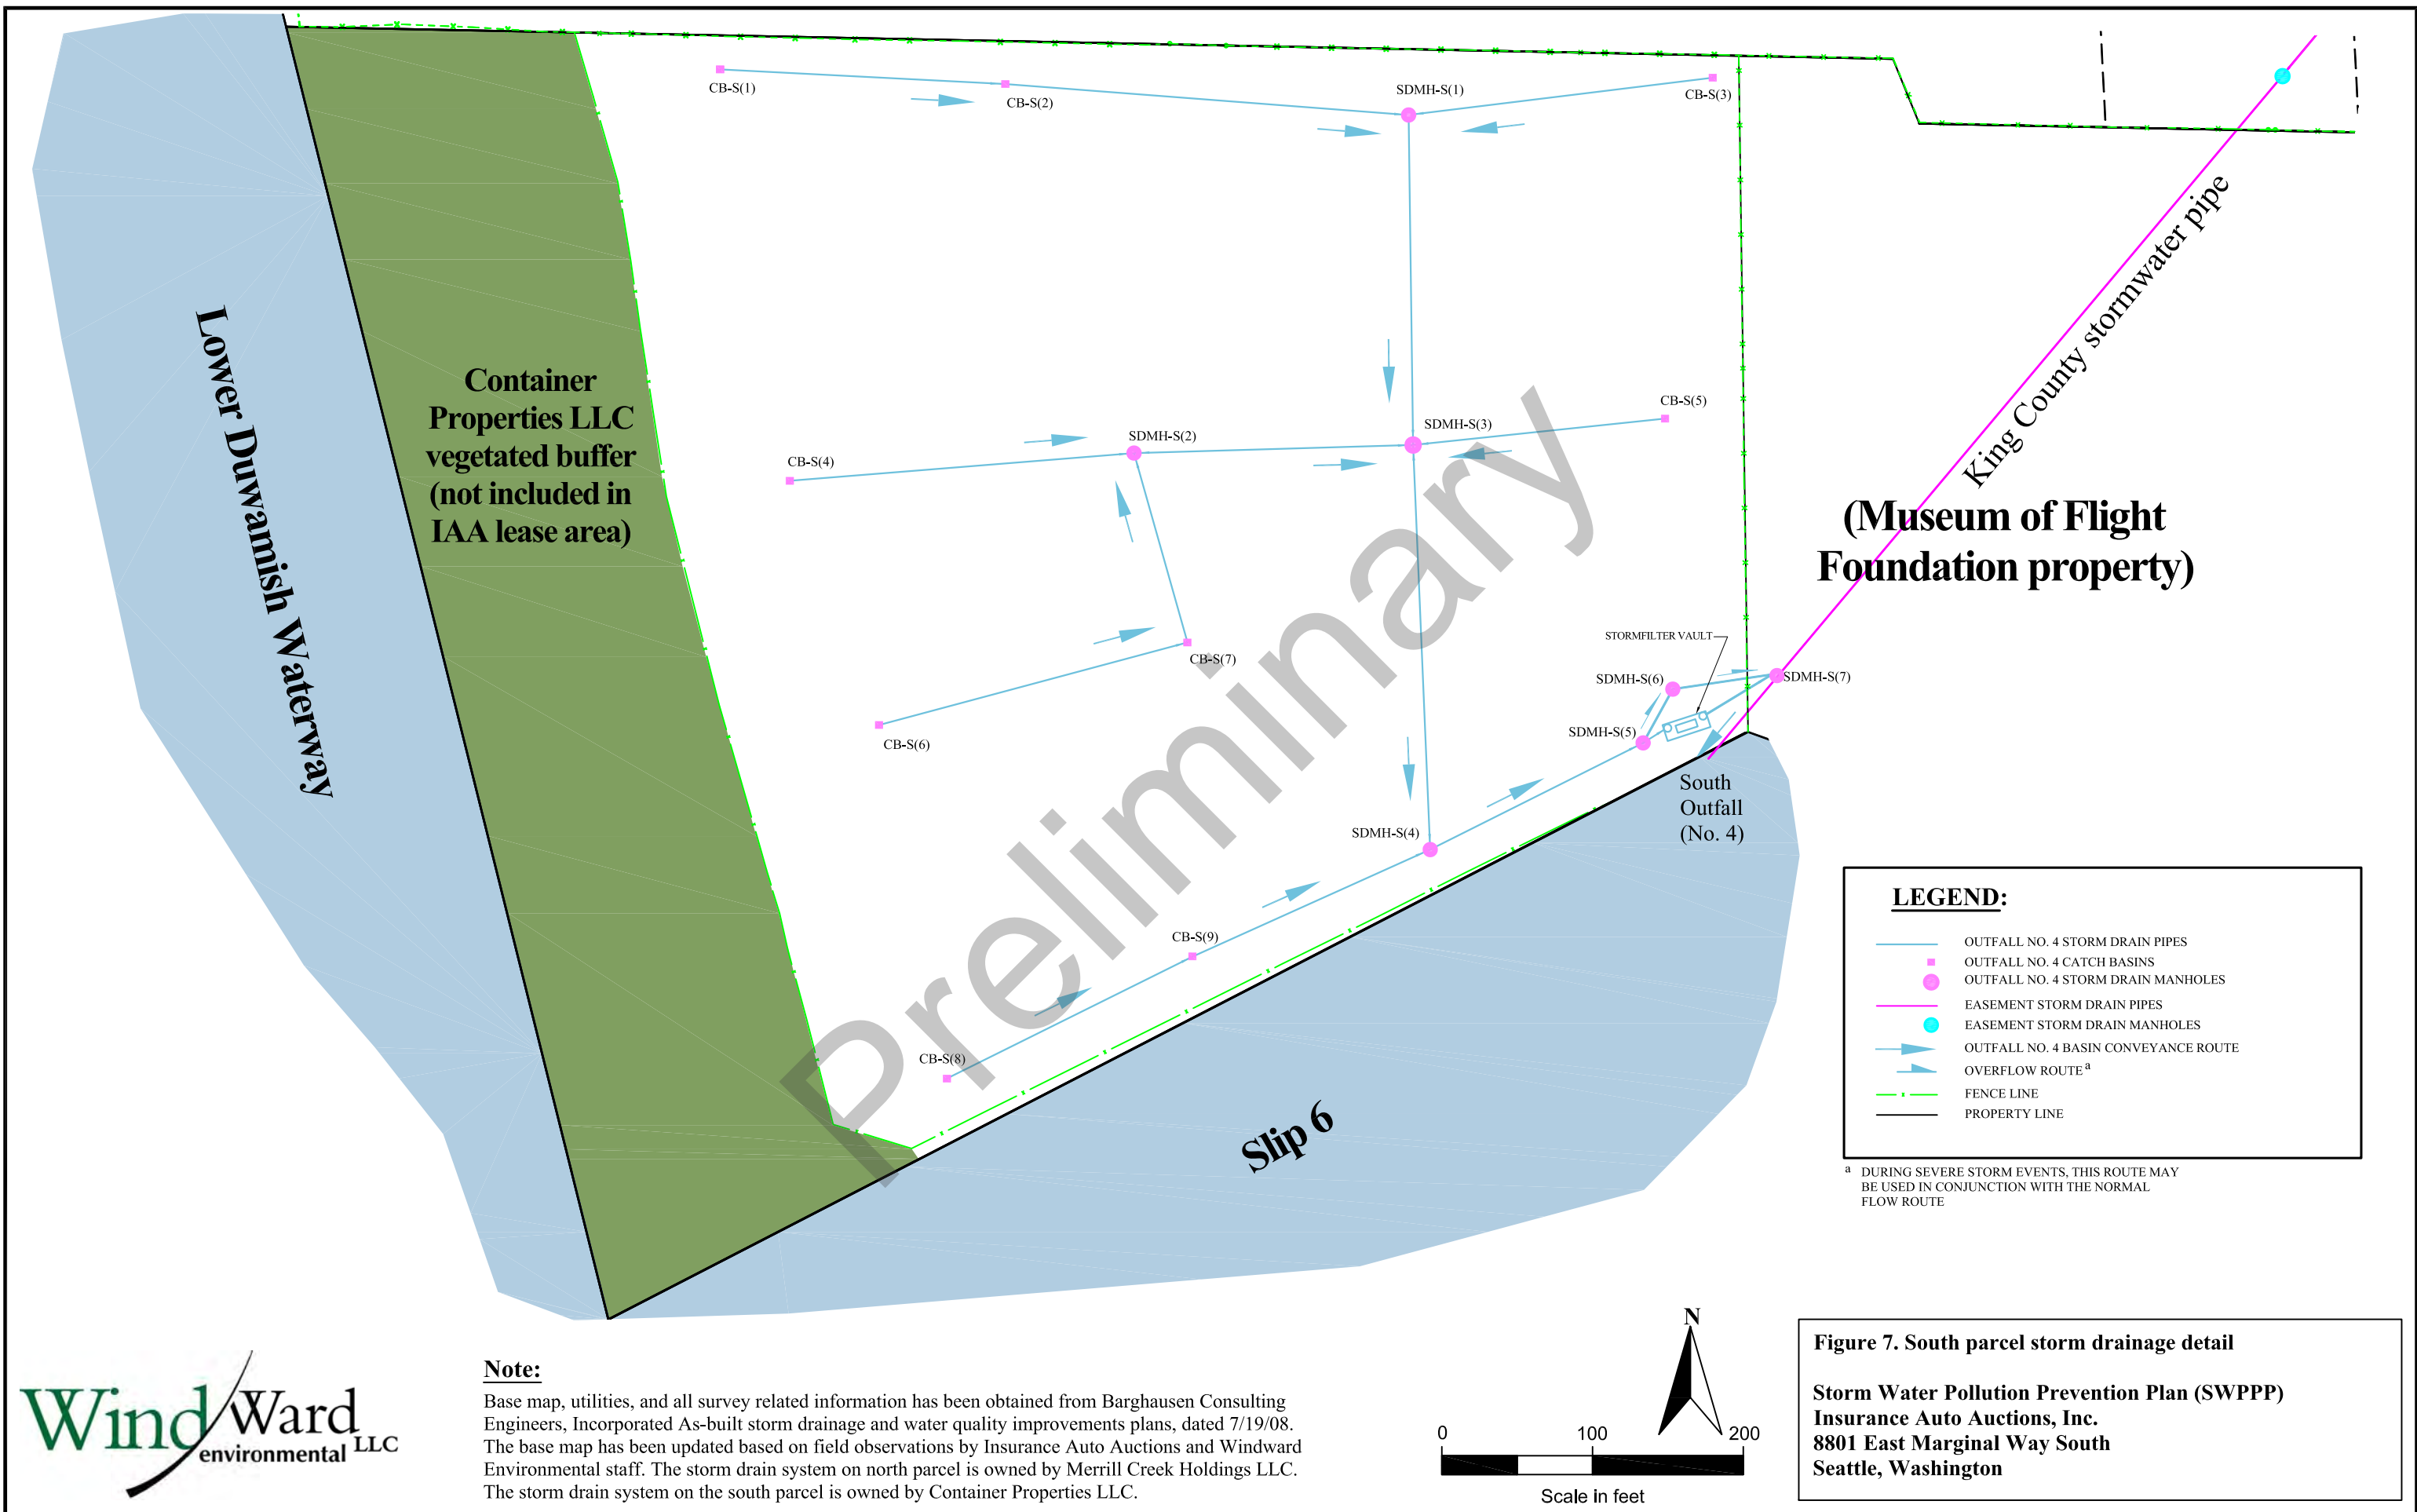
Note:
 Base map, utilities, and all survey related information has been obtained from Barghausen Consulting Engineers, Incorporated As-built storm drainage and water quality improvements plans, dated 7/19/08. The base map has been updated based on field observations by Insurance Auto Auctions and Windward Environmental staff. The storm drain system on north parcel is owned by Merrill Creek Holdings LLC. The storm drain system on the south parcel is owned by Container Properties LLC.

Figure 7. South parcel storm drainage detail
Storm Water Pollution Prevention Plan (SWPPP)
Insurance Auto Auctions, Inc.
8801 East Marginal Way South
Seattle, Washington

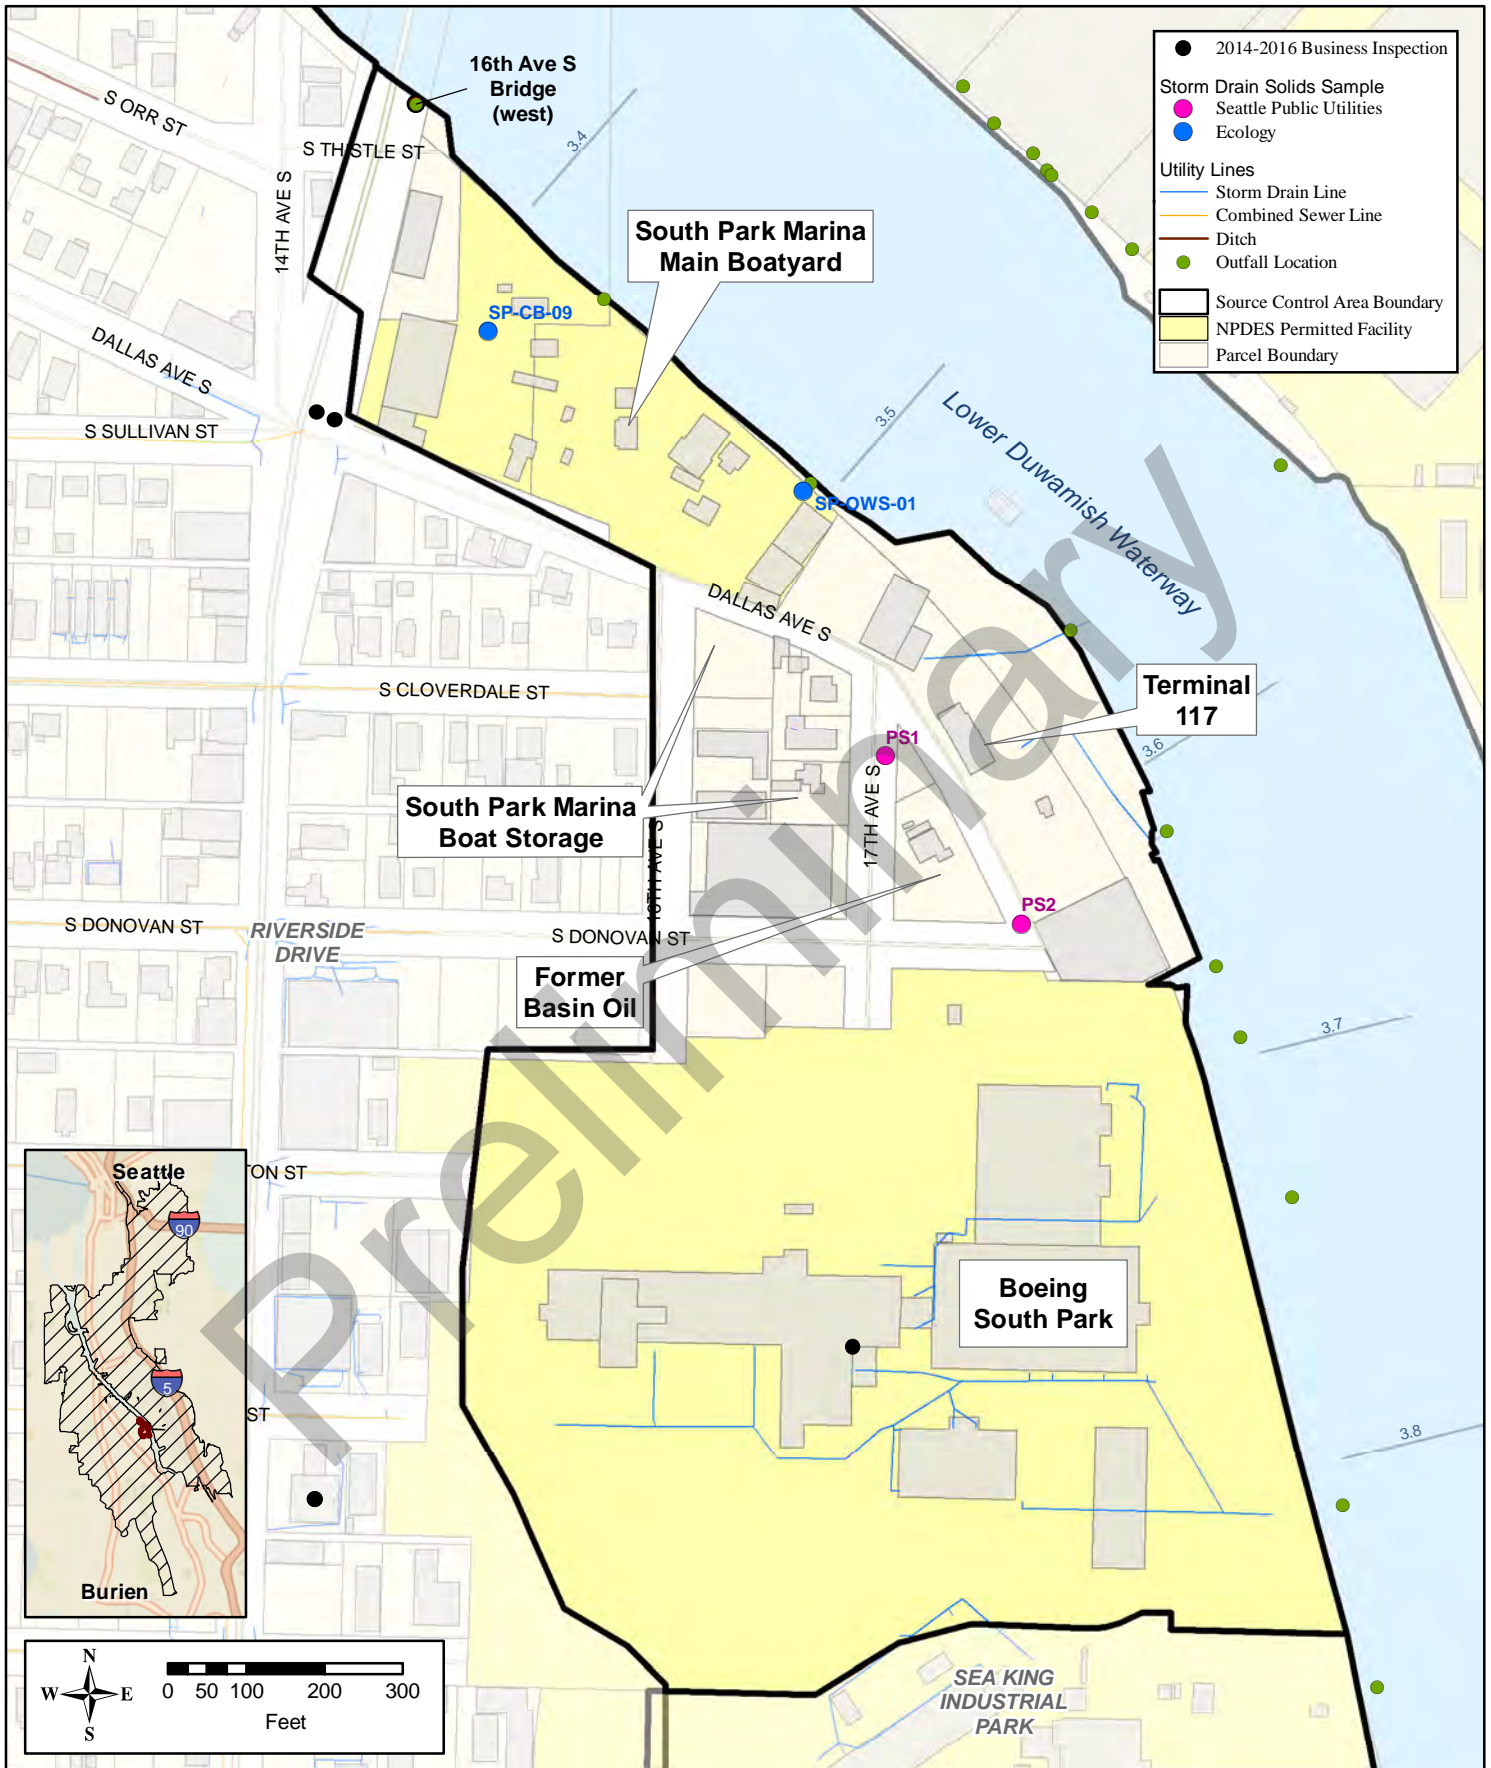
**Figure 1. RM 3.4-3.8 West
(EAA-5: Terminal 117)
Source Control Area**

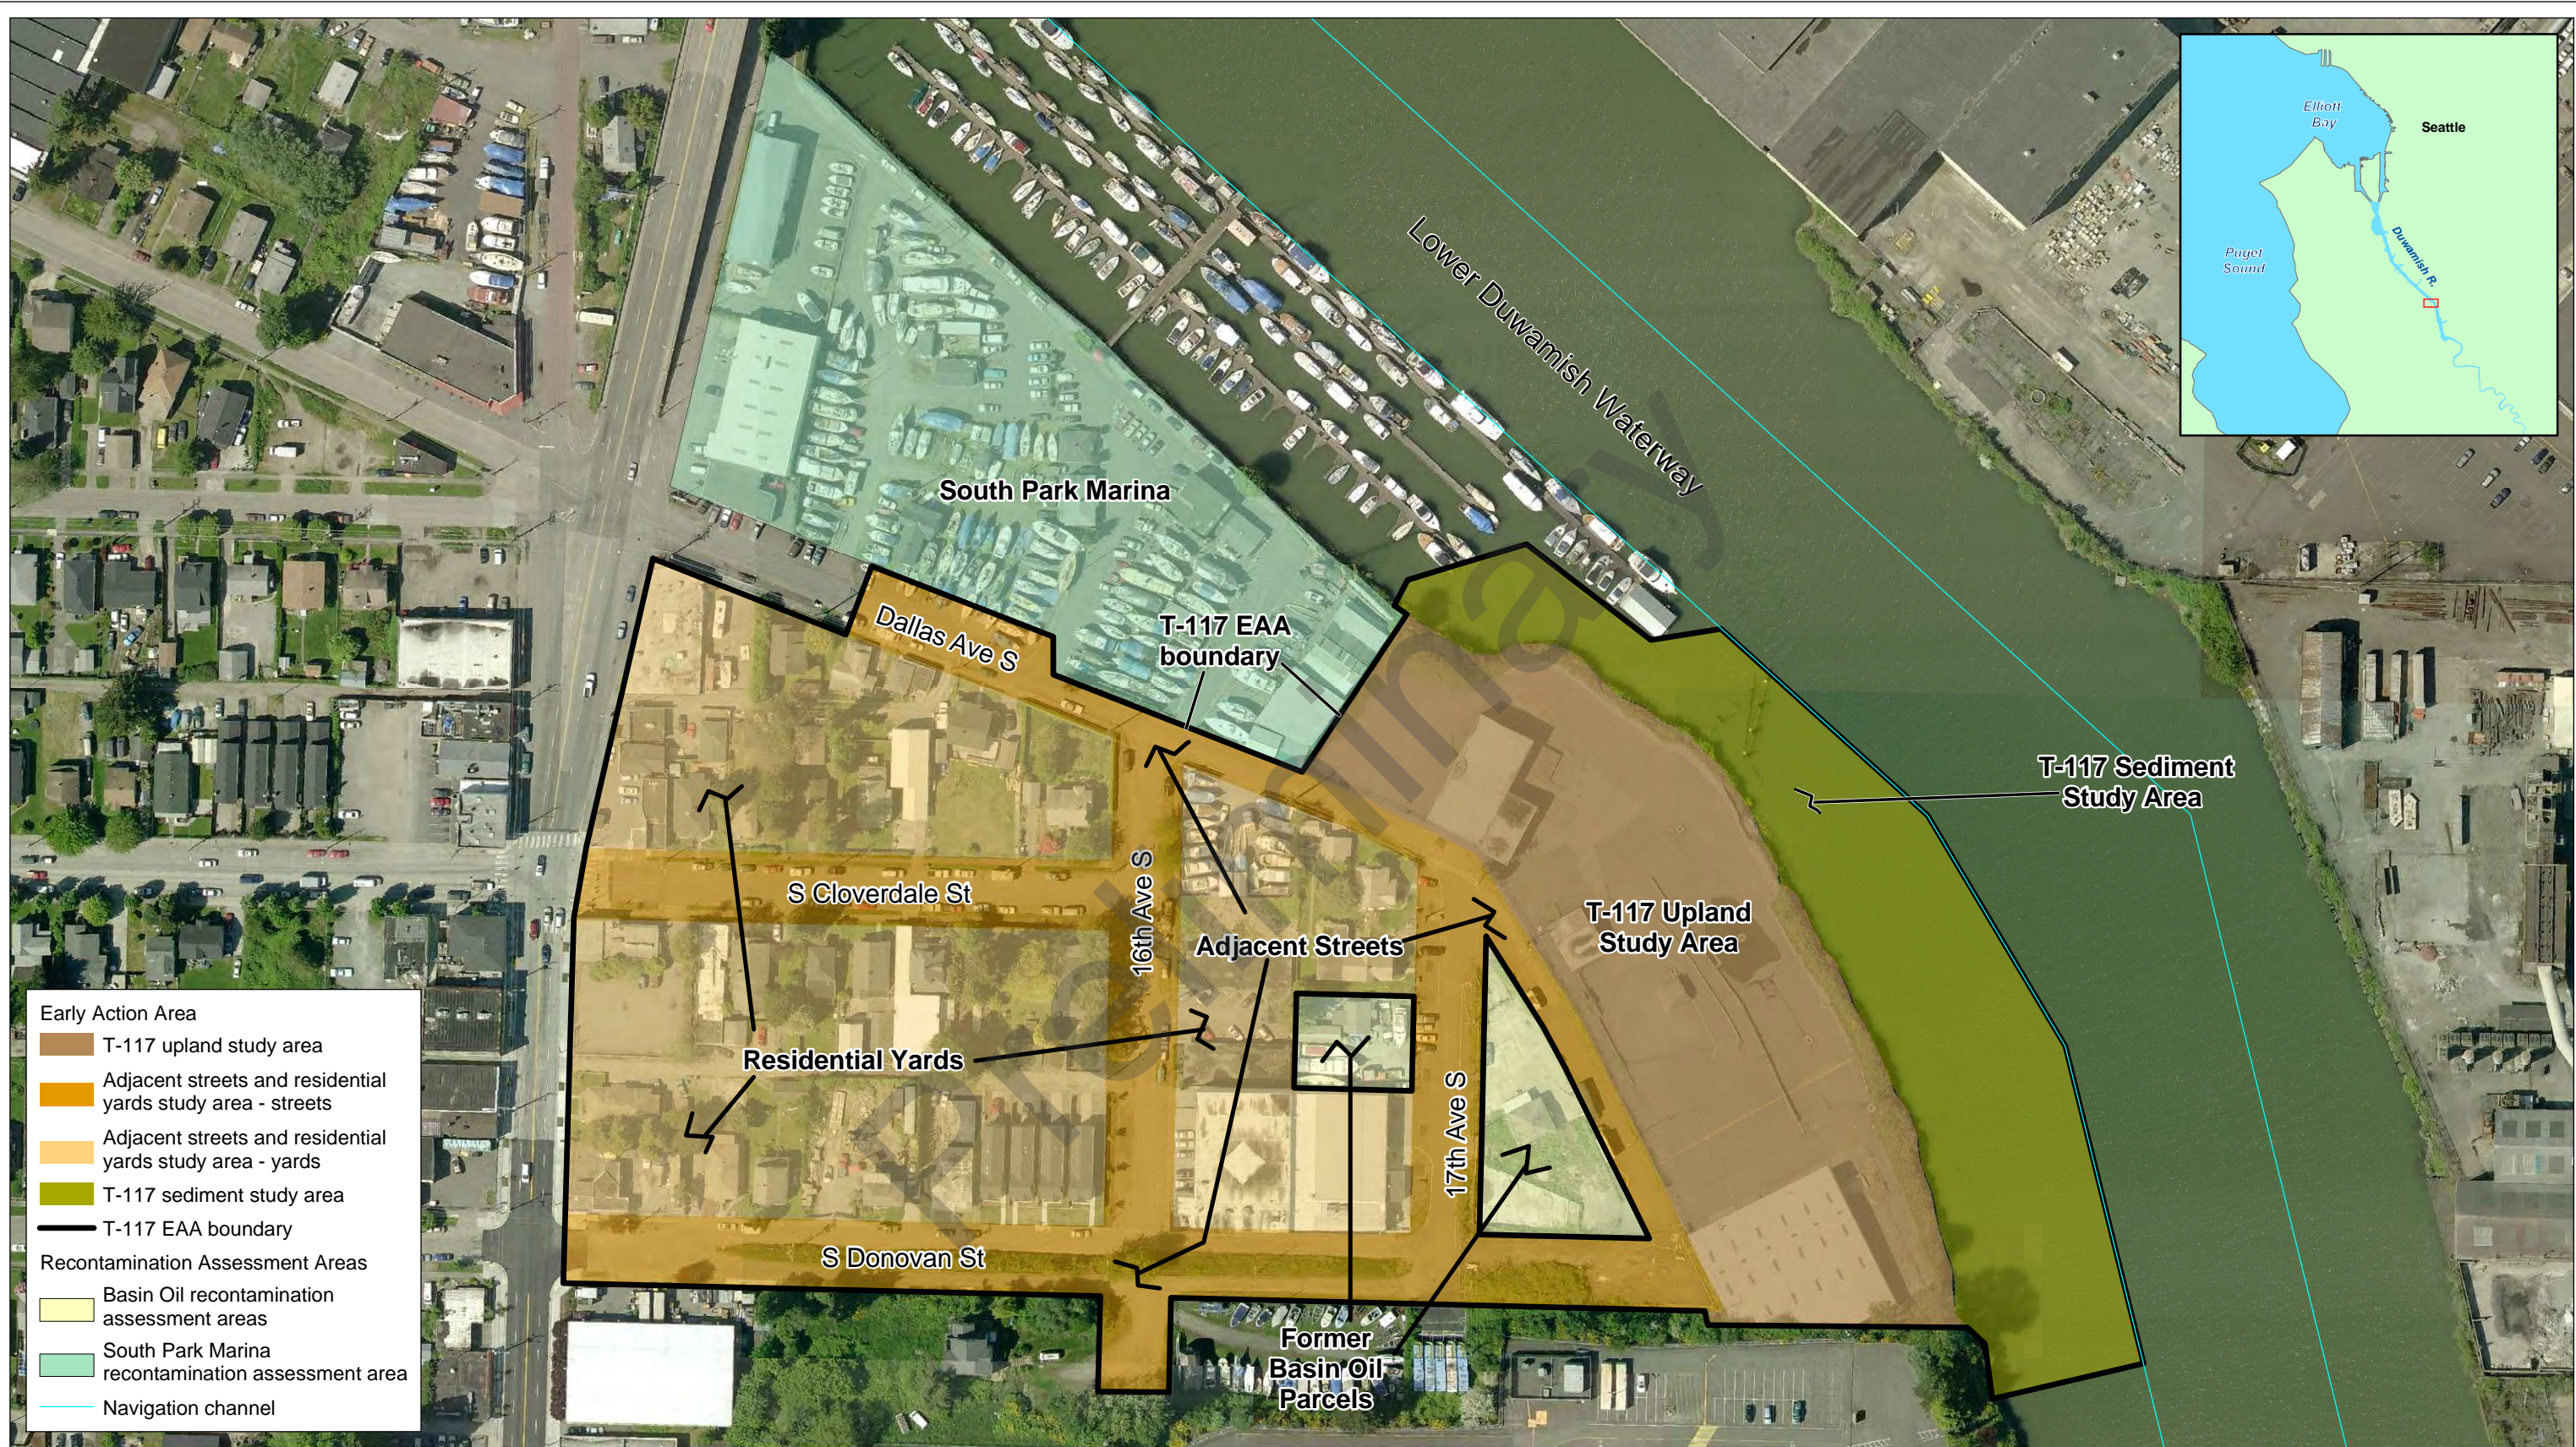
Map 1-1. T-117 EAA site overview
