**Re: Response to Ecology July 25, 2017 Opinion Letter**

Former Tosco Bainbridge Island Bulk Plant 1784  
Weaver Avenue & Shepard Way NW  
Bainbridge Island, Kitsap County, Washington  
Cleanup Site ID No. 3690  
Facility/Site ID No. 26595127  
VCP Site NW3070  
Project Number: 81177343

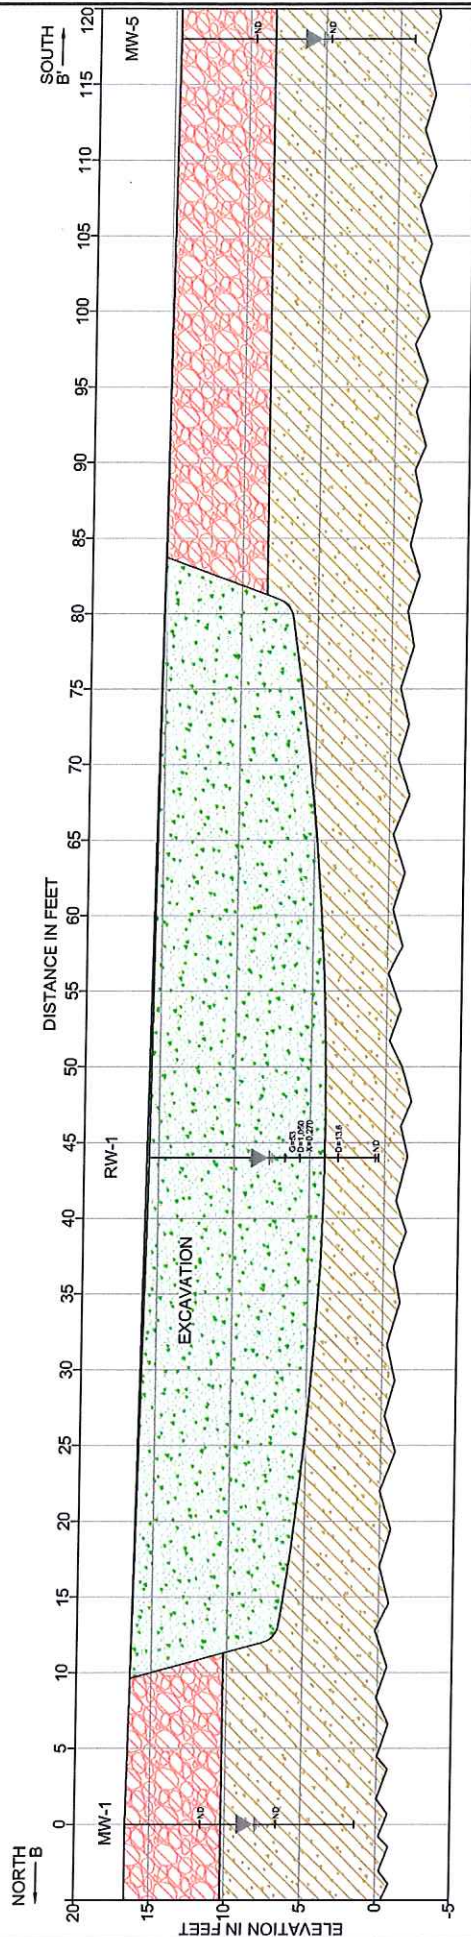
SOIL SAMPLE ANALYTICAL RESULTS (MILLIGRAMS PER KILOGRAM)

- *Ecology recommends using different colors for the lithologies presented in the two cross-sections (Exhibits 3 and 4). Ensure the cross sections accurately portray the slope of the sidewalls so that it is clear where and to what depth contaminated soil was removed.*
