STATE OF WASHINGTON  
DEPARTMENT OF ECOLOGY

**Re: No Further Action at the following Site:**

- **Site Name:** Taco Time Northwest Restaurant
- **Site Address:** 1420 East Madison Street, Seattle, WA
- **Facility/Site No.:** 5460498
- **VCP Project No.:** NW2954
- **Cleanup Site ID No.:** 811

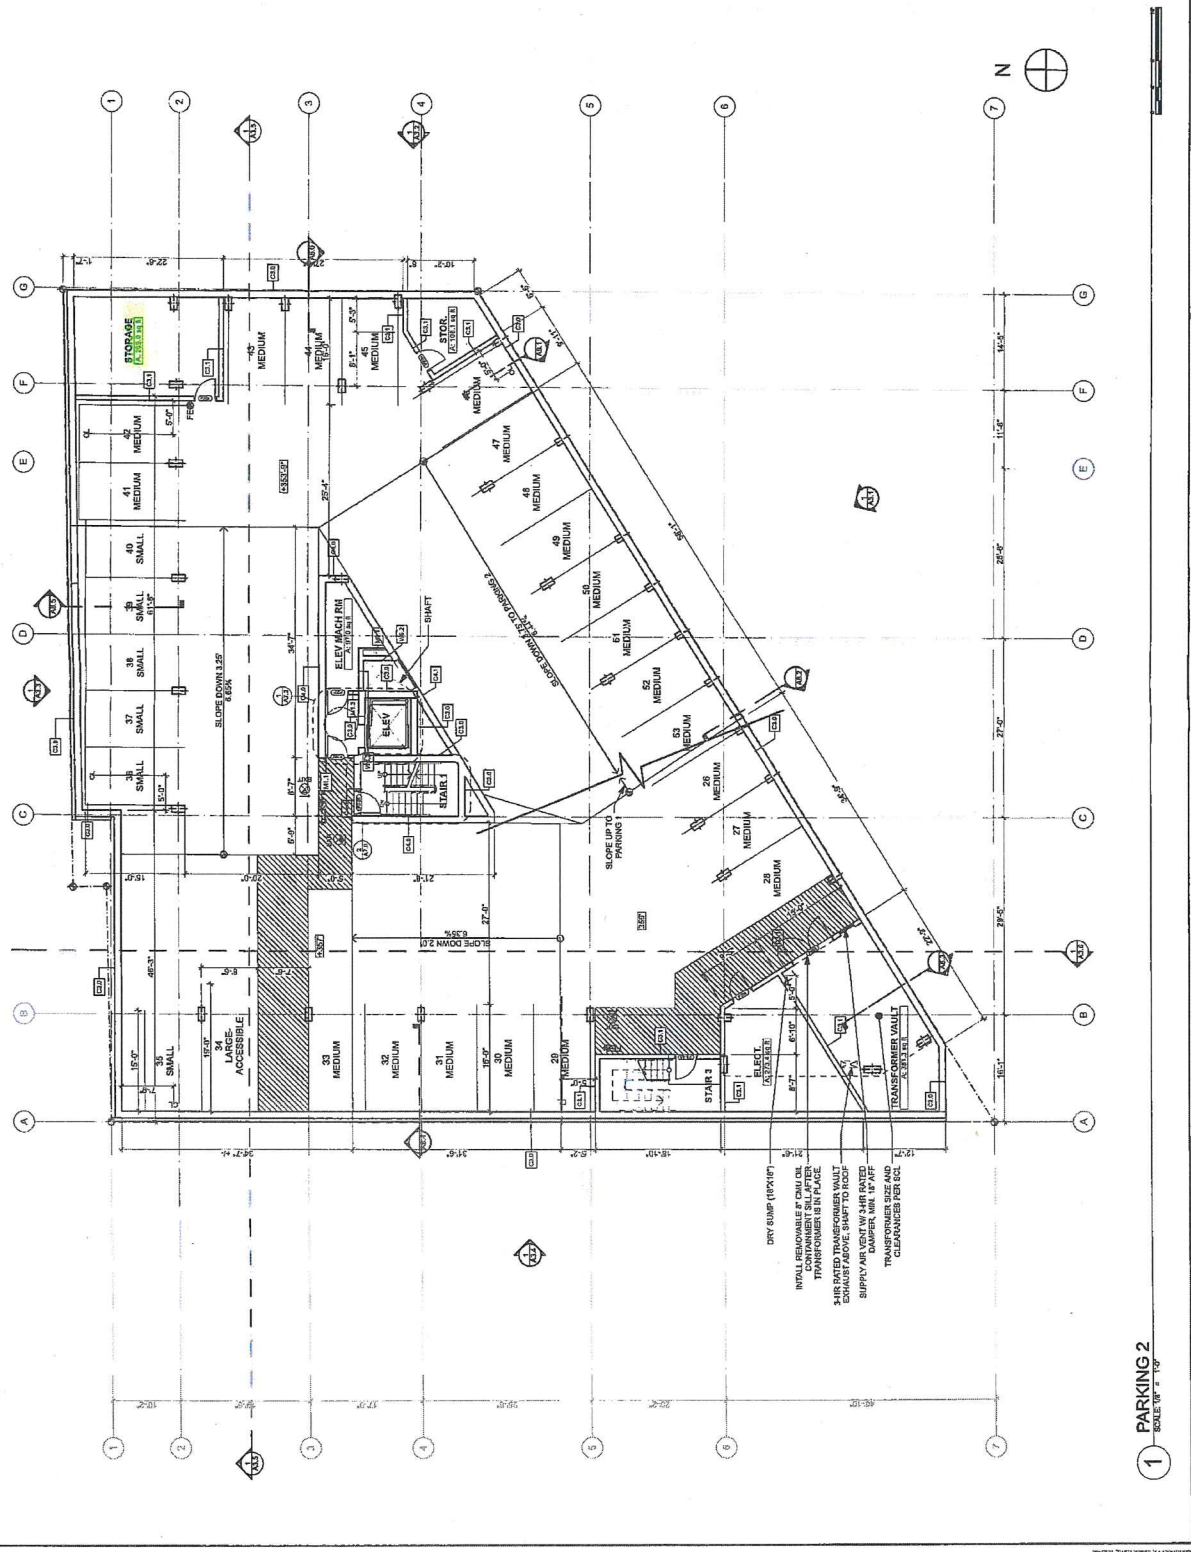
**1** PARKING 2  
SCALE: 1/8" = 1'-0"

**P-2 FLOOR PLAN**
