STATE OF WASHINGTON
DEPARTMENT OF ECOLOGY

Re: No Further Action at a Property associated with a Site:

- **Property Address:** 21 10th Avenue South, 1006 Lake Street South and 6700 Lake Washington Blvd NE, Kirkland, Washington
- **Facility/Site No.:** 4595
- **VCP Project No.:** NW2850
- **Cleanup Site ID No.:** 12329

**OPERATION & MAINTENANCE PLAN
POTALA VILLAGE PROPERTY
6700 LAKE WASHINGTON BOULEVARD
KIRKLAND, WASHINGTON**

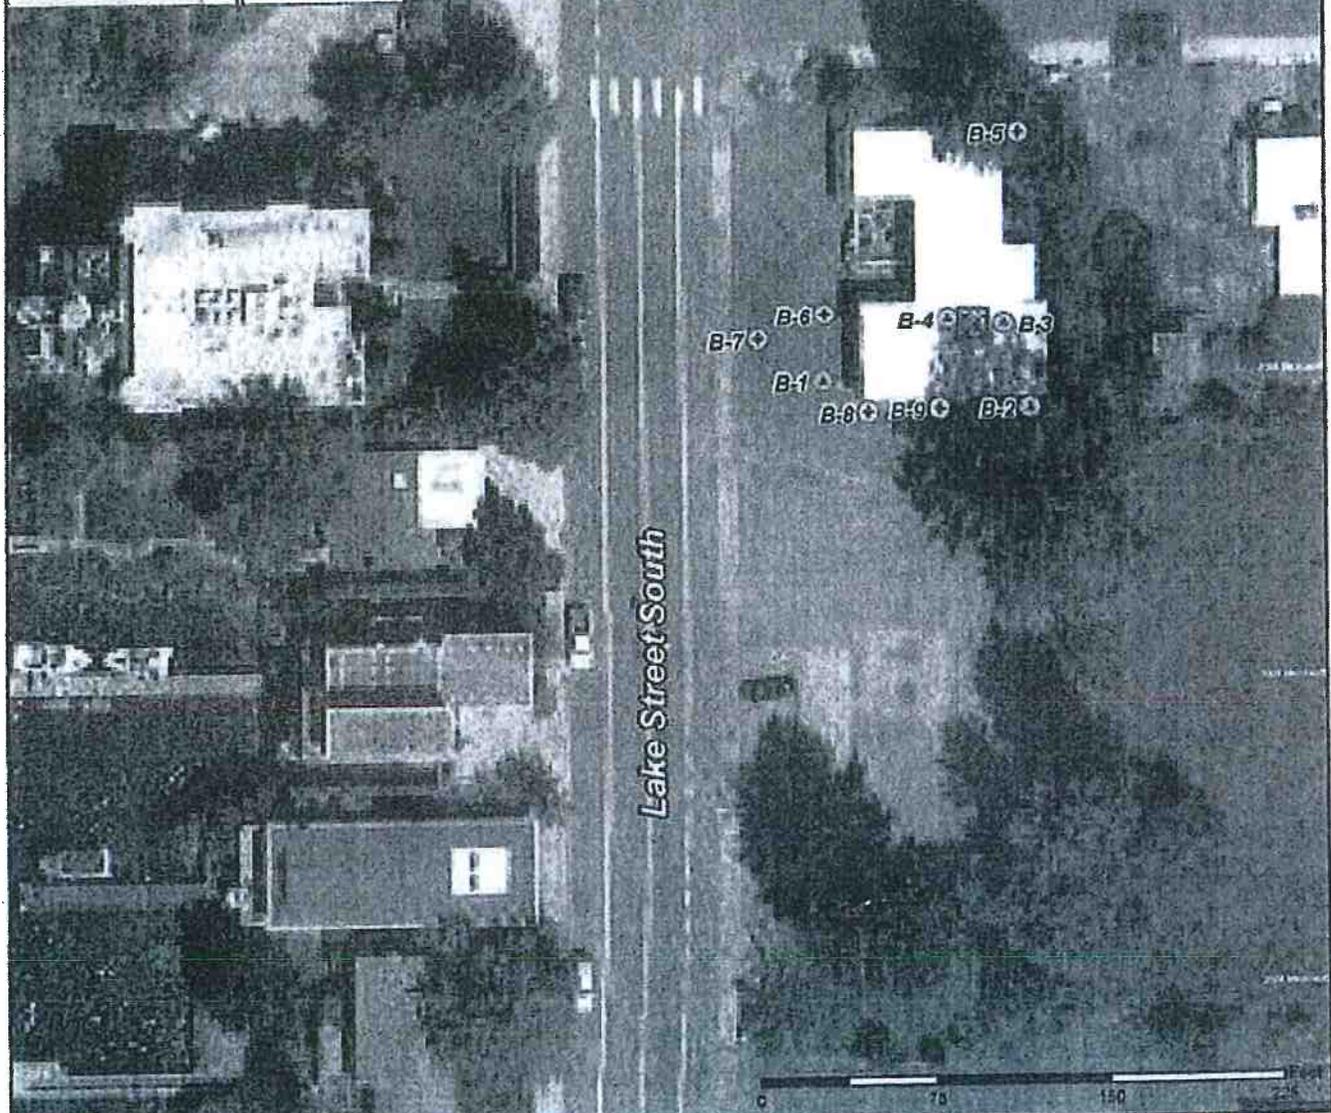
Soil Borings

Site Location and Exploration Locations
1006 Lake St. Kirkland, WA

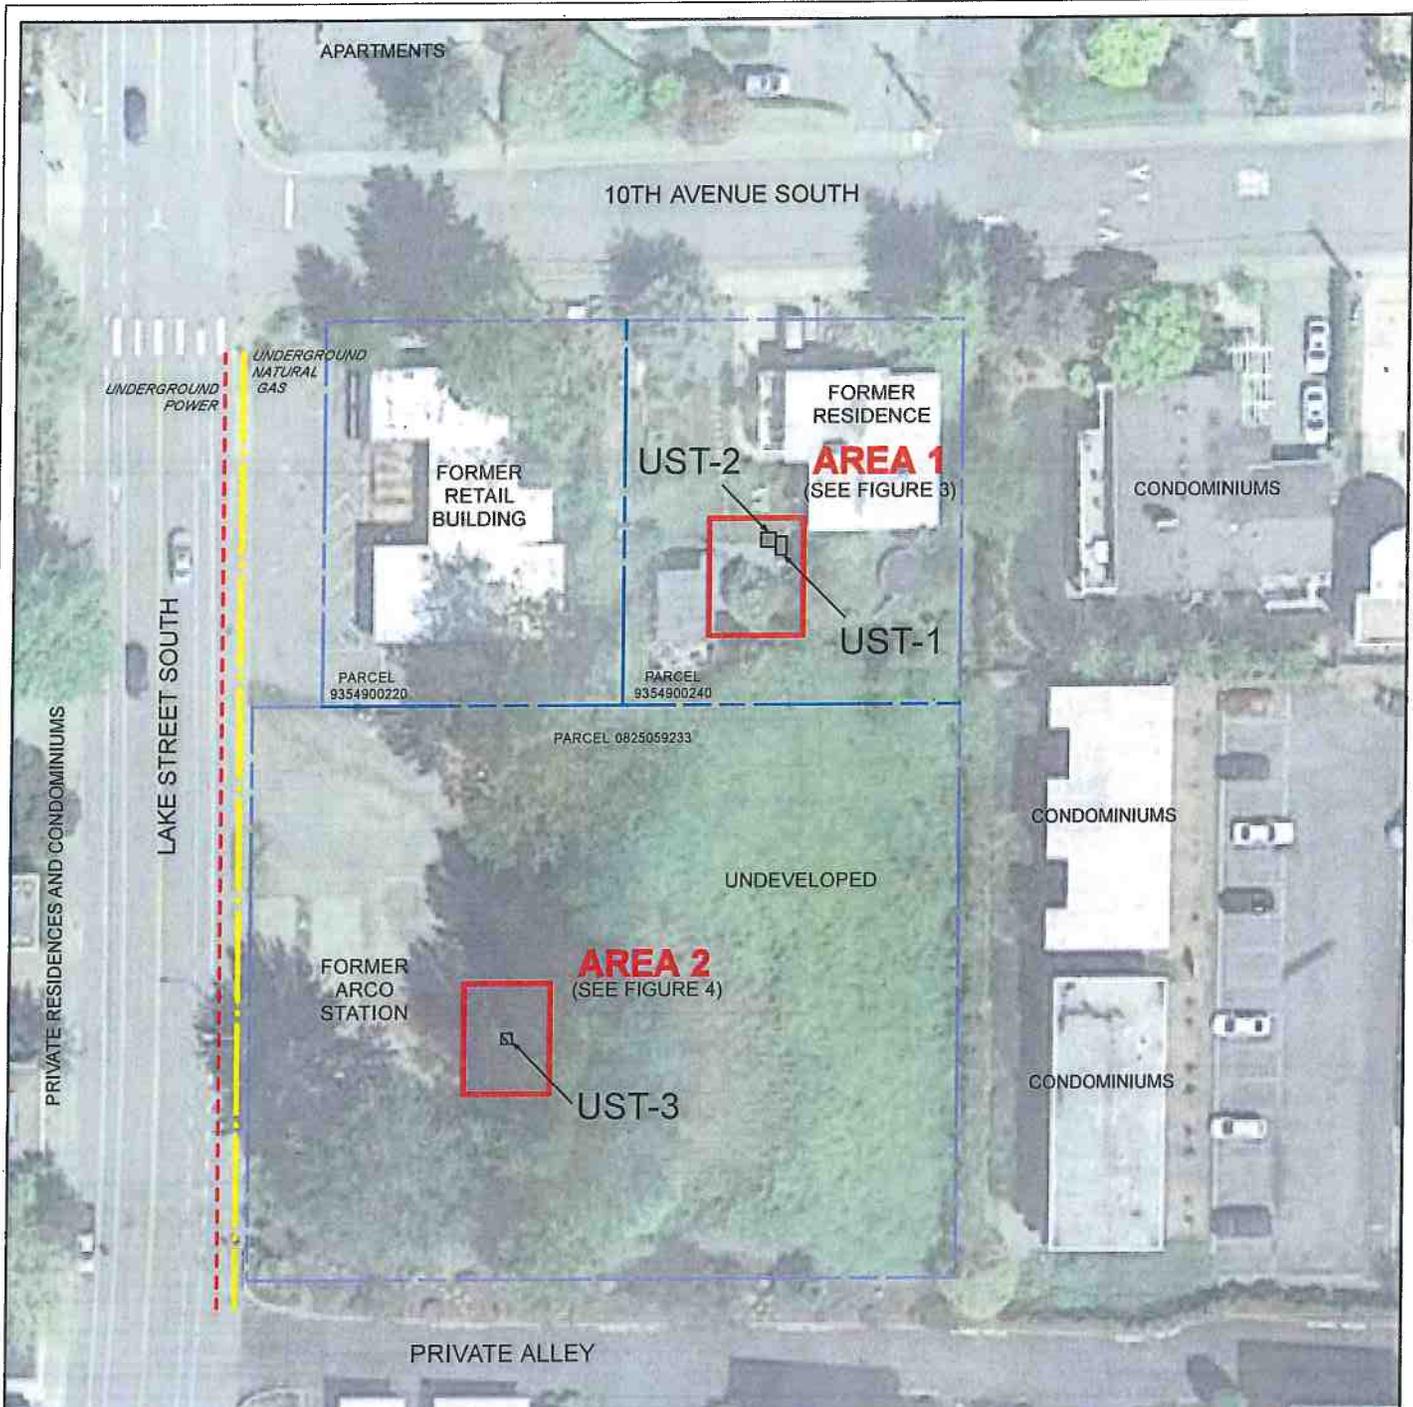
SITE REPRESENTATION

PREPARED BY	ENVIRONMENTAL PARTNERS INC		
REPORT	UST CLOSURE AND REMEDIAL ACTION REPORT		
LOCATION	21 TENTH AVENUE SOUTH AND 6700 LAKE WASHINGTON BLVD. KIRKLAND, WASHINGTON		
PREPARED FOR	EARTH SOLUTIONS NW, LLC		
DATE	DRAWN BY	REVIEWED BY	PROJECT NUMBER
5/16/14	CLM	ELC	48111.0

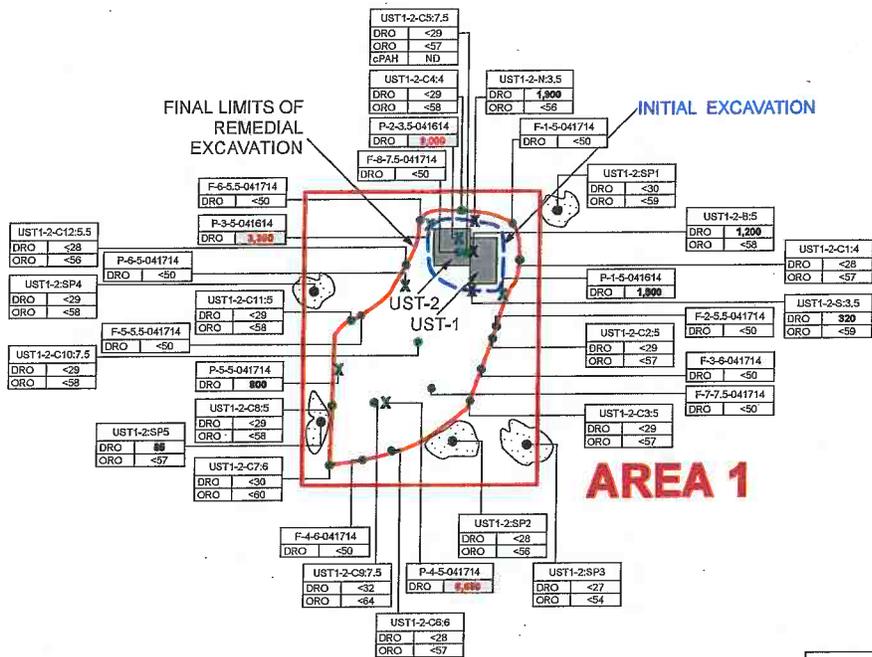
FIGURE 3
AREA 1 WITH ASSESSMENT AND CONFIRMATION SOIL SAMPLE RESULTS FOR UST-1 AND -2 (IN MG/KG)

- X UST ASSESSMENT SOIL SAMPLE LOCATIONS (COLLECTED BY ENVIRONMENTAL PARTNERS, ETC.)
- X UST ASSESSMENT SOIL SAMPLE LOCATIONS (COLLECTED BY PACIFIC ENVIRONMENTAL SERVICES)
- CONFIRMATION SOIL SAMPLE LOCATIONS (COLLECTED BY ENVIRONMENTAL PARTNERS, ETC.)
- CONFIRMATION SOIL SAMPLE LOCATIONS (COLLECTED BY PACIFIC ENVIRONMENTAL SERVICES)
- STOCKPILE SAMPLE
- FORMER HEATING OIL LIST
- EXCAVATED SOIL STOCK PILE

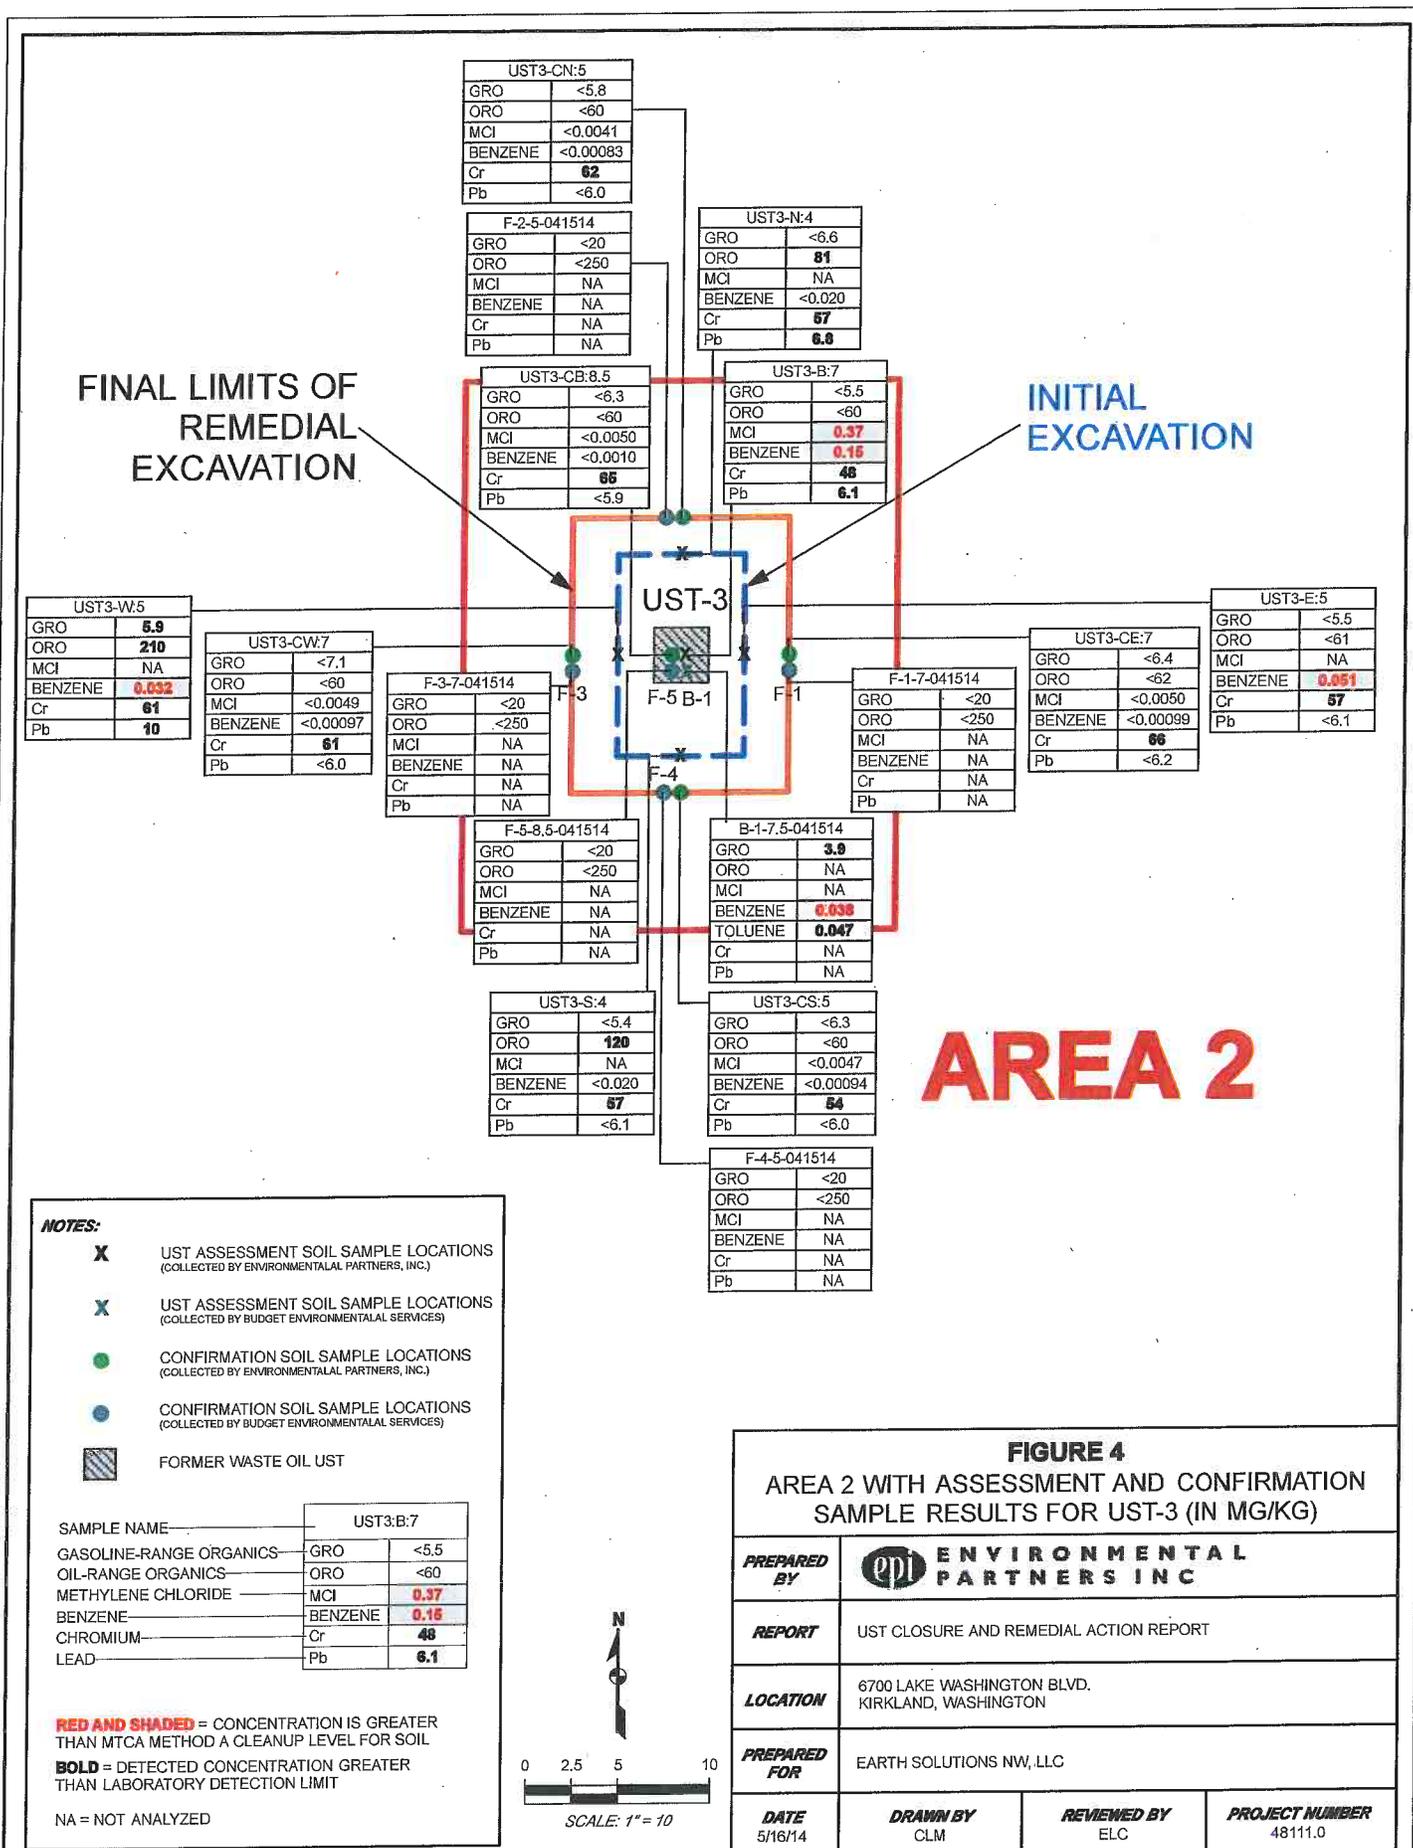
FIGURE 4
 AREA 2 WITH ASSESSMENT AND CONFIRMATION
 SAMPLE RESULTS FOR UST-3 (IN MG/KG)

UST3-CN:5	
GRO	<5.8
ORO	<60
MCI	<0.0041
BENZENE	<0.00083
Cr	62
Pb	<6.0

F-2-5-041514	
GRO	<20
ORO	<250
MCI	NA
BENZENE	NA
Cr	NA
Pb	NA

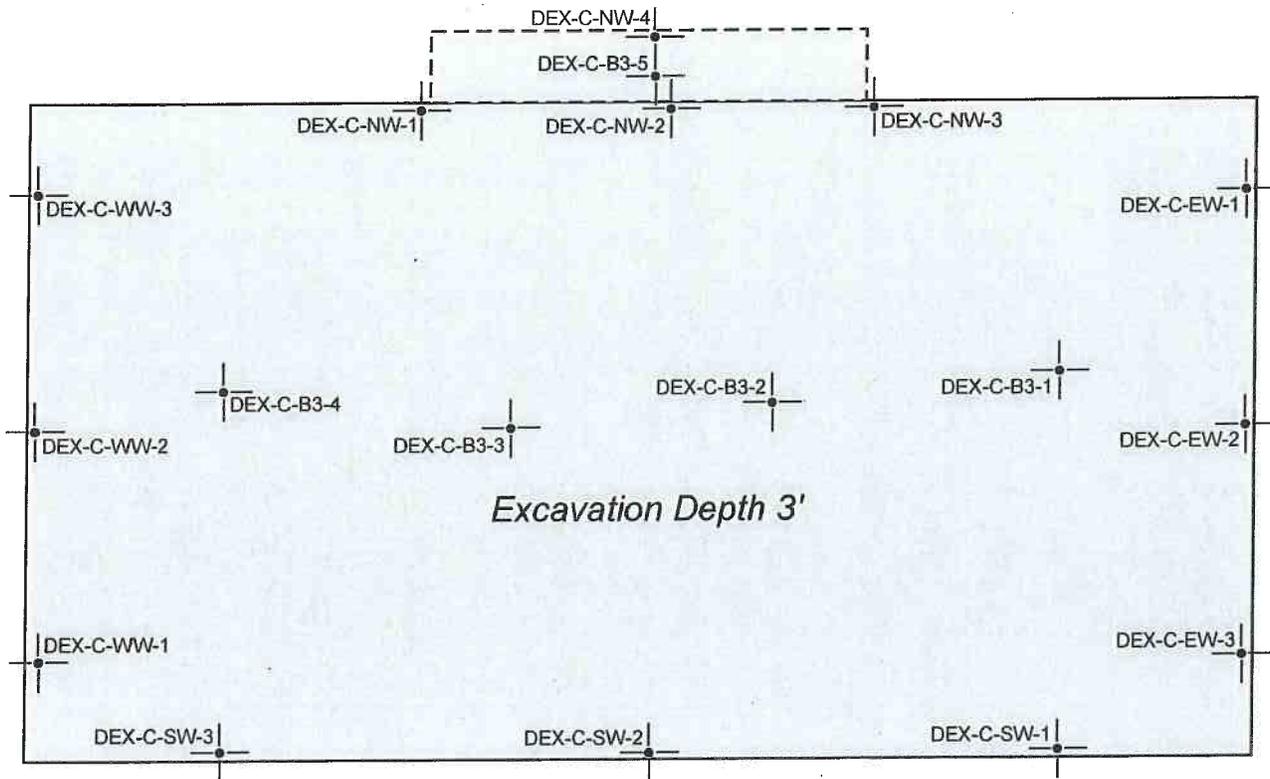
Drwn. GLS	Date 05/13/2014	Proj. No. 2880.05 & 07
Checked TWS	Date May 2014	Plate 3

Soil Sample Location Plan
Former Dry Cleaner Excavation - Potala Village
Kirkland, Washington

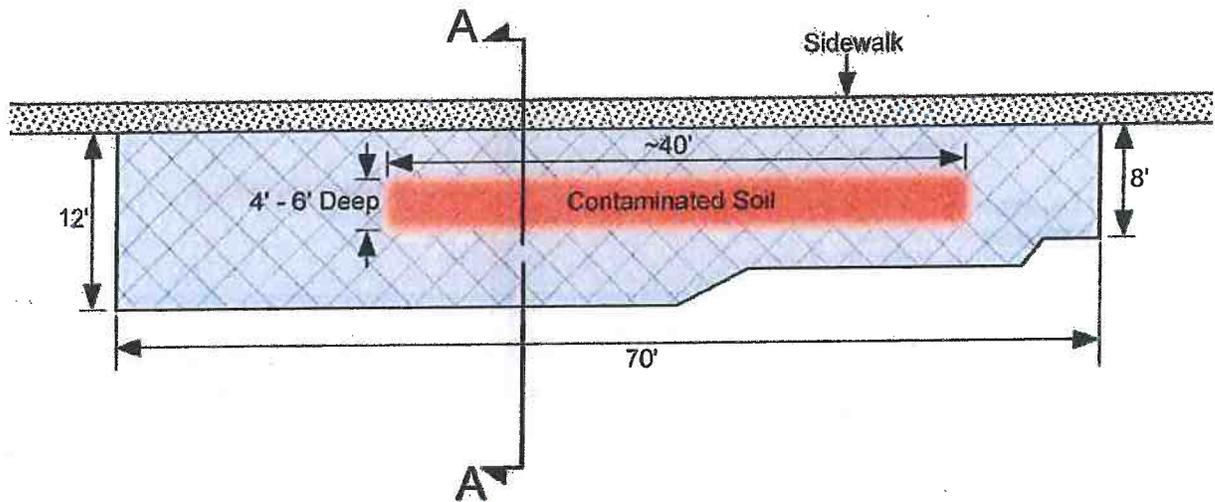
Drwn. GLS	Date 11/14/2014	Proj. No. 2880.07
Checked TWS	Date Nov. 2014	Plate 1

**Cross Section of West Excavation Sidewall
Potlatch Village
Kirkland, Washington**

On May 2, 2014, the sidewall along the southwest property boundary was sealed with bentonite (volclay) wall panels and a vapor sheet drain to prevent off-site contaminants and petroleum vapors from migrating back on-site. Details concerning the make-up and installation of the bentonite panels and vapor sheet drain are presented in an April 28, 2014 design letter prepared by ESNW (see Appendix A). Plates 3 and 4 include the lateral and vertical extent of contaminated soil remaining beyond the site's southwestern property boundary and the associated bentonite (volclay) wall panels and vapor sheet drain that were installed to cap the contaminated soil.

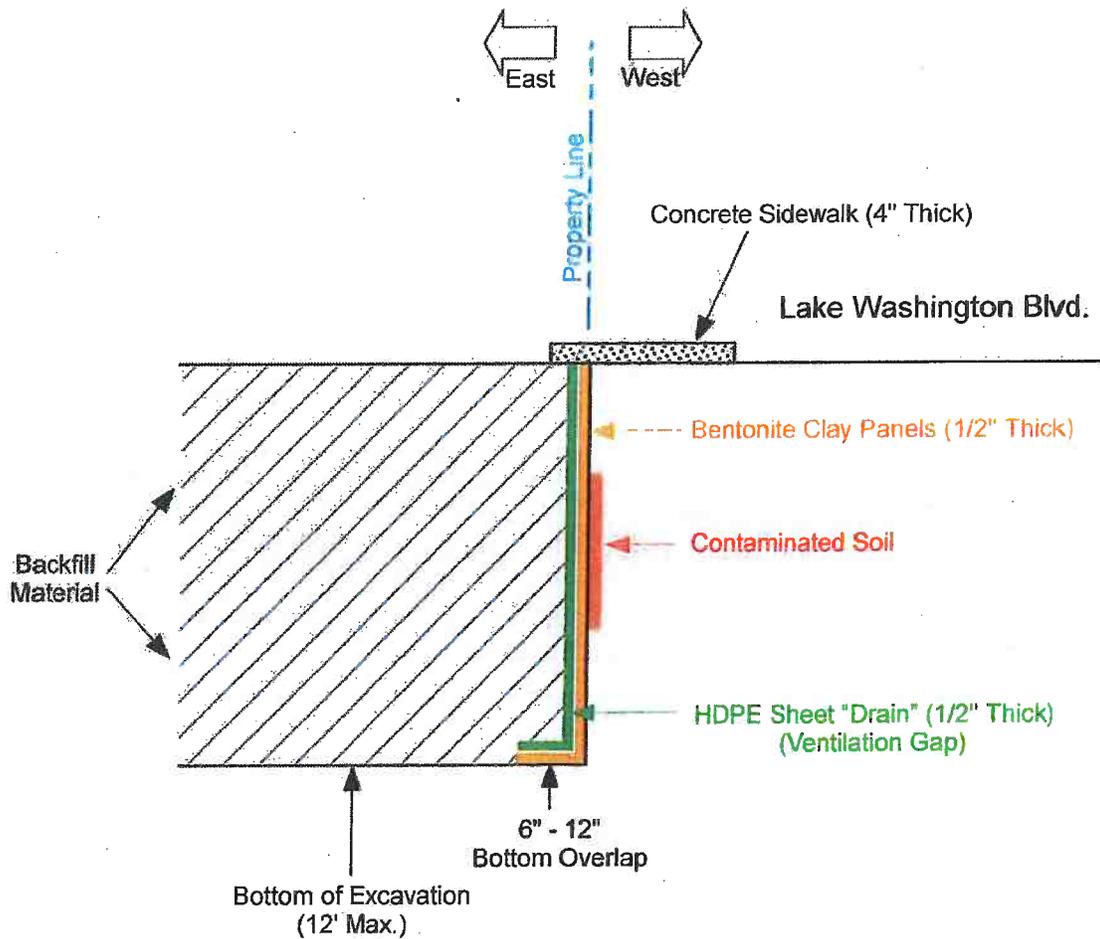
Drwn. GLS	Date 11/17/2014	Proj. No. 2880.07
Checked TWS	Date Nov. 2014	Plate 2

Solutions NW LLC <small>Investigating, Construction Monitoring and Environmental Sciences</small>	
	<p>Cross Section A of West Excavation Sidewall Potala Village Kirkland, Washington</p>

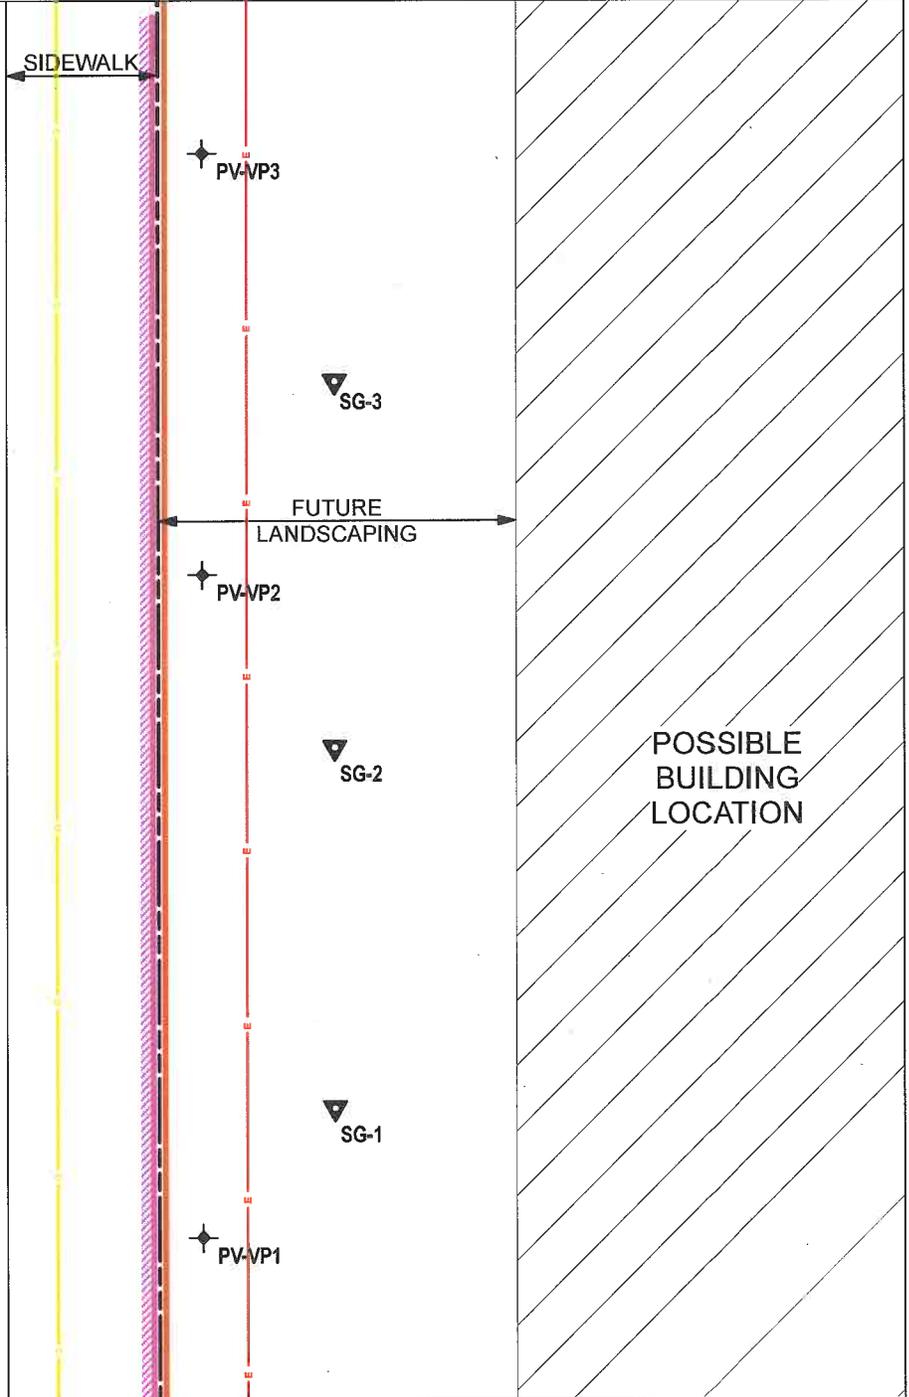
APPROXIMATE SUBJECT PROPERTY BOUNDARY
	UNDERGROUND NATURAL GAS
	UNDERGROUND ELECTRIC
	AREA OF RESIDUAL PETROLEUM SOIL IMPACTS
	VOLCLAY-BENTONITE PANAL
	PROPOSED PERMANENT SOIL GAS PROBE LOCATION
	VAPOR PROBE LOCATION

FIGURE 3 PROPOSED LOCATIONS FOR PERMANENT SOIL VAPOR WELLS			
PREPARED BY ENVIRONMENTAL PARTNERS INC			
REPORT	CONFIRMATION MONITORING PLAN - SOIL VAPOR SAMPLING		
LOCATION	POTOLA VILLAGE 6700 LAKE WASHINGTON BLVD, KIRKLAND, WASHINGTON		
PREPARED FOR	EARTH SOLUTIONS NW, LLC		
DATE 2/22/18	DRAWN BY CLM	REVIEWED BY ELC	PROJECT NUMBER 48111.1

c. Monitoring. A minimum of three (3) permanent soil gas probes shall be installed within the Restricted Area of the Property sited halfway between the western boundary of the Property and the foundation wall of any building constructed on the Property. The anticipated location of the soil gas probes is depicted on Exhibit C. The purpose of the soil gas probes is to monitor the effectiveness of the barrier and vapor shield in preventing harmful vapors from migrating to the Property. The soil gas probes should have 1-foot long screens set at approximately four to five feet below the ground surface (or above the water table, if encountered). Grantor shall maintain clear access to the soil gas probes and protect them from damage.

a horizontal distance of approximately 40 feet along the Property boundary. The approximate location of the residual soil impacts and the Volclay panel is shown on Figure 3. ESNW's remedial actions are documented in their Cleanup Action Report dated May 16, 2014.

The three permanent soil vapor wells will be installed by a Washington State licensed well drilling company using a direct-push technology (DPT) drilling rig. The wells will be placed along the southwestern property boundary, east of the remaining residual impacts located in the City of Kirkland Right-Of-Way as shown on Figure 3. The wells will be placed half way between the existing Volclay wall panels and the concrete wall of the structure when it is constructed. The final location of the wells will be dependent on actual site conditions at the time of drilling as well as the location of subsurface utilities and the proposed building walls and footings. The vapor wells will be placed at locations that are accessible, yet protected from damage.

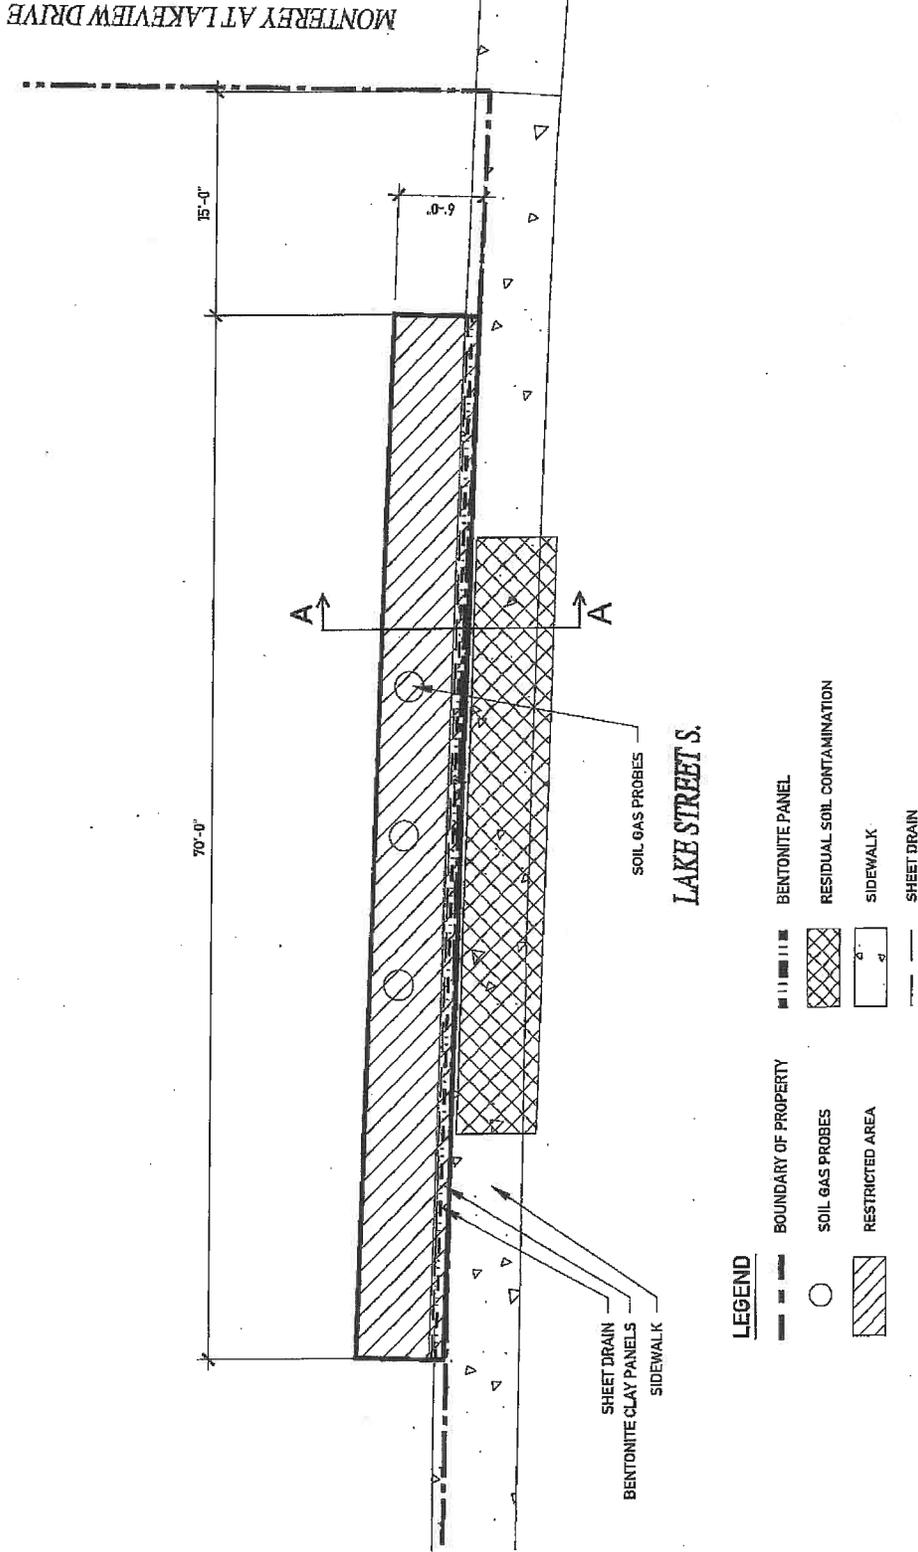
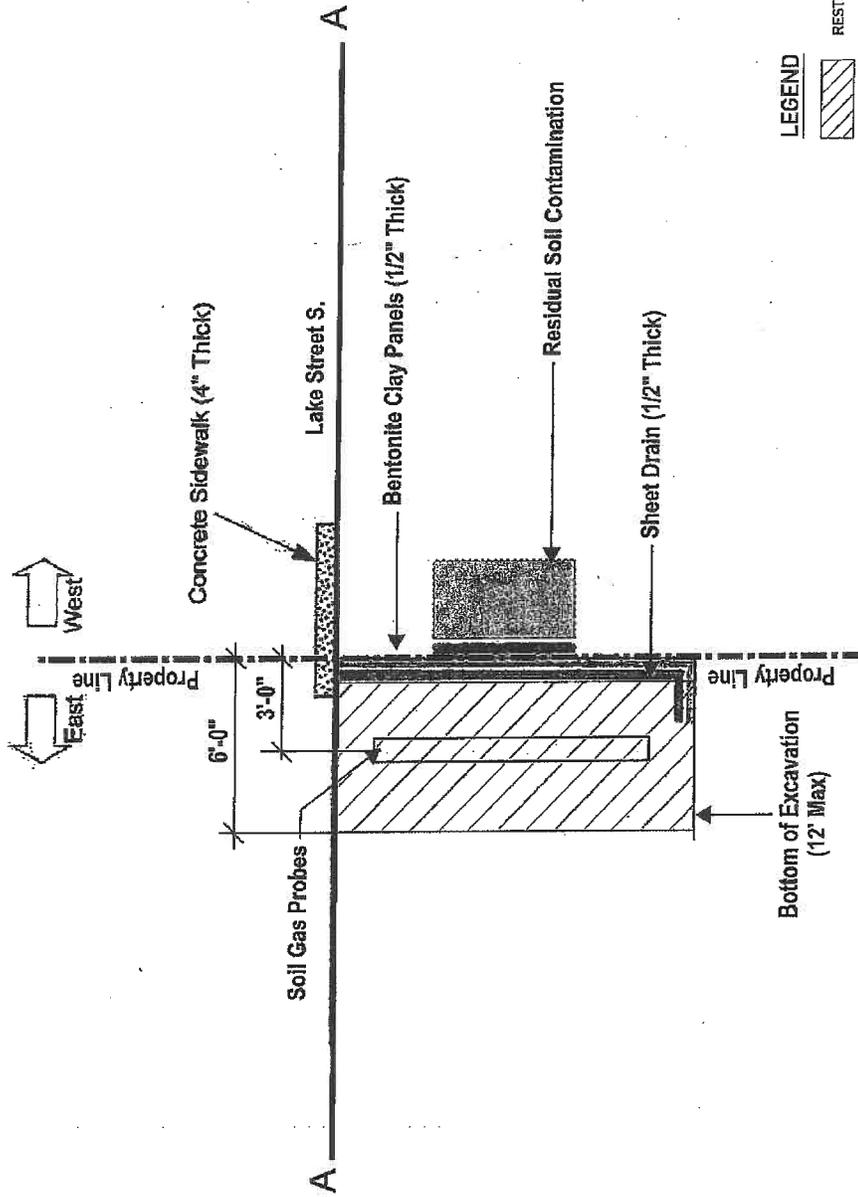
EXHIBIT C - DEPICTION OF RESTRICTED AREA & REMEDIAL ACTION COMPONENTS (CROSS SECTION VIEW)

**EXHIBIT C - DEPICTION OF RESTRICTED AREA &
REMEDIAL ACTION COMPONENTS (PLAN VIEW)**

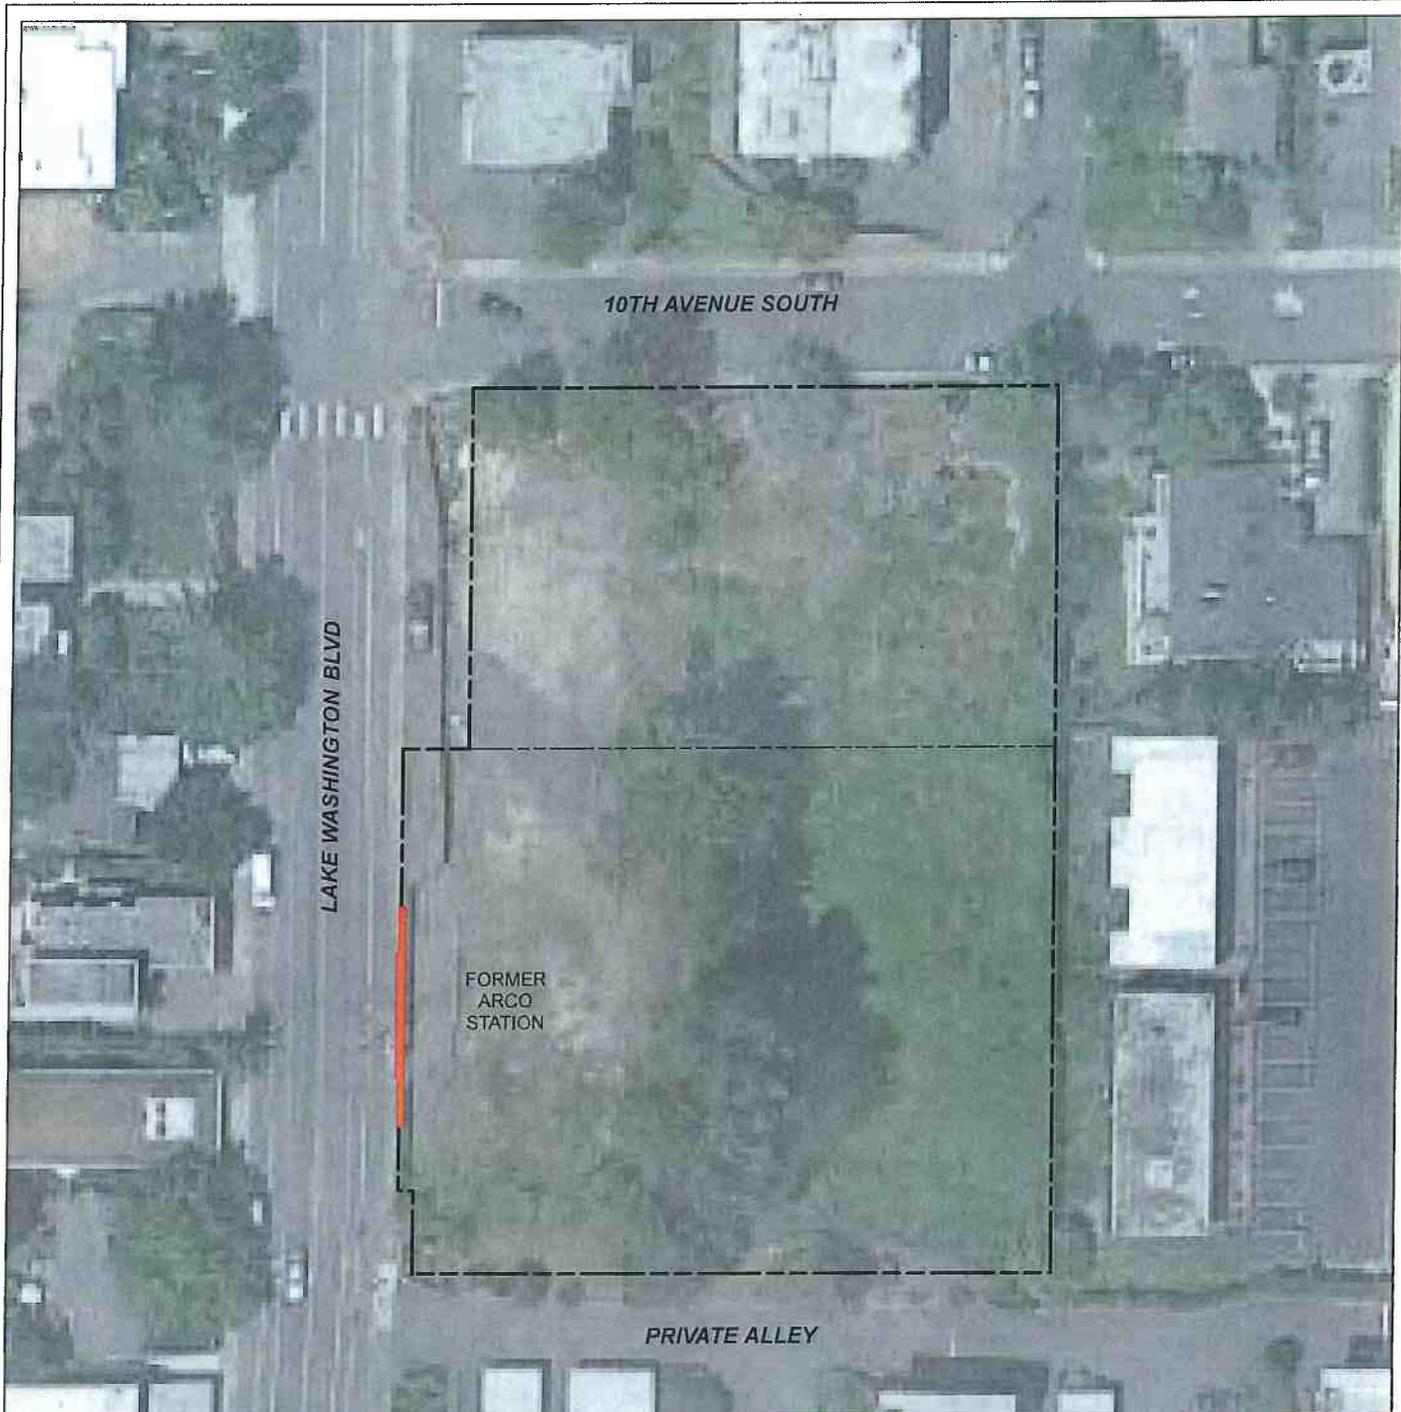
Figure 2 – Site Representation

ENVIRONMENTAL PARTNERS INC		
REPORT	CONFIRMATION MONITORING PLAN - SOIL VAPOR SAMPLING		
LOCATION	POTALA VILLAGE 6700 LAKE WASHINGTON BLVD, KIRKLAND, WASHINGTON		
PREPARED FOR	EARTH SOLUTIONS NW, LLC		
DATE	DRAWN BY	REVIEWED BY	PROJECT NUMBER
5/15/17	CLM	ELC	48111.1
