STATE OF WASHINGTON
DEPARTMENT OF ECOLOGY

Re: Opinion on Proposed Cleanup of a Property associated with a Site (Penthouse Drapery Cleaners and Manufacturers, Inc):

- Address: 1752 Rainier Ave. S., Seattle, WA
 - Facility/Site No.: 23408
 - VCP No.: NW 2278
- CSIO # 3184

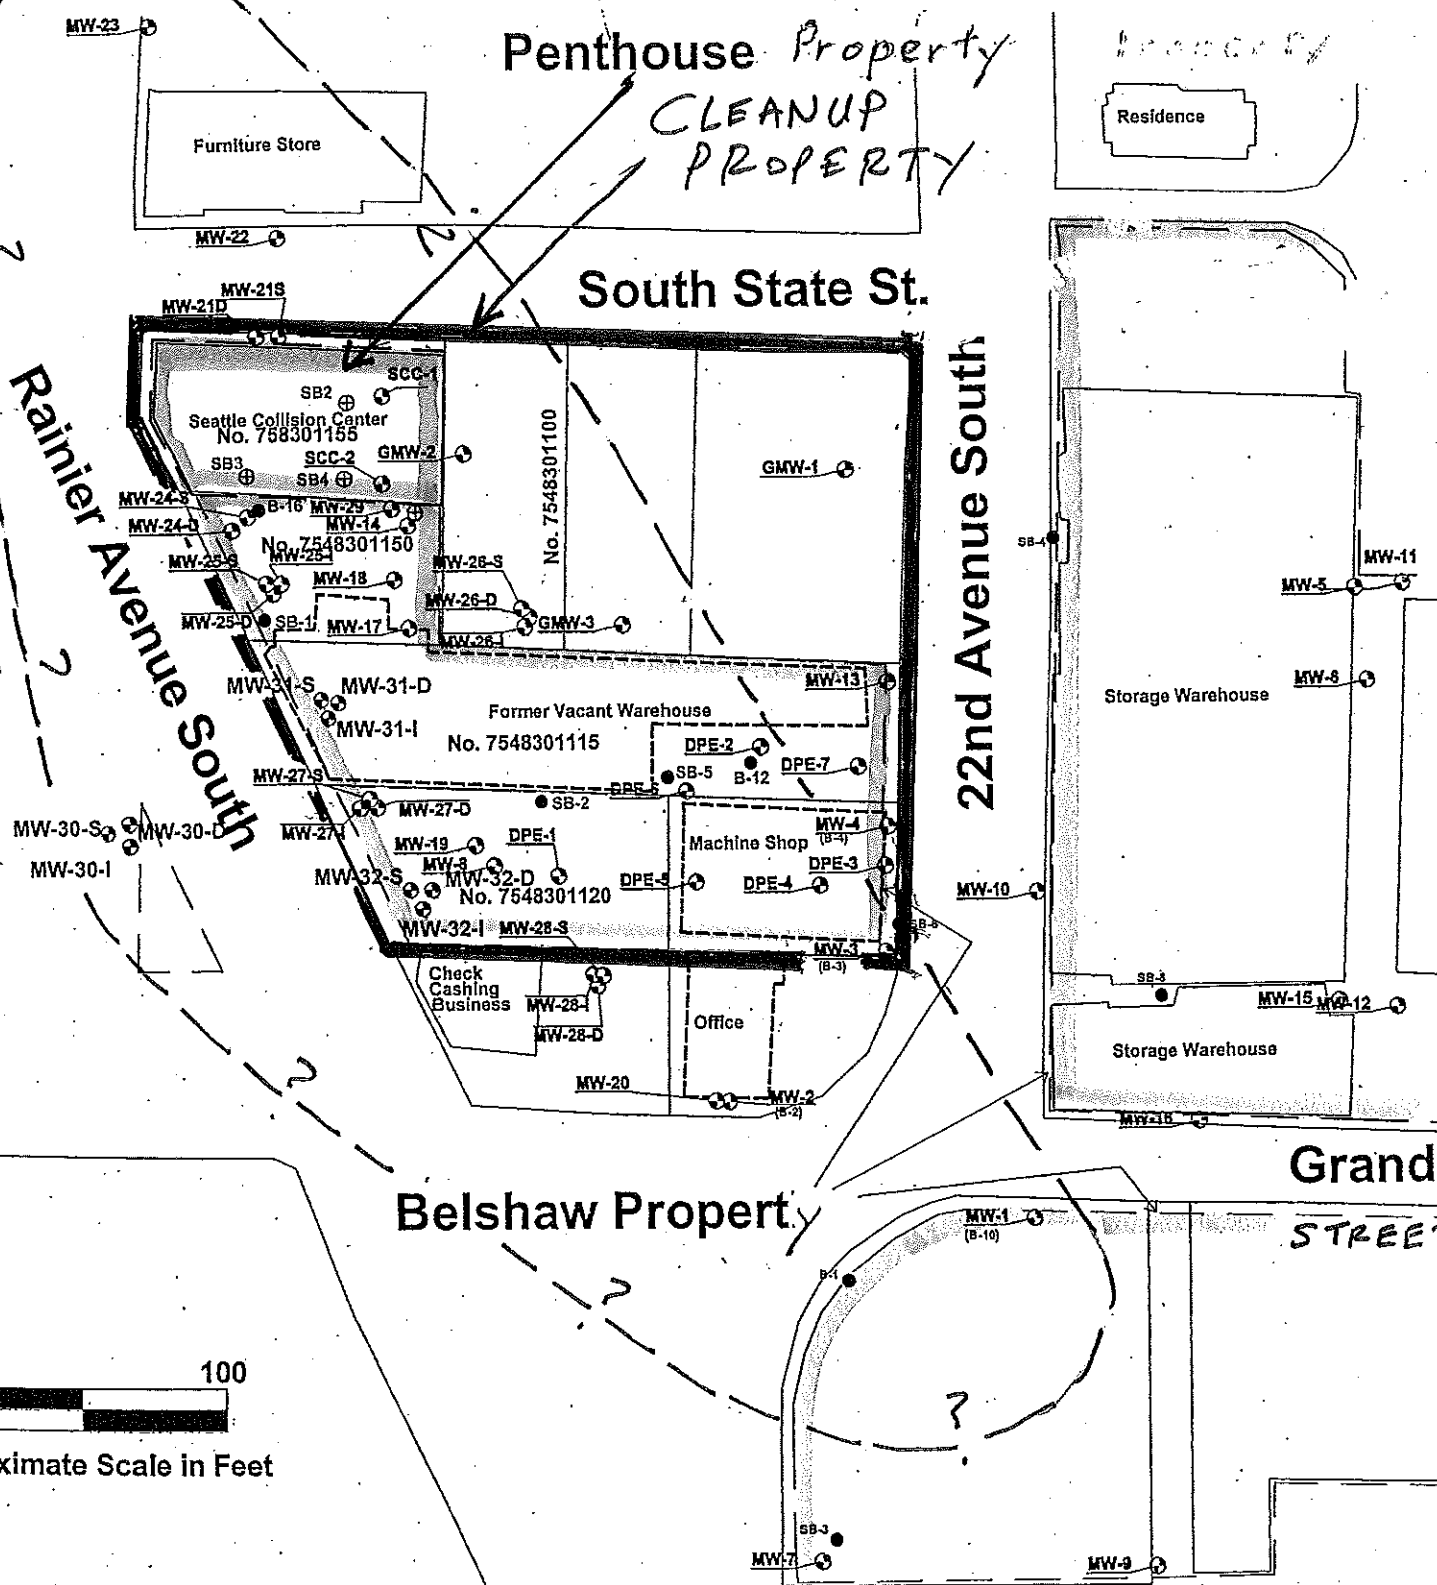
SITE BOUNDARY

The boundary of the contaminant plume within the three or four water bearing zones has been largely determined to the east and north, but not to the southeast, southwest, or west. The base of contaminant plume has also not been determined.
