STATE OF WASHINGTON
DEPARTMENT OF ECOLOGY

Re: Opinion pursuant to WAC 173-340-515(5) on Proposed Remedial Action for the following Hazardous Waste Site:

- **Site Name:** Precision Engineering
- **Site Address:** 1231 South Director Sreet, Seattle, WA 98108
- **Facility/Site No.:** 2056
- **VCP Project No.:** NW 1511

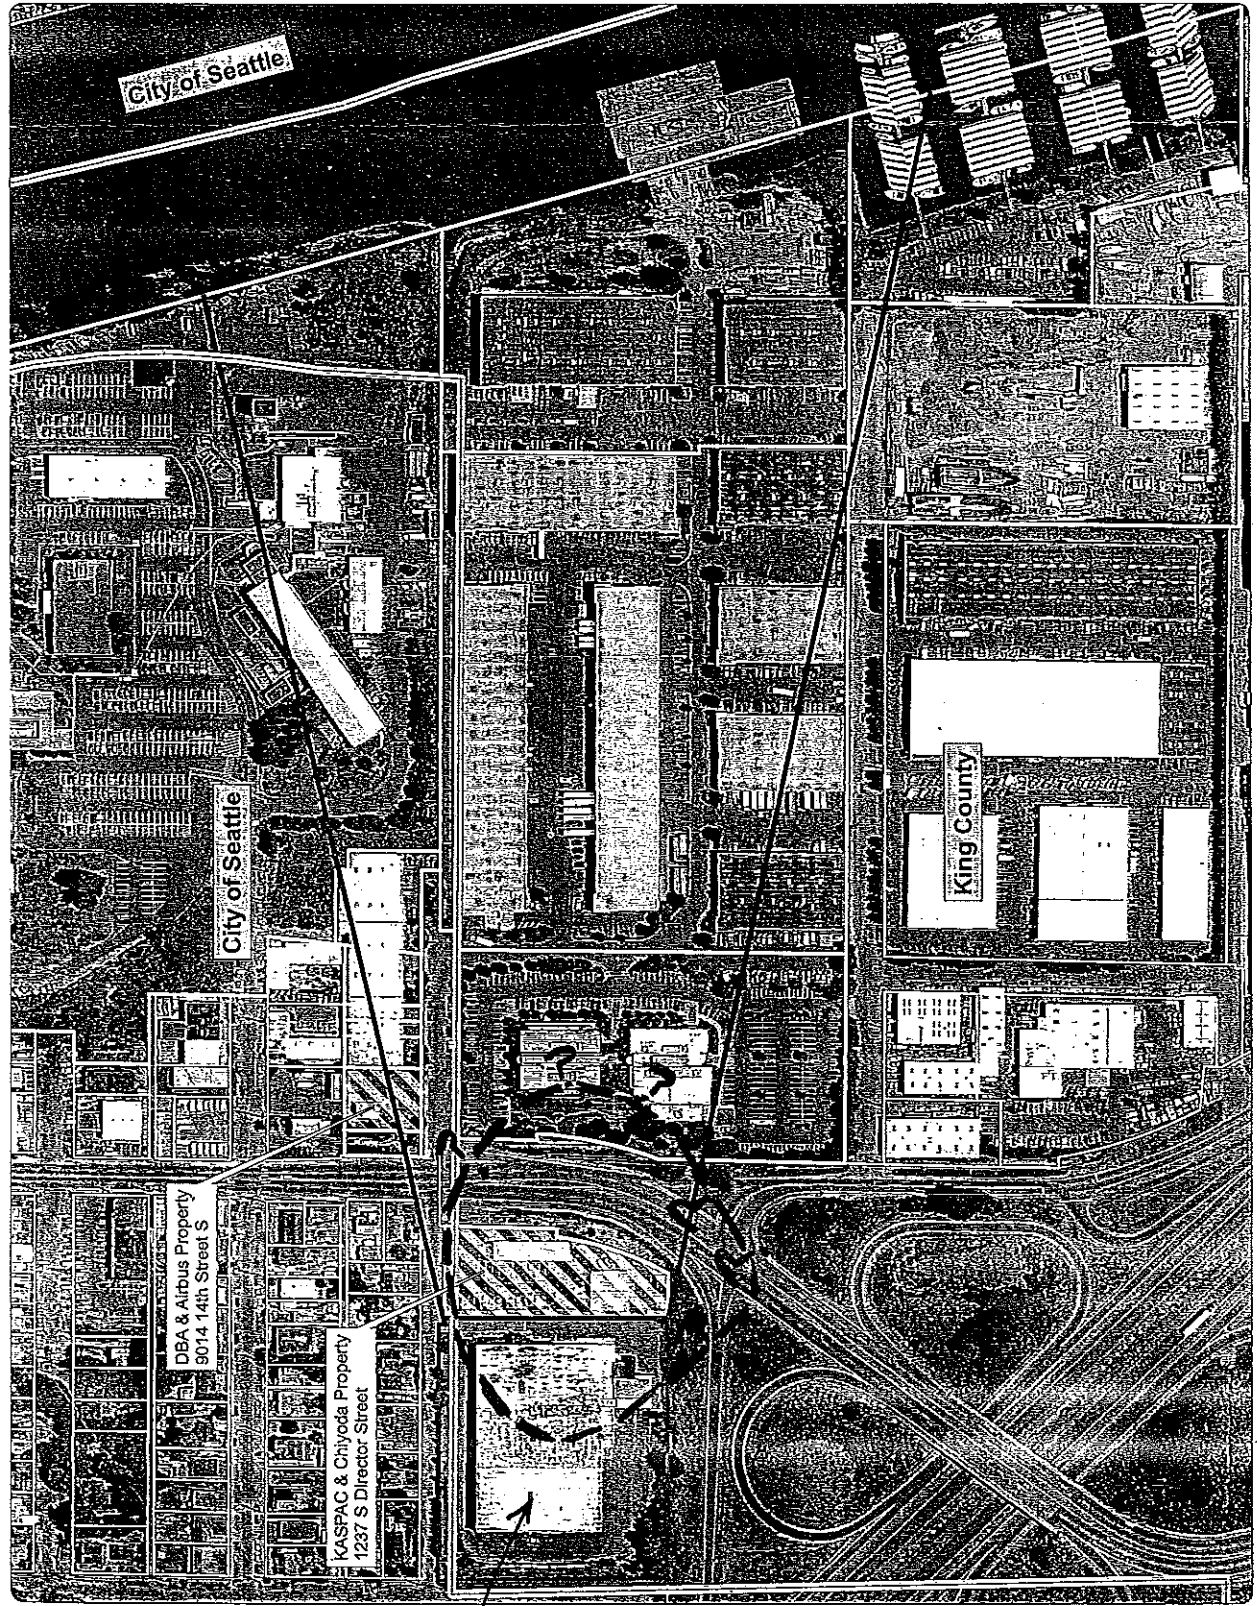
SITE MAP
 Mark Adams
 Ecology
 7/8/11

Source: Aerial photograph obtained from ESRI, Inc. ArcGIS Online/Microsoft Virtual Earth; tax lots obtained from King County; city boundary obtained from Washington Department of Transportation

--- APPROXIMATE BOUNDARY OF SITE
