**RE: REQUEST FOR A NO FURTHER ACTION DETERMINATION FOR
LAKESHORE LANDING PROPERTY (LOT 10-80s BUILDINGS),
745 PARK AVENUE NORTH, RENTON, WASHINGTON**

Lakeshore Landing
Renton, Washington

21-1-12309-004

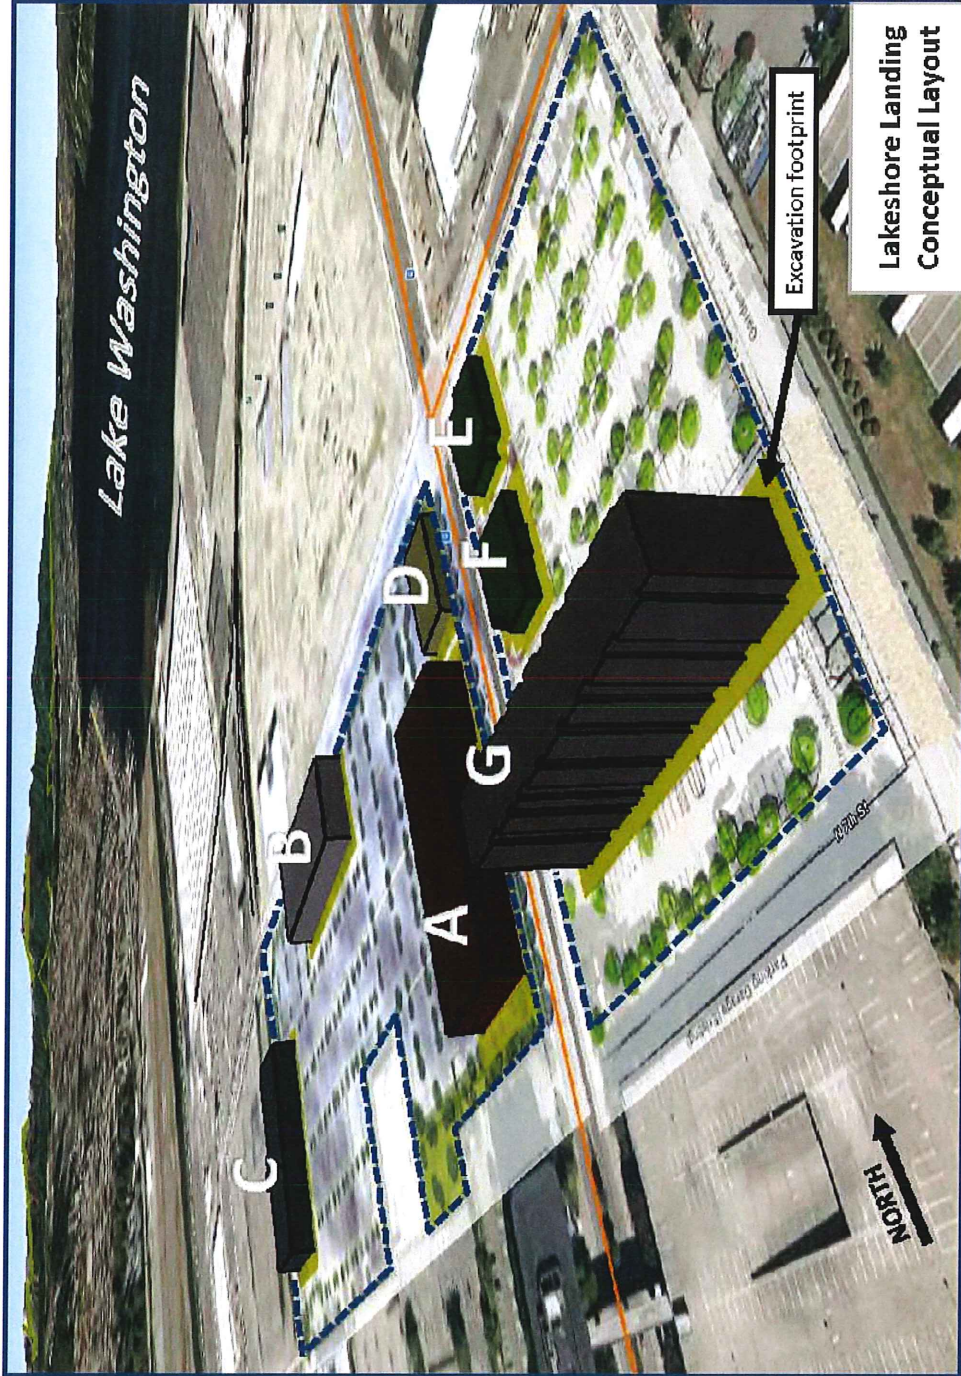
FIG. 3

- A. 3-Story Office/Lab (47,000 sqft)
- B. 3-Story Office/Lab (45,300 sqft)
- C. 3-Story Office/Lab (48,100 sqft)
- D. 1-Story Retail (12,300 sqft)
- E. 1-Story Restaurant (11,200 sqft)
- F. 1-Story Restaurant (8,800 sqft)
- G. 7-Story Hotel (29,700 sqft)

Note: Sqft estimates include 20-foot of lateral overexcavation.

**LAKESHORE LANDING
CONCEPTUAL LAYOUT**

Table 749-1 and the terrestrial ecological evaluation form are attached and the 500-foot radius for evaluation is identified on Figure 2. The subject property due to its size had continued ecological evaluation undertaken as shown on the terrestrial ecological evaluation form. Since soil and groundwater was not detected or detected below the cleanup criteria established by MTCA the subject property does not have a pathway to either human health or ecological exposure. Development is also planned which includes offices, labs, and paved parking lots (Figure 3). The subject property does not present an ecological exposure pathway.
