STATE OF WASHINGTON
DEPARTMENT OF ECOLOGY

Re: Further Action at the following Site:

- **Site Name:** Mowhawk Flush Doors (also, Seattle Door, SEEDORCO, Sauder Door, Premdor)
- **Site Address:** 747, 777, and 787 - 6th Street South (formerly 733 and 815), Kirkland, Washington
- **Facility/Site No.:** 98437118
- **VCP Project No.:** NW 1543

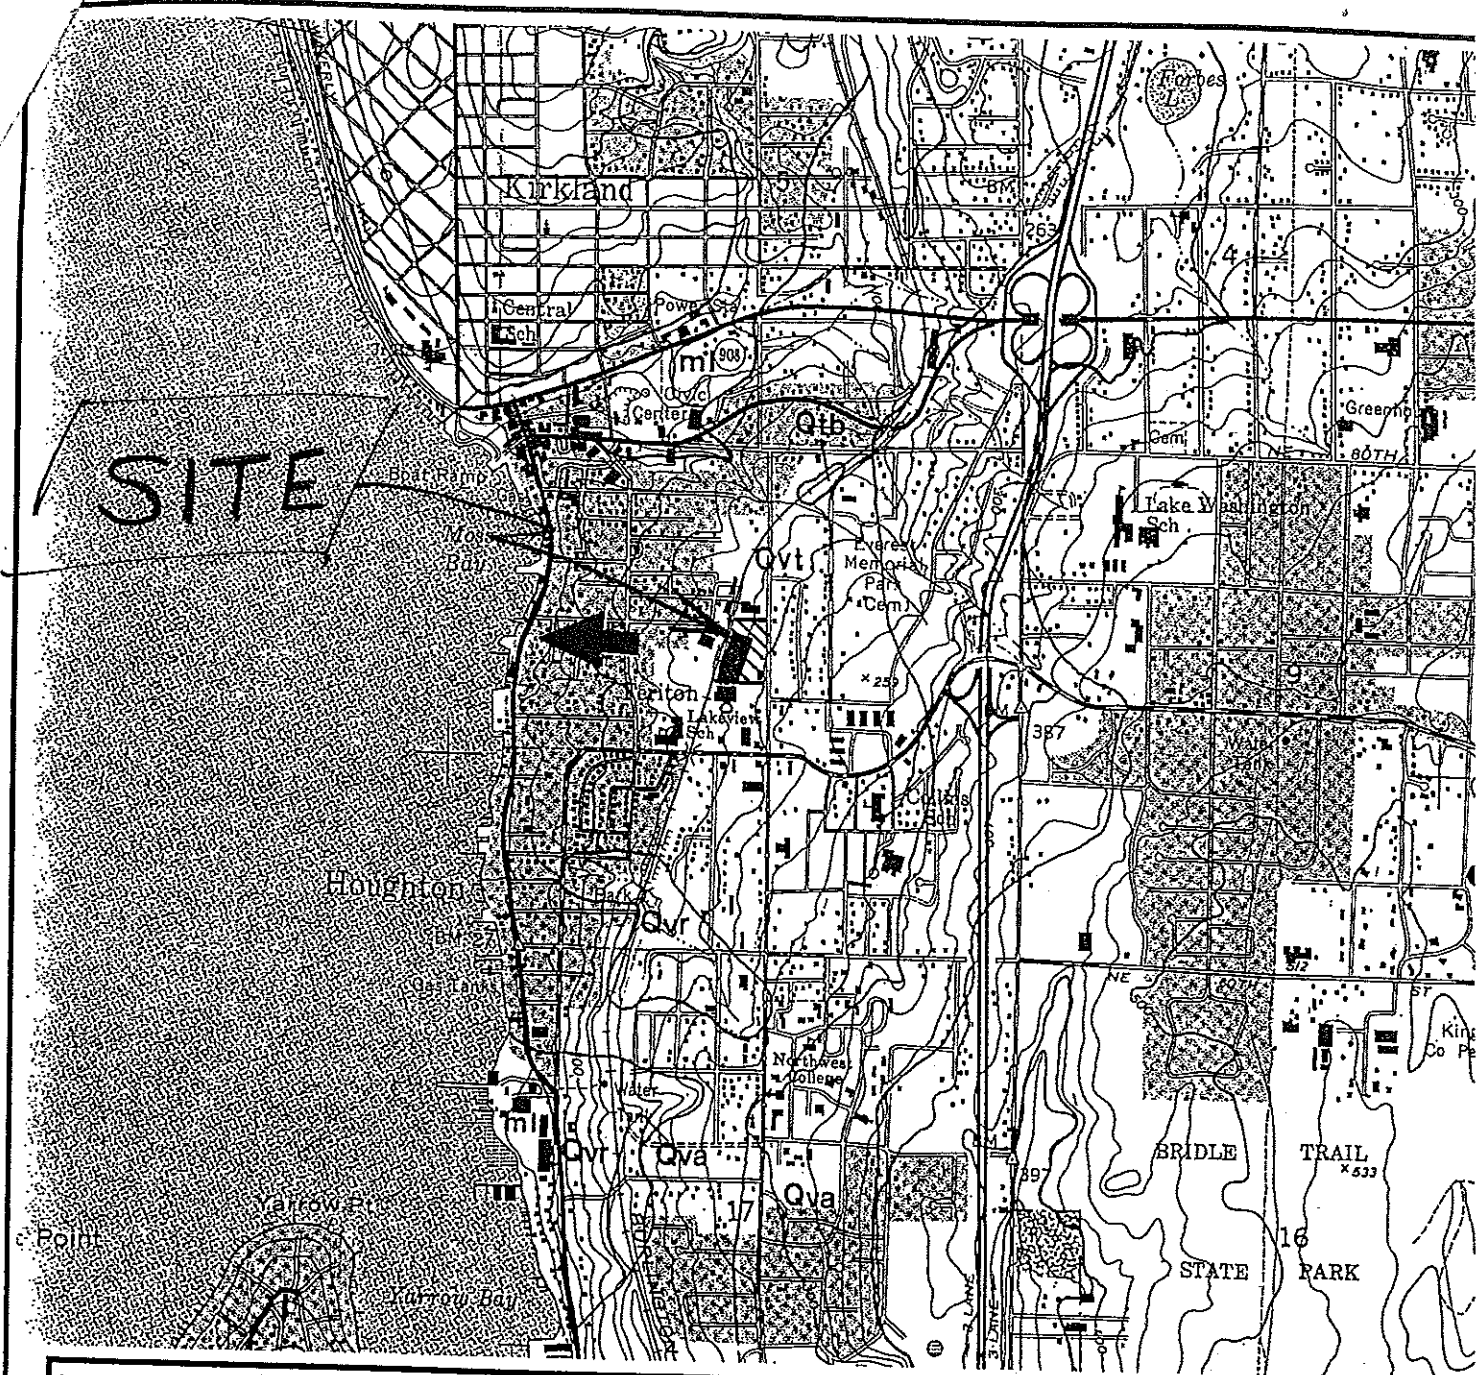
SITE VICINITY MAP
SAUDER DOOR PROPERTY
815 - 6th STREET SOUTH
KIRKLAND, WASHINGTON

PROBABLE DIRECTION OF REGIONAL SHALLOW GROUNDWATER FLOW

(SOURCE: USGS GEOLOGIC MAP, KIRKLAND, WA. QUADRANGLE 1983)

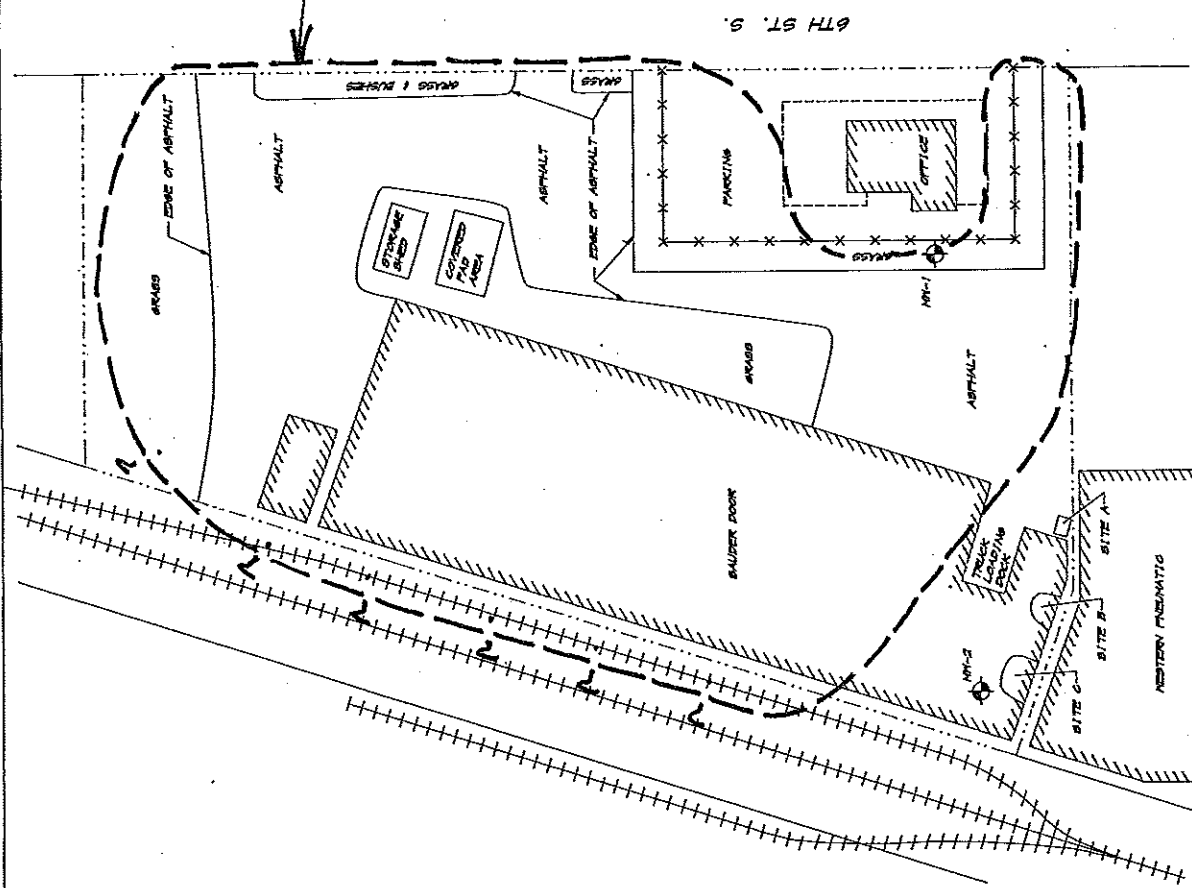
BASE MAP

LEGEND	
SYMBOL	EXPLANATION
---	PROPERTY BOUNDARY
-X-X-X-	FENCE LINE
NH-1	MONITORING WELL LOCATION

APPROXIMATE BOUNDARY
OF SITE
M. ADAMS, ECOLOGY
SEPT, 2009

SAUDER DOOR COMPANY
815 6TH ST. S.
KIRKLAND, WASH.

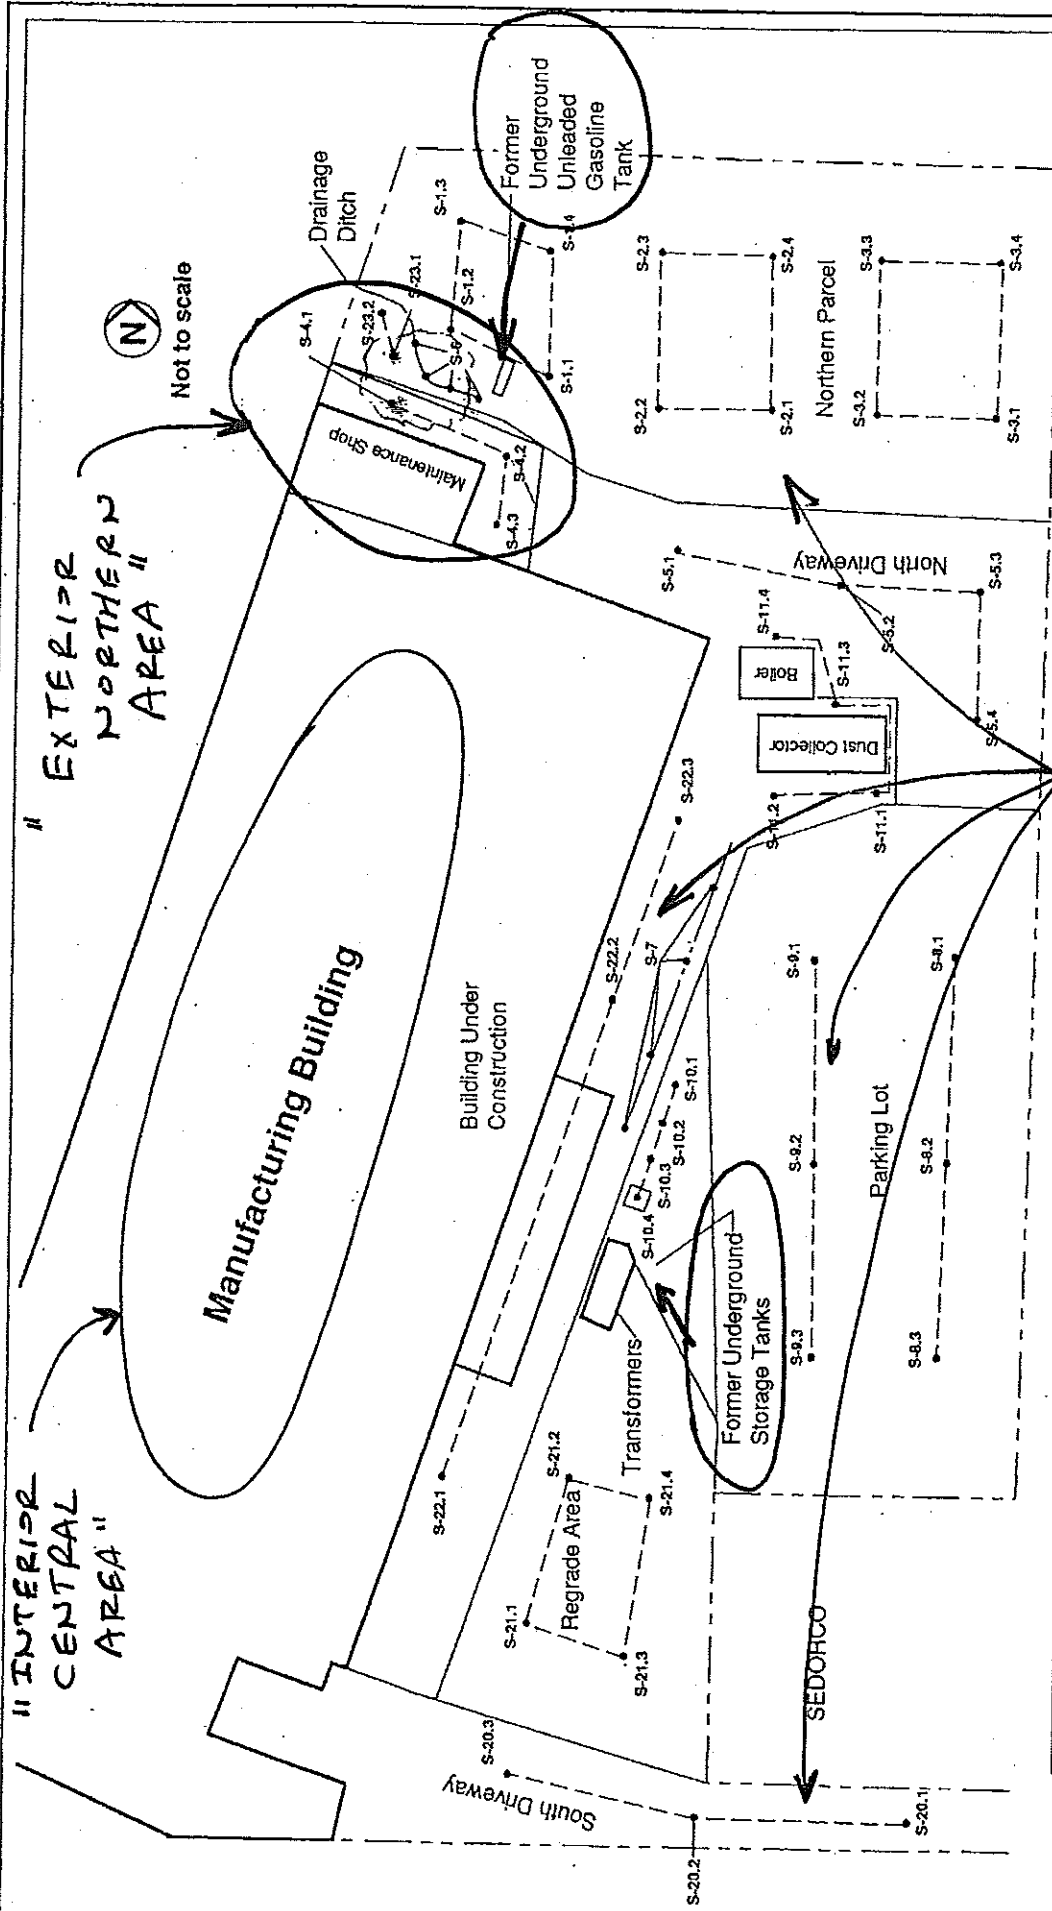
Surface Soil
Sampling Locations

- Legend
- Discrete sampling locations
 - Composite samples formed by combining discrete samples at locations designated by •

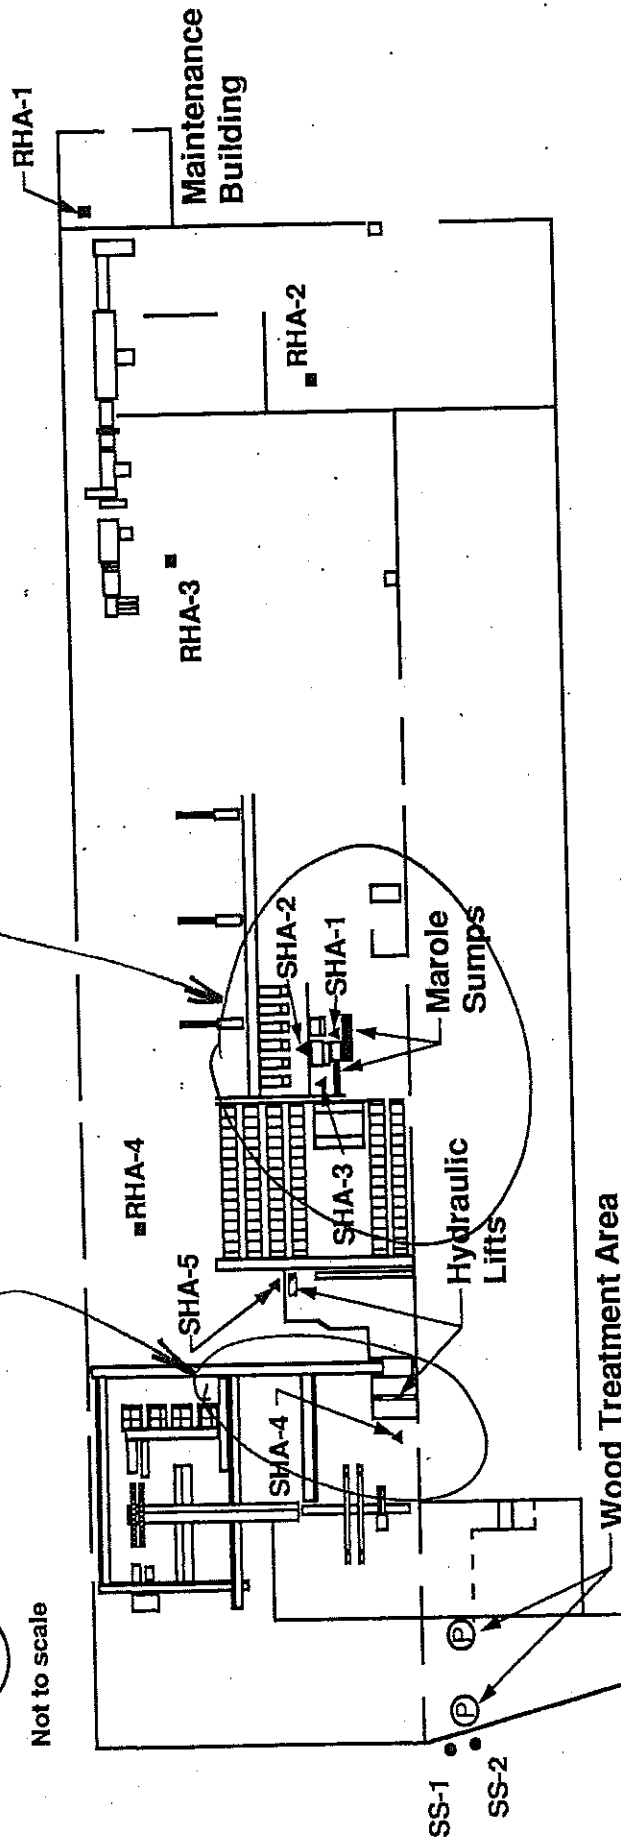
"INTERIOR CENTRAL AREA - SUMPS"

- RHA-3 ■ Random Hand Auger Number and Location
- SHA-3 ▲ Sump Hand Auger Number and Location
- SS-1 ● Soil Sample Number and Location

This area has been variously referred to as the marole sumps, hydraulic pits, hydraulic lift pits, hydraulic press sumps, and the press pits. Hydraulic oils and other contaminants were released to soil in this area via cracks and leaks in two concrete sumps within the central portion of the former main building. The two sumps served as the foundation for door fabrication equipment (i.e., the presses), and were about 4.5 feet deep relative to floor slab grade. In an early 1990 investigation, one of the sumps contained spent hydraulic fluid and the other contained some kind of resin.
