### STATE OF WASHINGTON DEPARTMENT OF ECOLOGY

#### Re: Opinion on Proposed Cleanup of the following Site:

Site Name: South Kenyon Street

• Site Address: 110, 130, 150, 200 S. Kenyon St., Seattle, WA

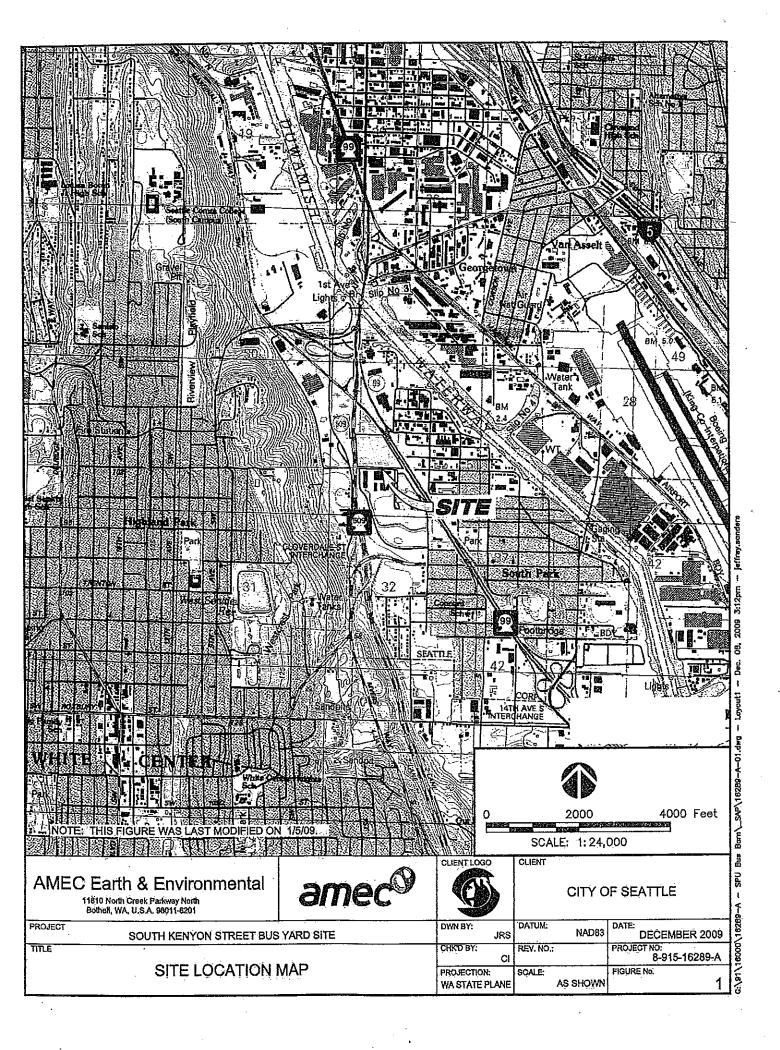
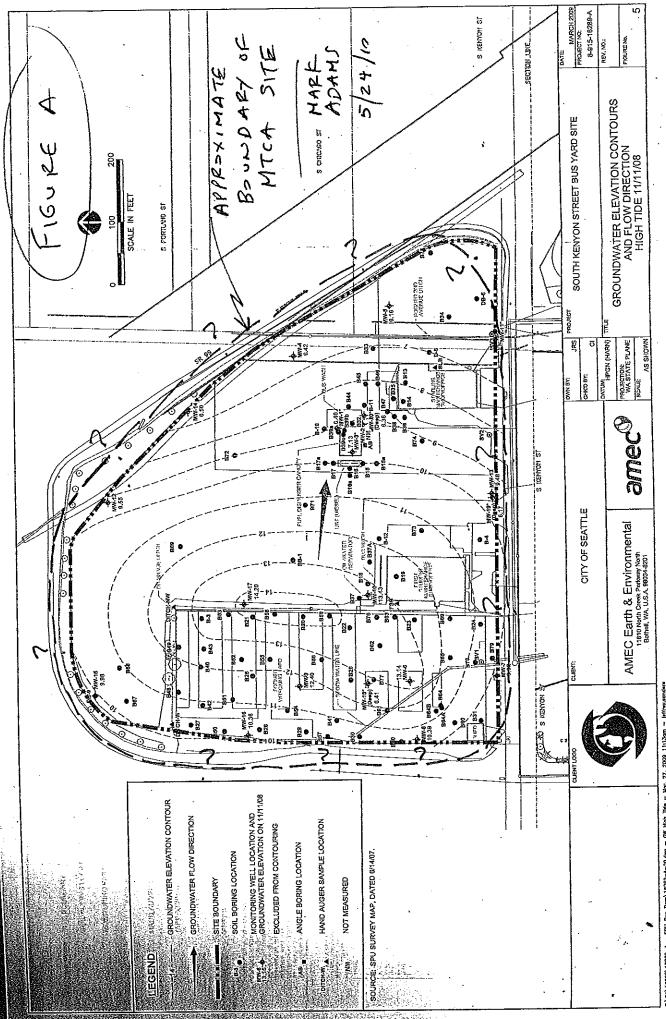
S CHICAGO ST 8-915-16289-A MARCH 20 PROJECT NO: RBV. NO. CLEAN UP LESELS WITHIN カンチブン APPROTIMATE APEA OF SOIL EXCERBING SOIL REMEDIATION AREAS MARK 5/24/10 SOUTH KENYON STREET BUS YARD SITE SIGE MTCA DATUM: HPGN (HARN) PROJECTION: WA STATE PLANE SCALE: 872 S KENYON ST CHKD BY: *amec* CITY OF SEATTLE AMEC Earth & Environmental 11910 North Crost Parkway North Botholl, WA, U.S.A. 89034-6201 PUSH PROBE SOIL BORING LOCATION (JULY 2008) APPROXIMATE AREA REQUIRING DEWATERING HAND AUGER SAMPLE LOCATION MONITORING WELL LOCATION ANGLE BORING LOCATION SOIL BORING LOCATION/ TEMPORARY WELL SOURCE: SPU SURVEY MAP, DATED 6/14/07. **EXCAVATION AREA** SITE BOUNDARY

• Wrecking Yard – Area 3: Most of this area is underlain by cement kiln dust fill (CKD), which contains elevated concentrations of arsenic, cadmium, and lead. The CKD extends over an area measuring approximately 200 feet by 500 feet within the Property, and reaches maximum depths of 16 feet below existing ground surface. The CKD likely extends a short distance off-Property to the west, following the original drainage channel. The CKD also contains a number of contaminants apparently associated with former wrecking yard operations including: gasoline- and diesel-range petroleum hydrocarbons, and PAHs. The insecticide endosulfan is also present in the area, and also spread widely across the property. The area of soil contamination in Area 3 appears to be largely constrained to within the CKD.
