STATE OF WASHINGTON
DEPARTMENT OF ECOLOGY

Re: No Further Action at the following Site:

- **Site Name:** Mowhawk Flush Doors (also, Seattle Door, SEEDORCO, Sauder Door, Premdor)
- **Site Address:** 747, 777, and 787 - 6th Street South (formerly 733 and 815), Kirkland, Washington
- **Facility/Site No.:** 98437118
- **VCP Project No.:** NW 1543

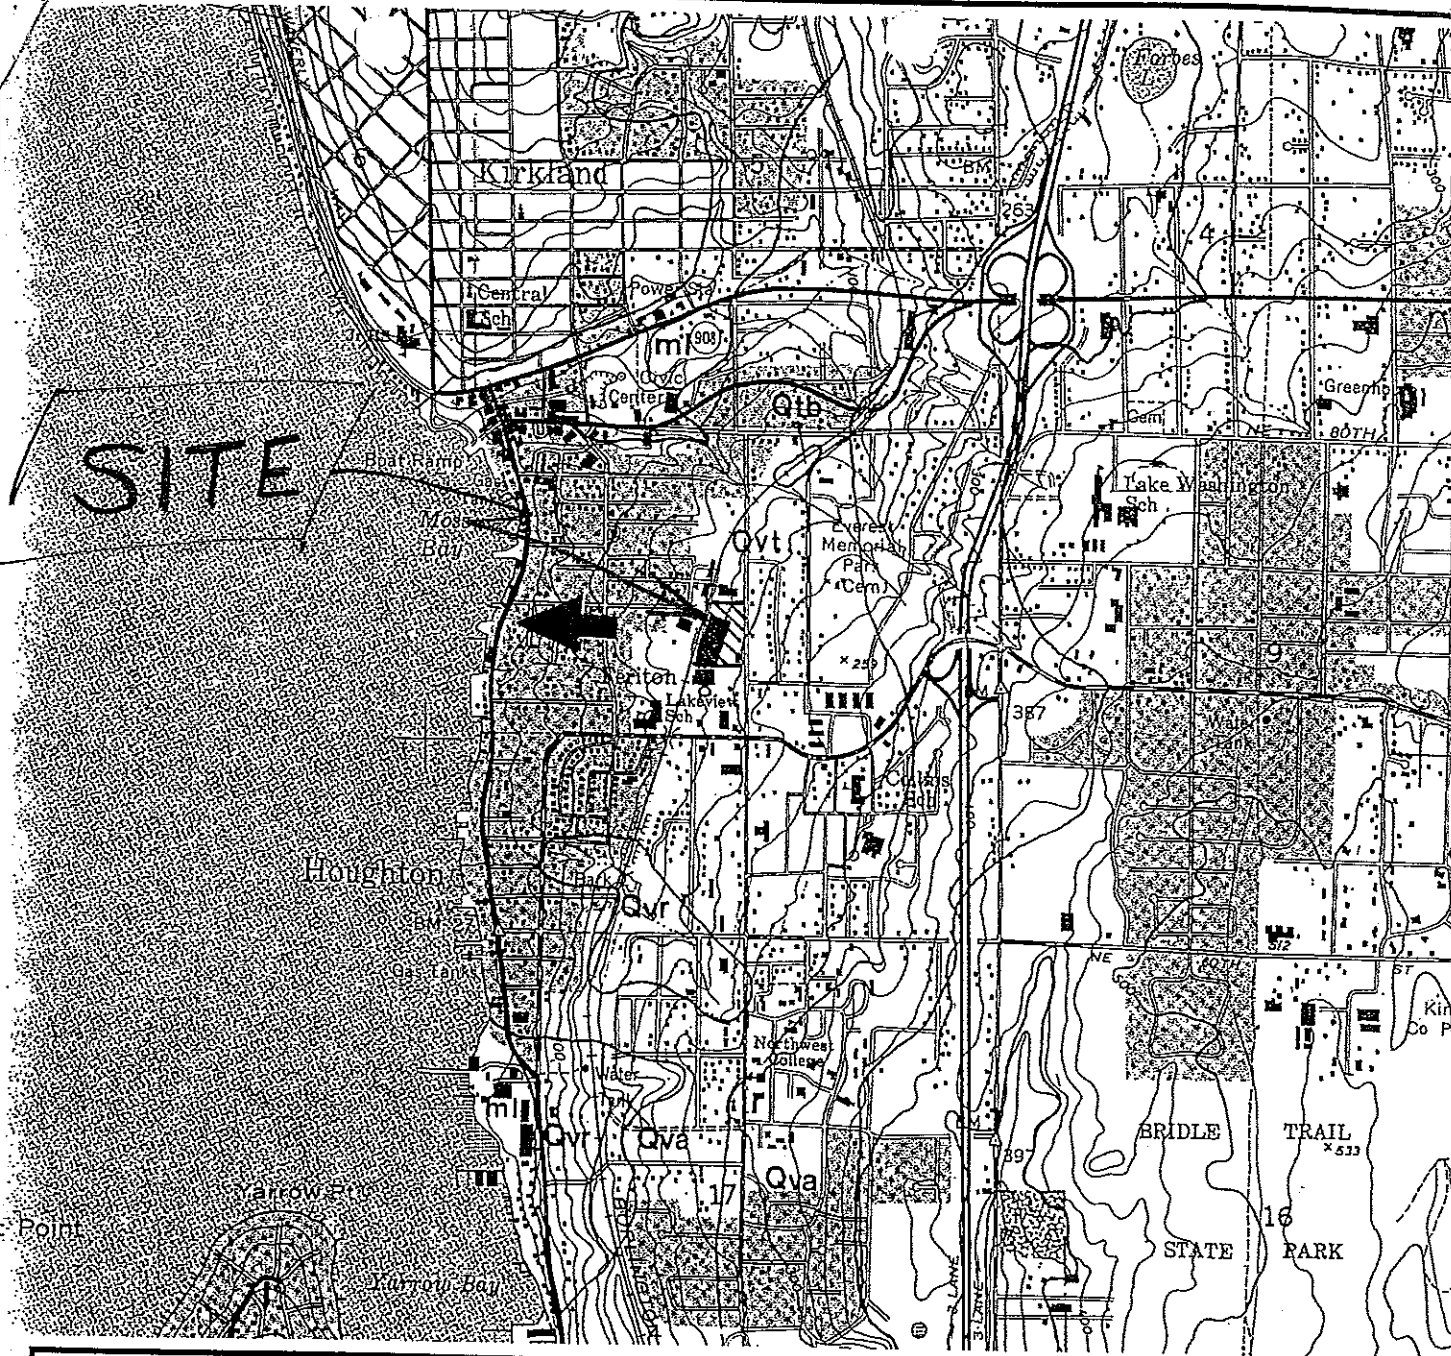
DATE	PROJECT NO.	FIG#
1-19-91	0-91-7104	2
SCALE	DWG NO.	SHEET
1"=94'	SDC01E--	B
DRAWN BY	APPROVED BY	REV
M. ARNSTRONG	J. DAISLE	-

PROBABLE DIRECTION OF REGIONAL SHALLOW GROUNDWATER FLOW

BASE MAP
