STATE OF WASHINGTON
DEPARTMENT OF ECOLOGY

Re: No Further Action at the following Site:

- **Site Name:** HCI Steel Building Systems Inc.
- **Site Address:** 18510-18520 67th Av NE, Arlington, Washington
- **Facility/Site No.:** 3876845
- **VCP Project No.:** NW2346

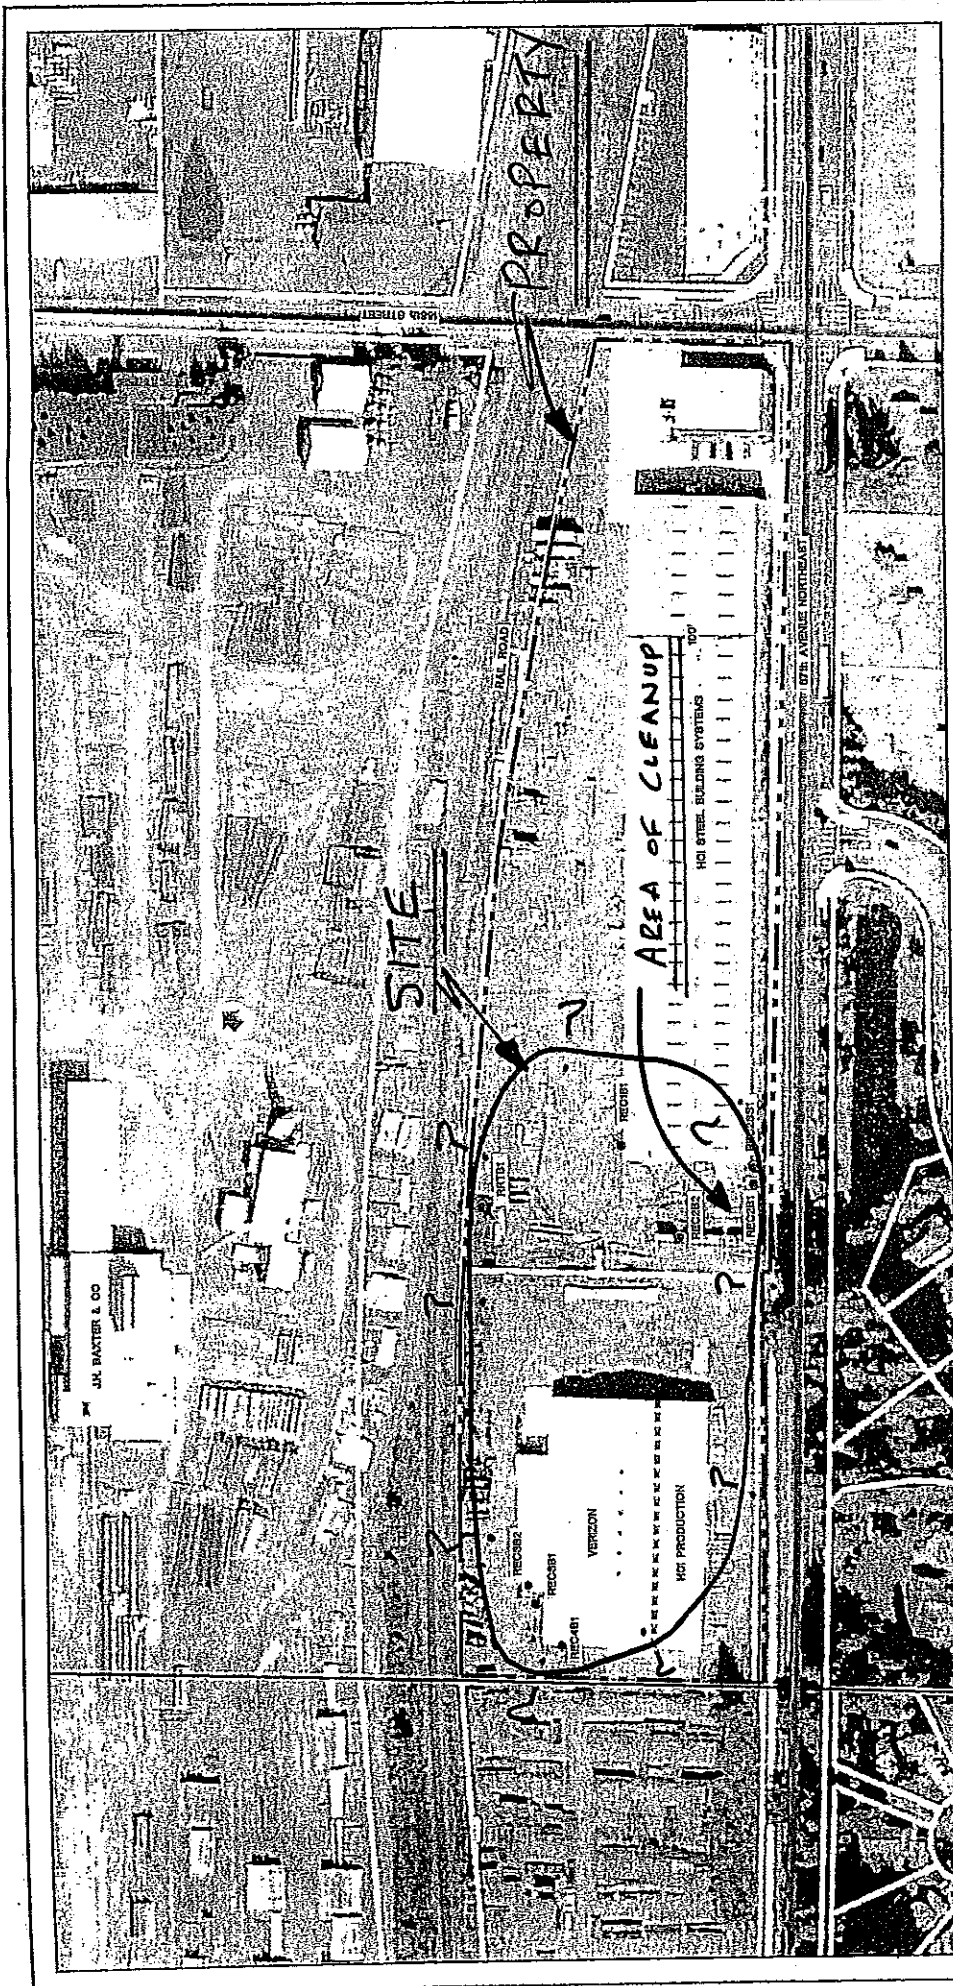
PROJECT NO.	62403465
CLIENT	HCI STEEL BUILDING SYS. ARLINGTON, WA
DATE	9/20/07
DRAWN	TJM
CHECKED	
DATE	9/20/07
KDO	0
FIGURE	3

FIELD
 SAMPLE LOCATIONS
 SEPTEMBER 6-10, 2007

**ACTUAL AREAS
OF CLEANUP**

Release and Extent of Contamination - Soil: Soil investigations at the Property have focused on the four separate RECs identified above, as guided by surface soil staining present in each of the areas. One soil sample was also obtained from an area at the western edge of the Property closest to retorts on the Baxter property. The retort area is where pole treating occurred and where releases of pentachlorophenol or creosote would be most likely.

In summary, the Site consists of near-surface soil contamination extending out some undetermined distance from the sampling locations, whereas the areas exceeding cleanup levels are restricted to the two described above associated with REC2.
