STATE OF WASHINGTON
DEPARTMENT OF ECOLOGY

Re: Opinion pursuant to WAC 173-340-515(5) on Proposed Remedial Action for the following Hazardous Waste Site:

- Name: Dry Cleaning Facility (a.k.a Former Fabricare Facility)
- Address: 2912 NW Bucklin Hill Road, Silverdale, Washington
- Facility/Site No.: 947 953 64
- VCP No.: NW 2328

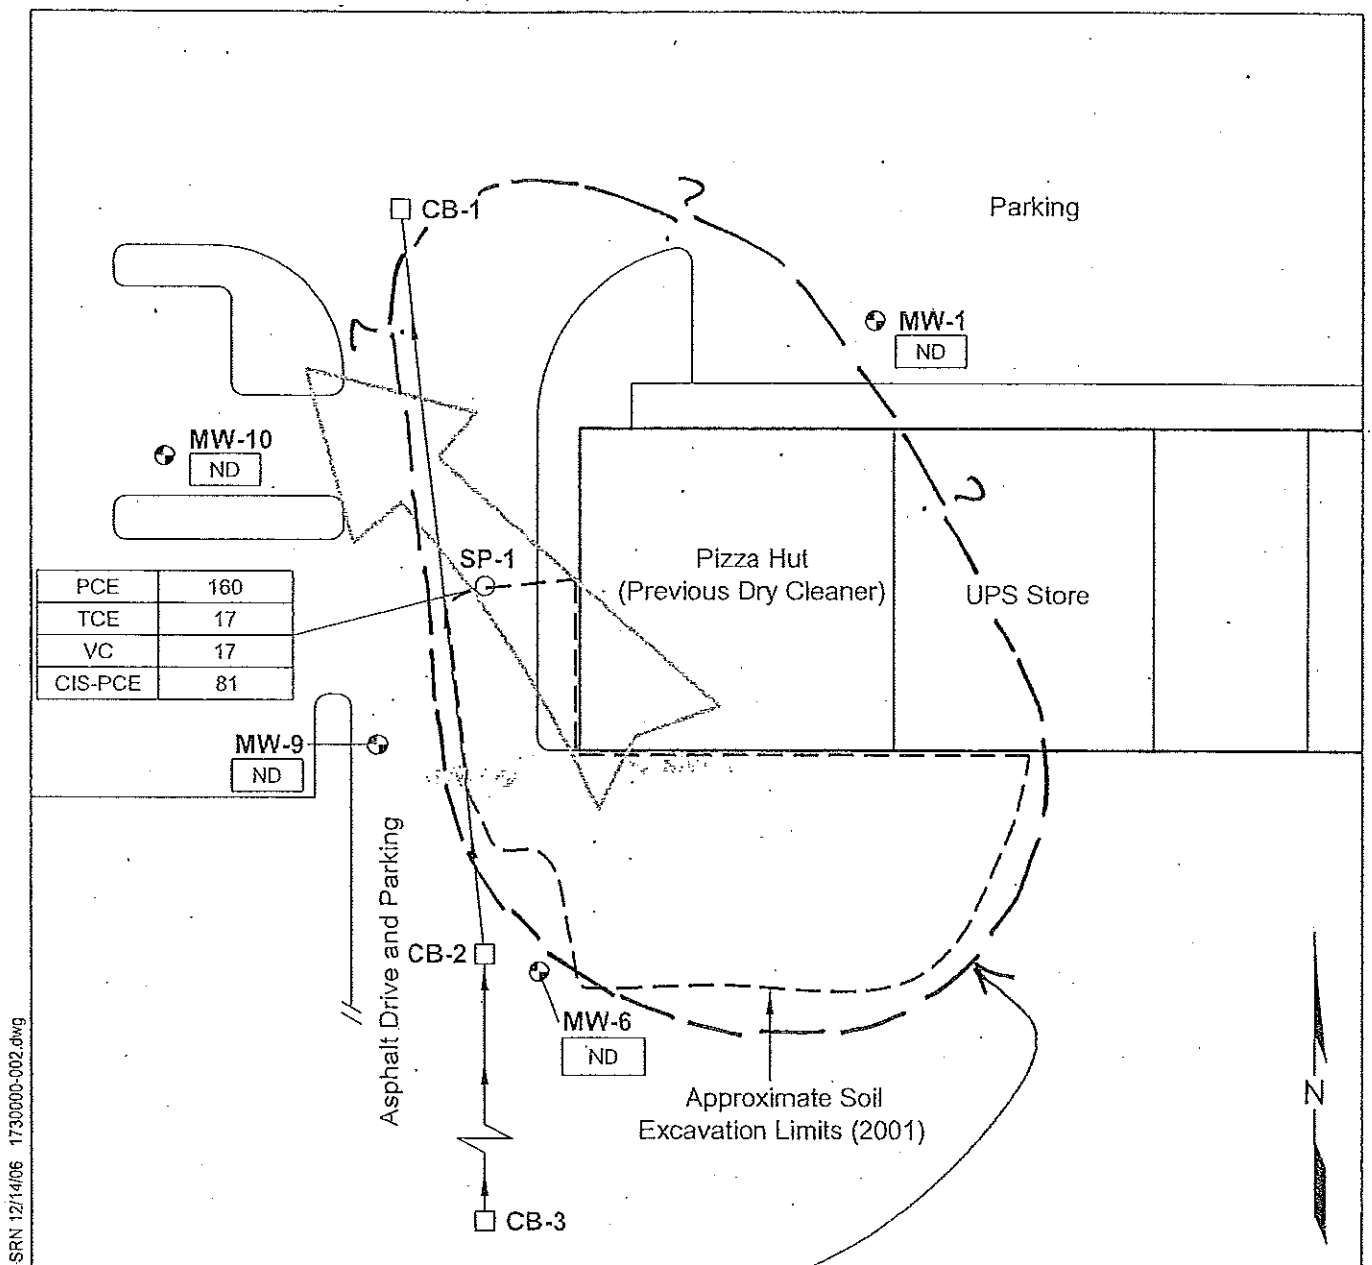
Site Plan

Summary of Groundwater (SP-1 & MW-1, MW-6, MW-9, MW-10) Results

APPROXIMATE
BOUNDARY OF
SITE
