STATE OF WASHINGTON DEPARTMENT OF ECOLOGY

RE: No Further Action at the following Site (Groundwater Model Remedy #5):

- Site Name: 7 Eleven 25821 (aka 7 Eleven Store 2304 25821)
 - Site Address: 1824 George Washington Way, Richland
- Facility/Site No.: 77113577
- CSID No: 6650
- VCP Project No.: CE0457

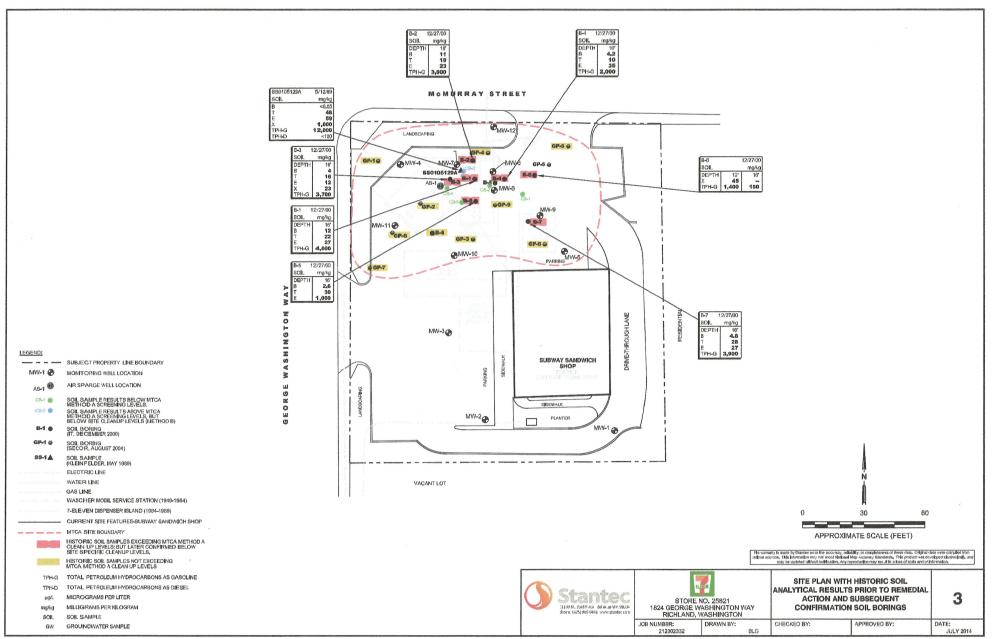
Site Diagram

The Site description is a summary of information taken from the May 2017 CAP
