STATE OF WASHINGTON
DEPARTMENT OF ECOLOGY

Re: Ecology Comments on Draft Remedial Investigation Work Plan
Texaco 211577 Monterey
631 Queen Anne Avenue N, Seattle, WA 98109
Facility Site No.: 77774779
Cleanup site ID No.: 6663

On December 10, 2020, the Washington State Department of Ecology (Ecology) received the *Draft Remedial Investigation Work Plan (December 2020 Draft RIWP)*, for the Texaco 211577 Monterey facility (Site). The Site is generally located at 631 Queen Anne Avenue North in Seattle (the Property), and consists of the Property and multiple nearby properties and rights-of-way. Ecology appreciates your timely submission of this work plan.

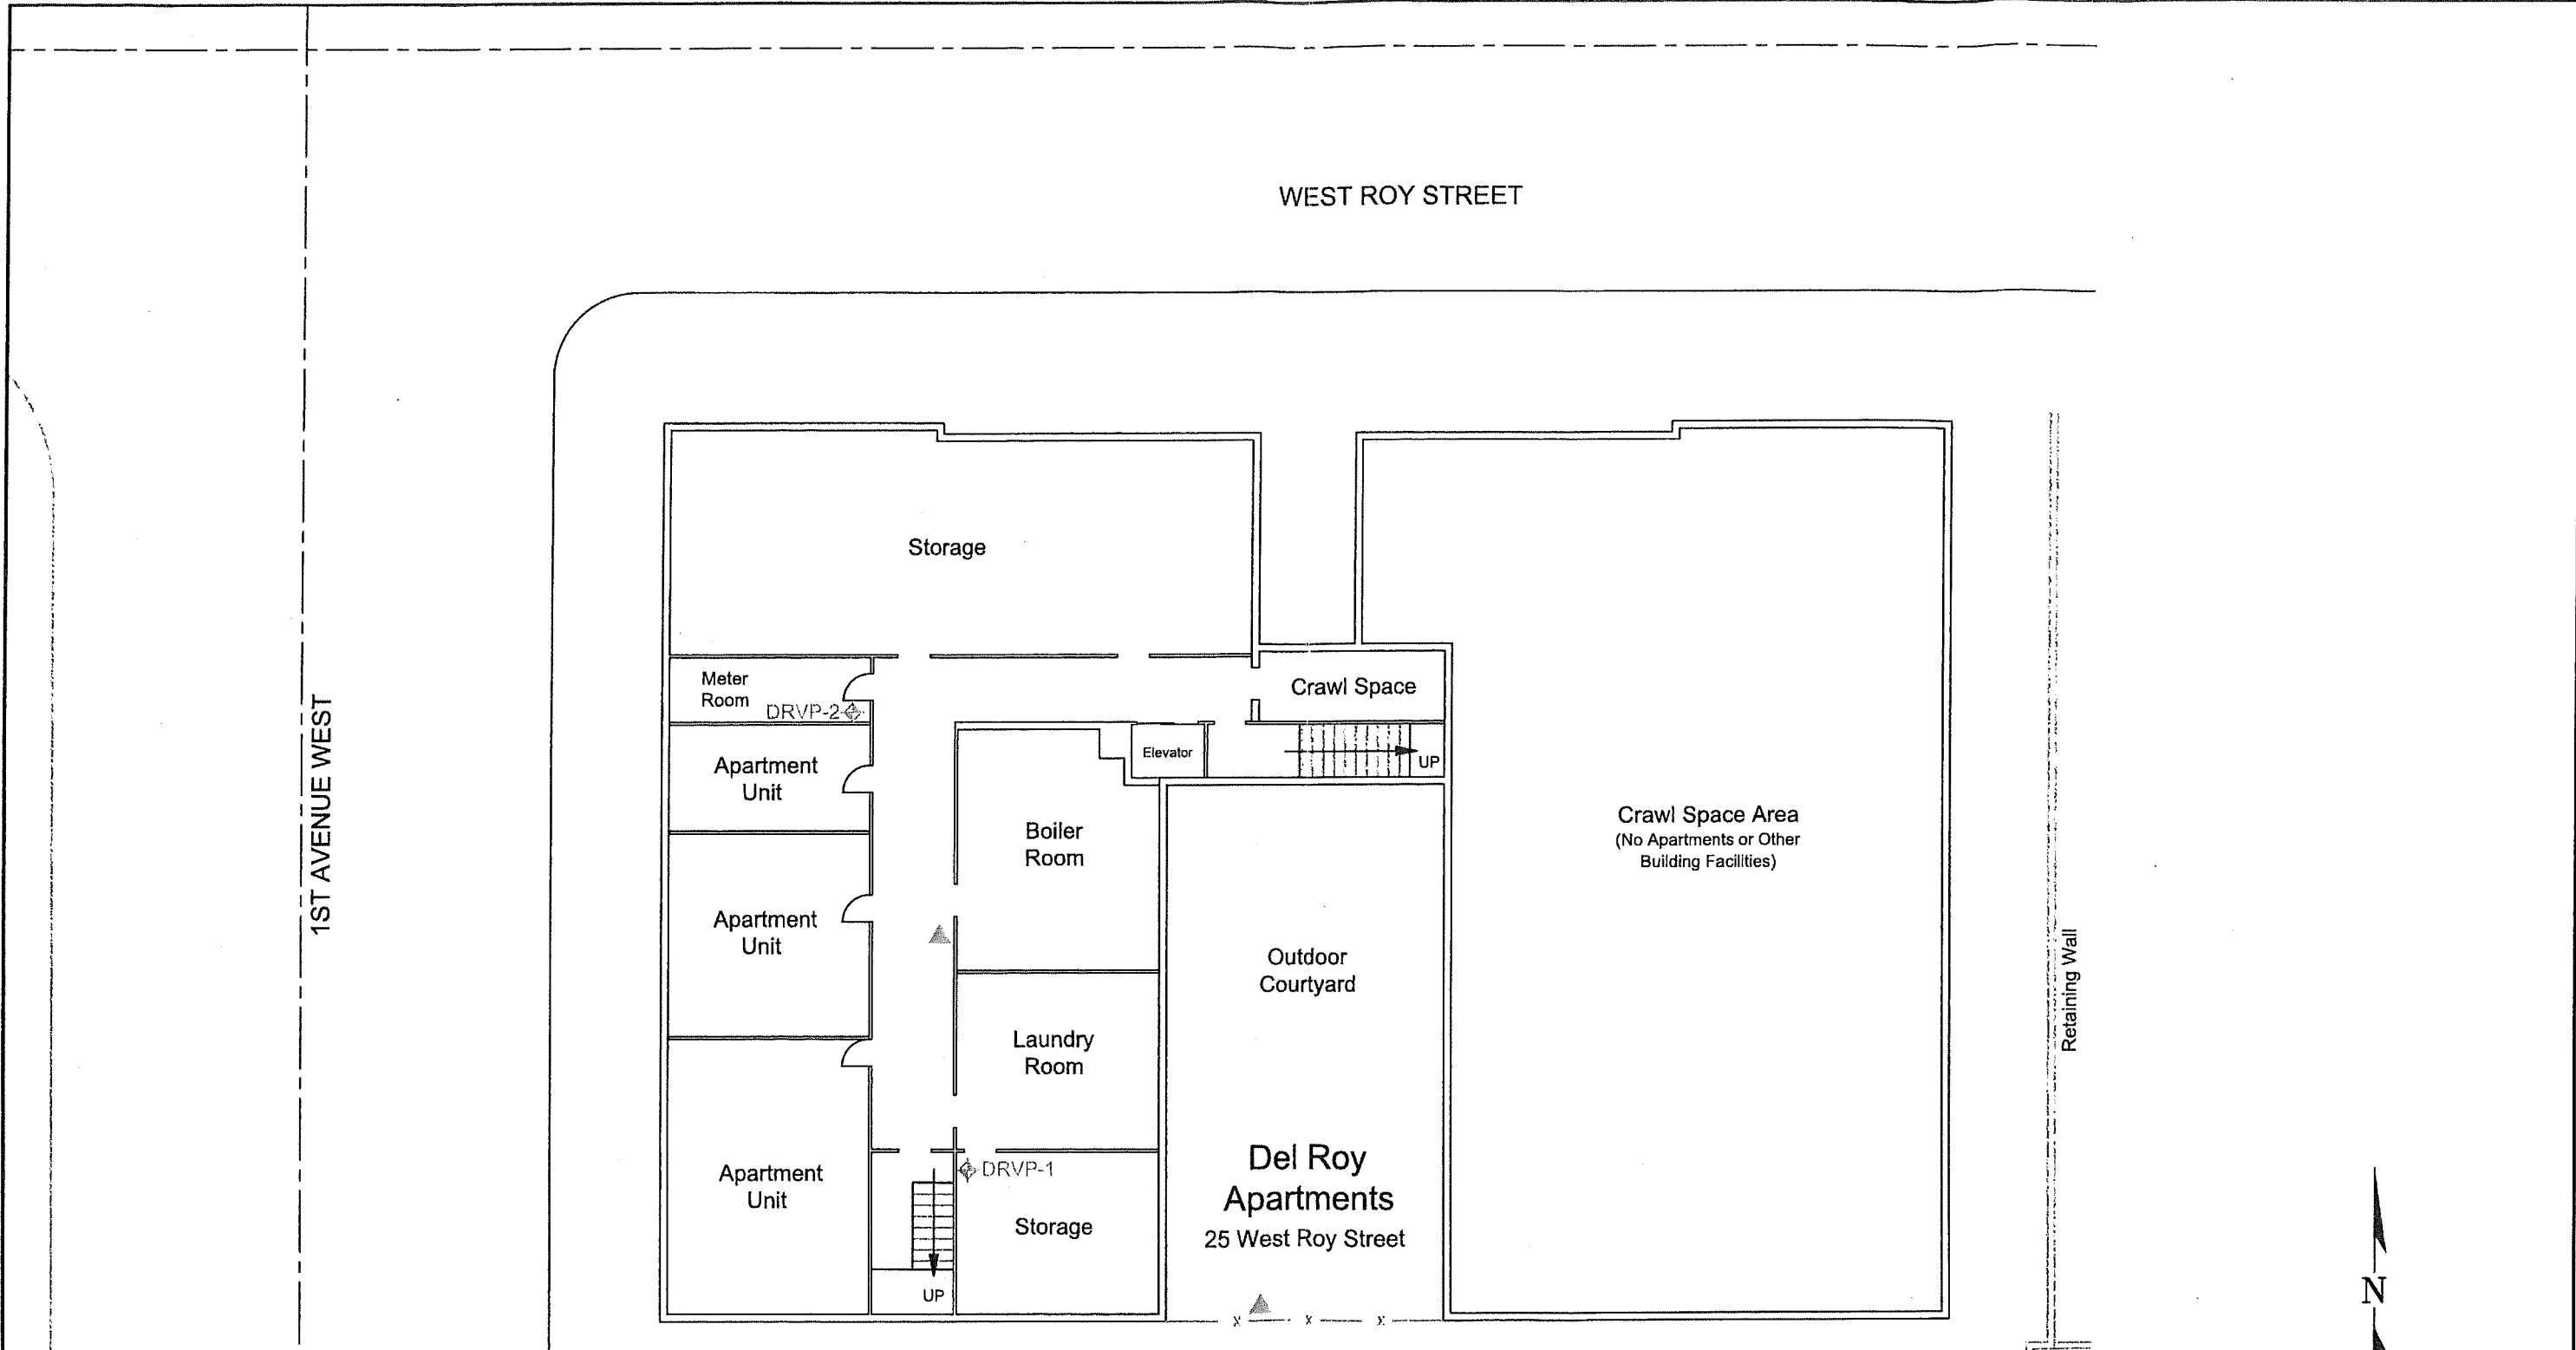
Figure 1 2008 Soil Vapor Probe Locations on Del Roy Apartment

FORMER TEXACO SERVICE STATION CHEVRON SITE No. 211577 631 QUEEN ANNE AVENUE NORTH SEATTLE, WASHINGTON	FIGURE 2 DEL ROY APARTMENTS BASEMENT FLOOR VAPOR SAMPLE LOCATIONS 08/19/09	
	FILE NAME: Del Roy Basement Map.dwg	DATE: 09/24/2009

- In 2008, two soil vapor probes (DRVP-1 and DRVP-2) were installed immediately below the basement (sub-slab) of the Del Roy Apartments building (**Figure 1**); one vapor probe

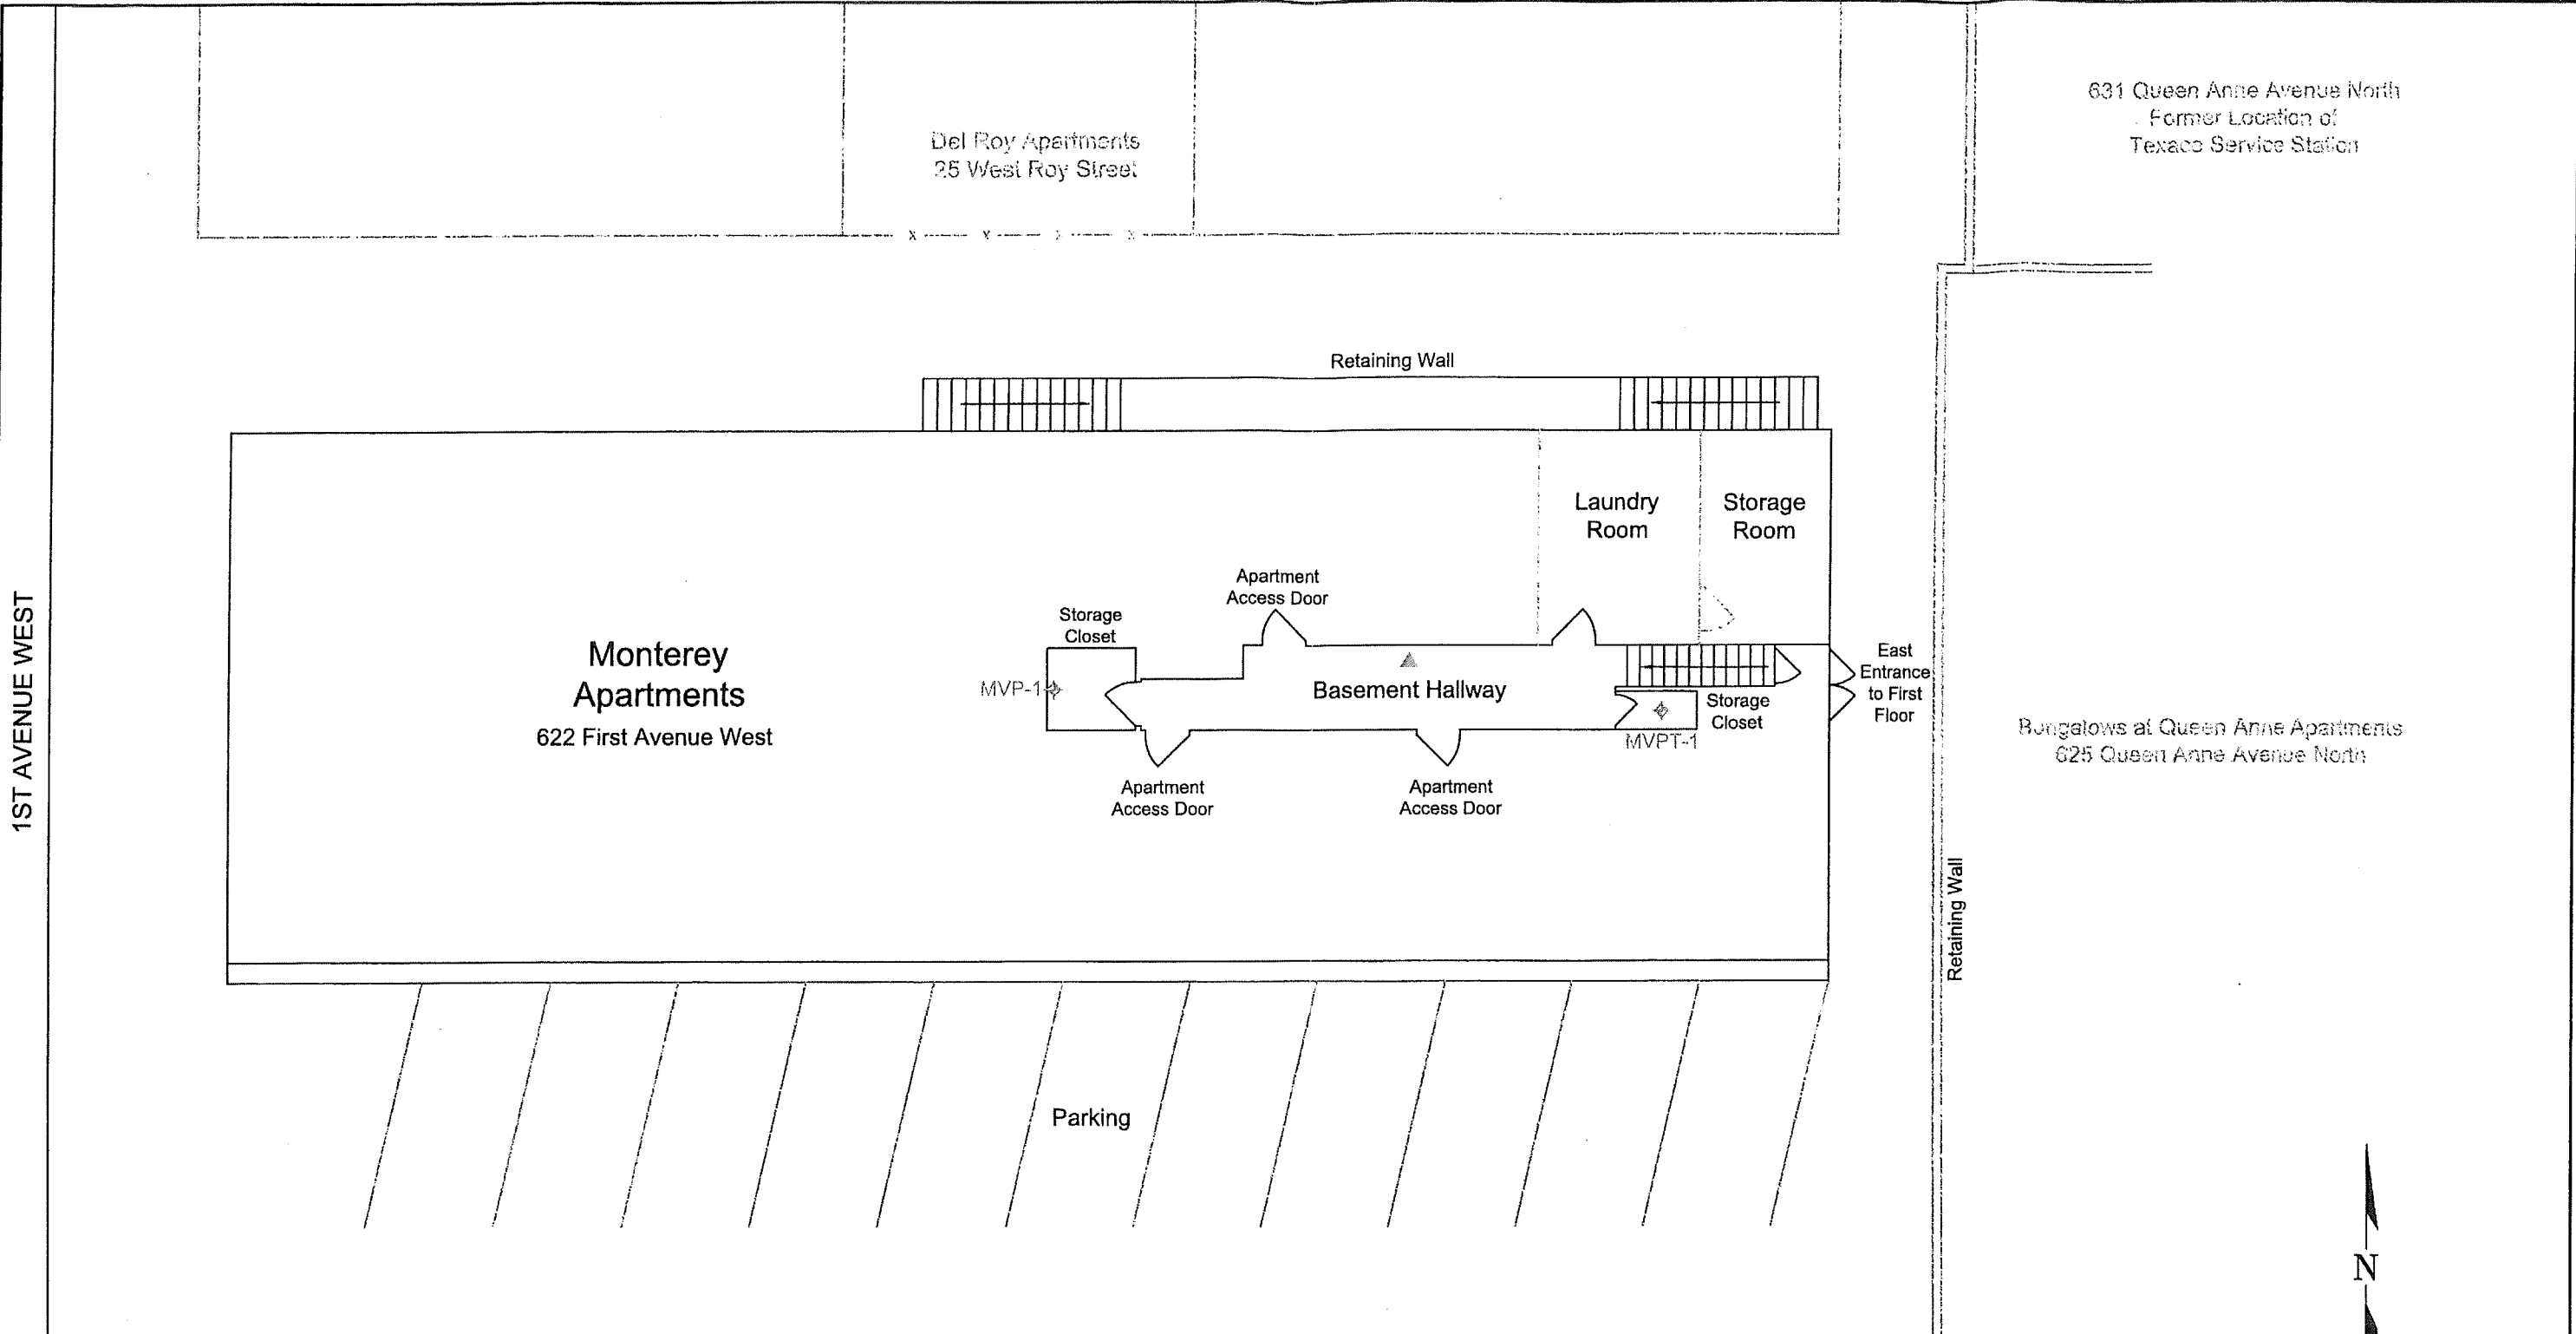
Figure 2 2008 Soil Vapor Probe Locations on Monterey Apartment

FORMER TEXACO SERVICE STATION CHEVRON No. 211577 631 QUEEN ANNE AVENUE NORTH SEATTLE, WASHINGTON		FIGURE 3 MONTEREY APARTMENTS VAPOR SAMPLE LOCATIONS 8/19/09	
FILE NAME: 211577_Monterey_Vapor.dwg	DATE: 10/16/2009

(MVP-1) and one temporary vapor probe (MVPT-1) were installed sub-slab in the basement of Monterey Apartments building (**Figure 2**)⁷.
