Subject: The Boeing Company's Comments on Public Comment Draft Documents – Boeing Everett Facility

I am writing to provide comments from The Boeing Company's (Boeing) regarding the Uplands/Powder Mill Gulch (PMG) Draft Cleanup Action Plan, Draft Agreed Order for the Bomarc Property, and the Draft Enforcement Order. Boeing's comments are provided pursuant to the current public comment period for these documents. Boeing appreciates the opportunity to provide the attached comments.

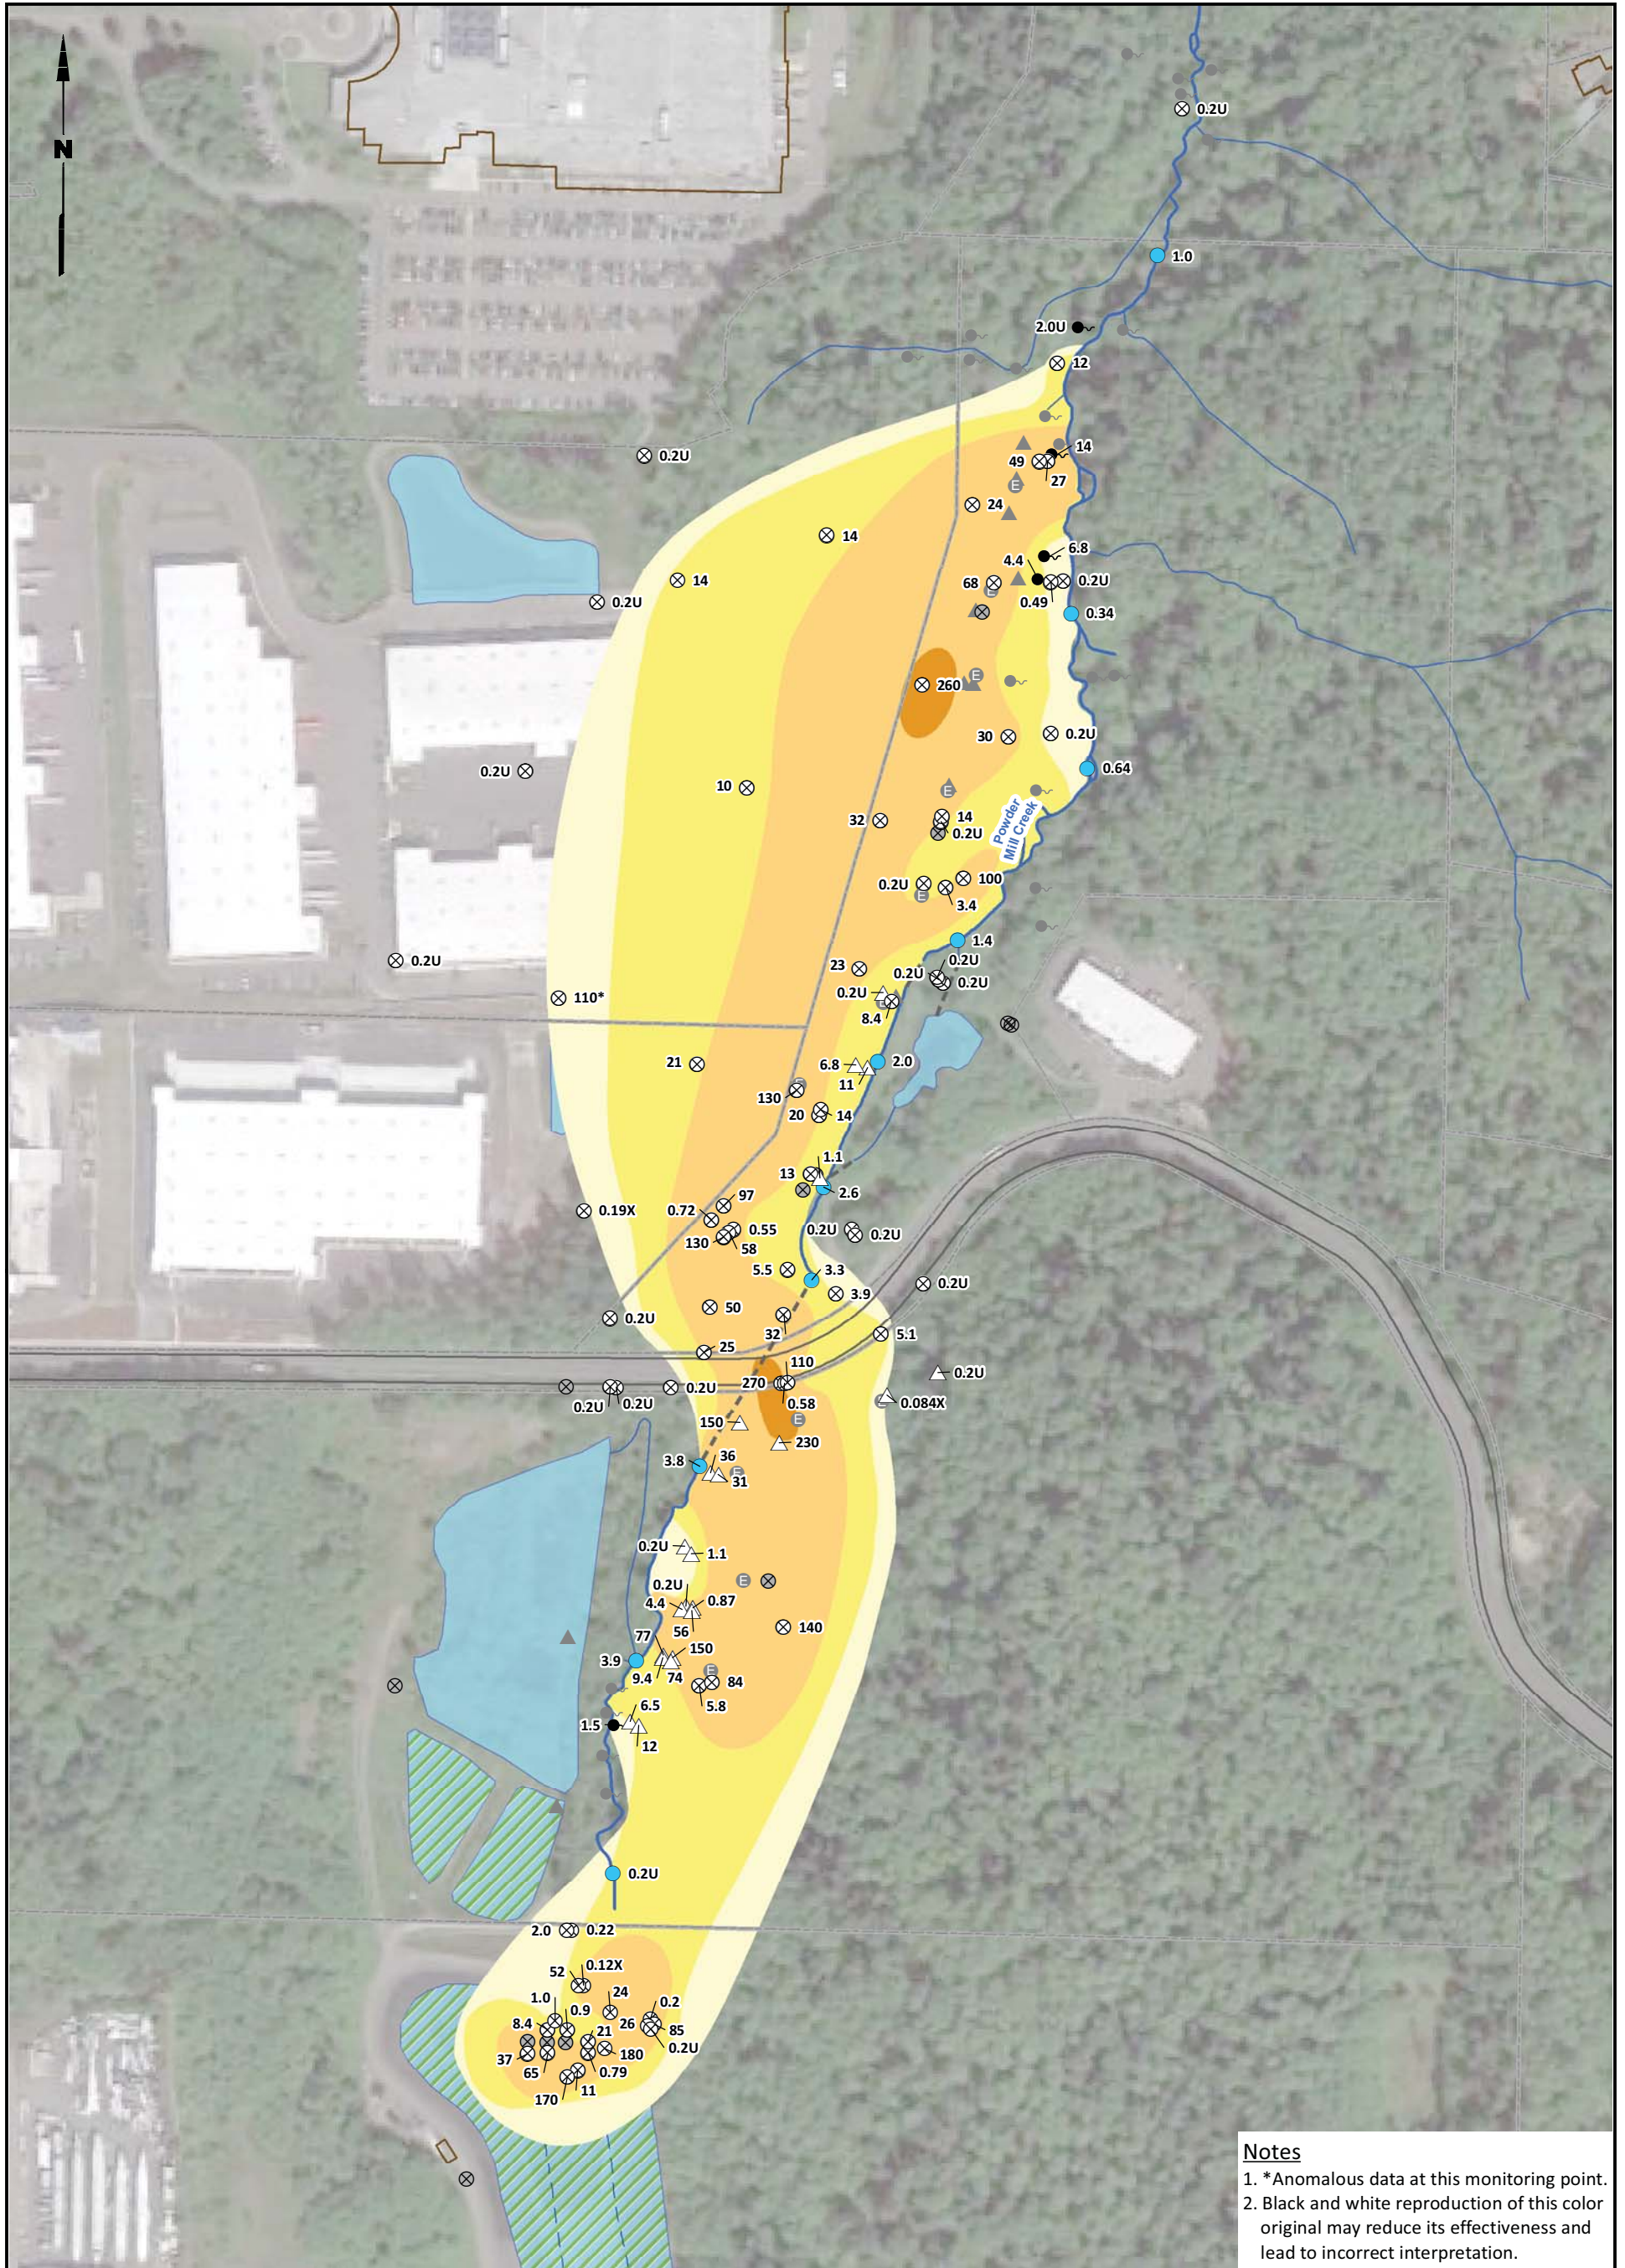
2-3 TCE Concentrations – PMG (Post-Interim Action Groundwater Conditions October ~~2019~~2020)

Section 2.1.2.1 Groundwater Conditions and Interim Actions
