Amendment to CLEANUP ACTION PLAN

Landsburg Mine Site MTCA Remediation Project Ravensdale, Washington

Washington State Department of Ecology

March 26, 2021

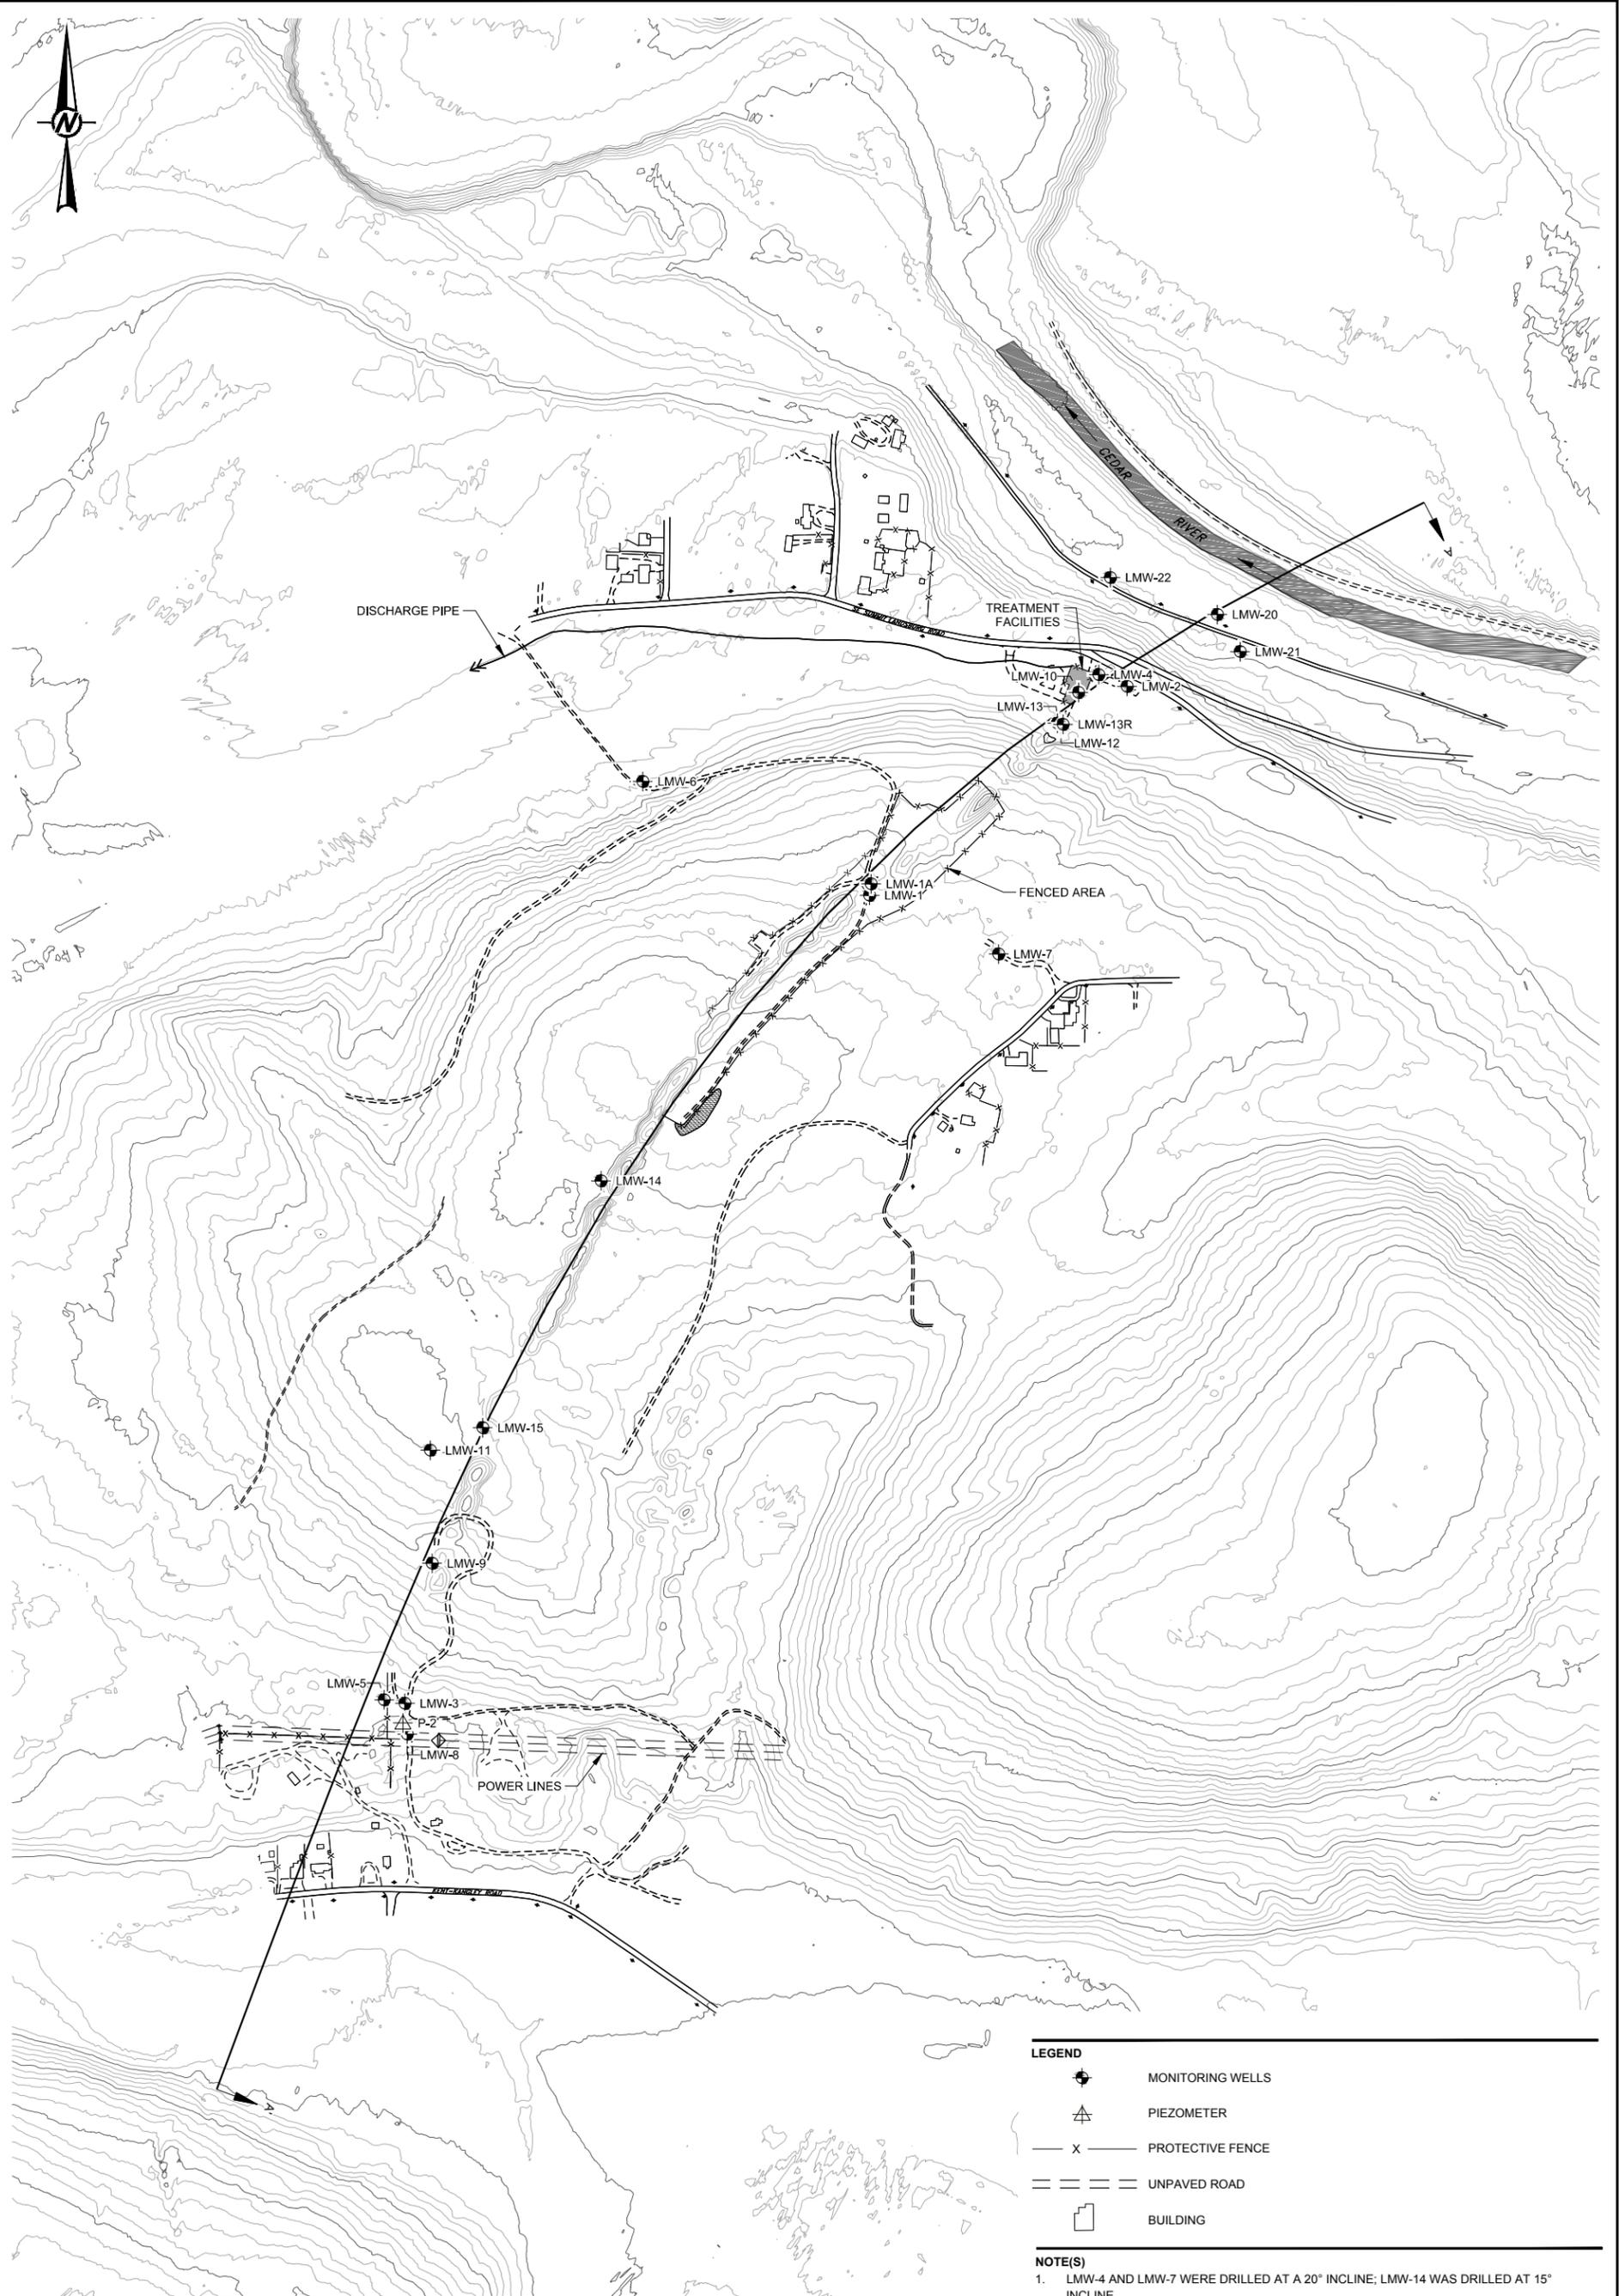
Figure 1: Site Map

NOTE(S)
 1. LMW-4 AND LMW-7 WERE DRILLED AT A 20° INCLINE; LMW-14 WAS DRILLED AT 15° INCLINE

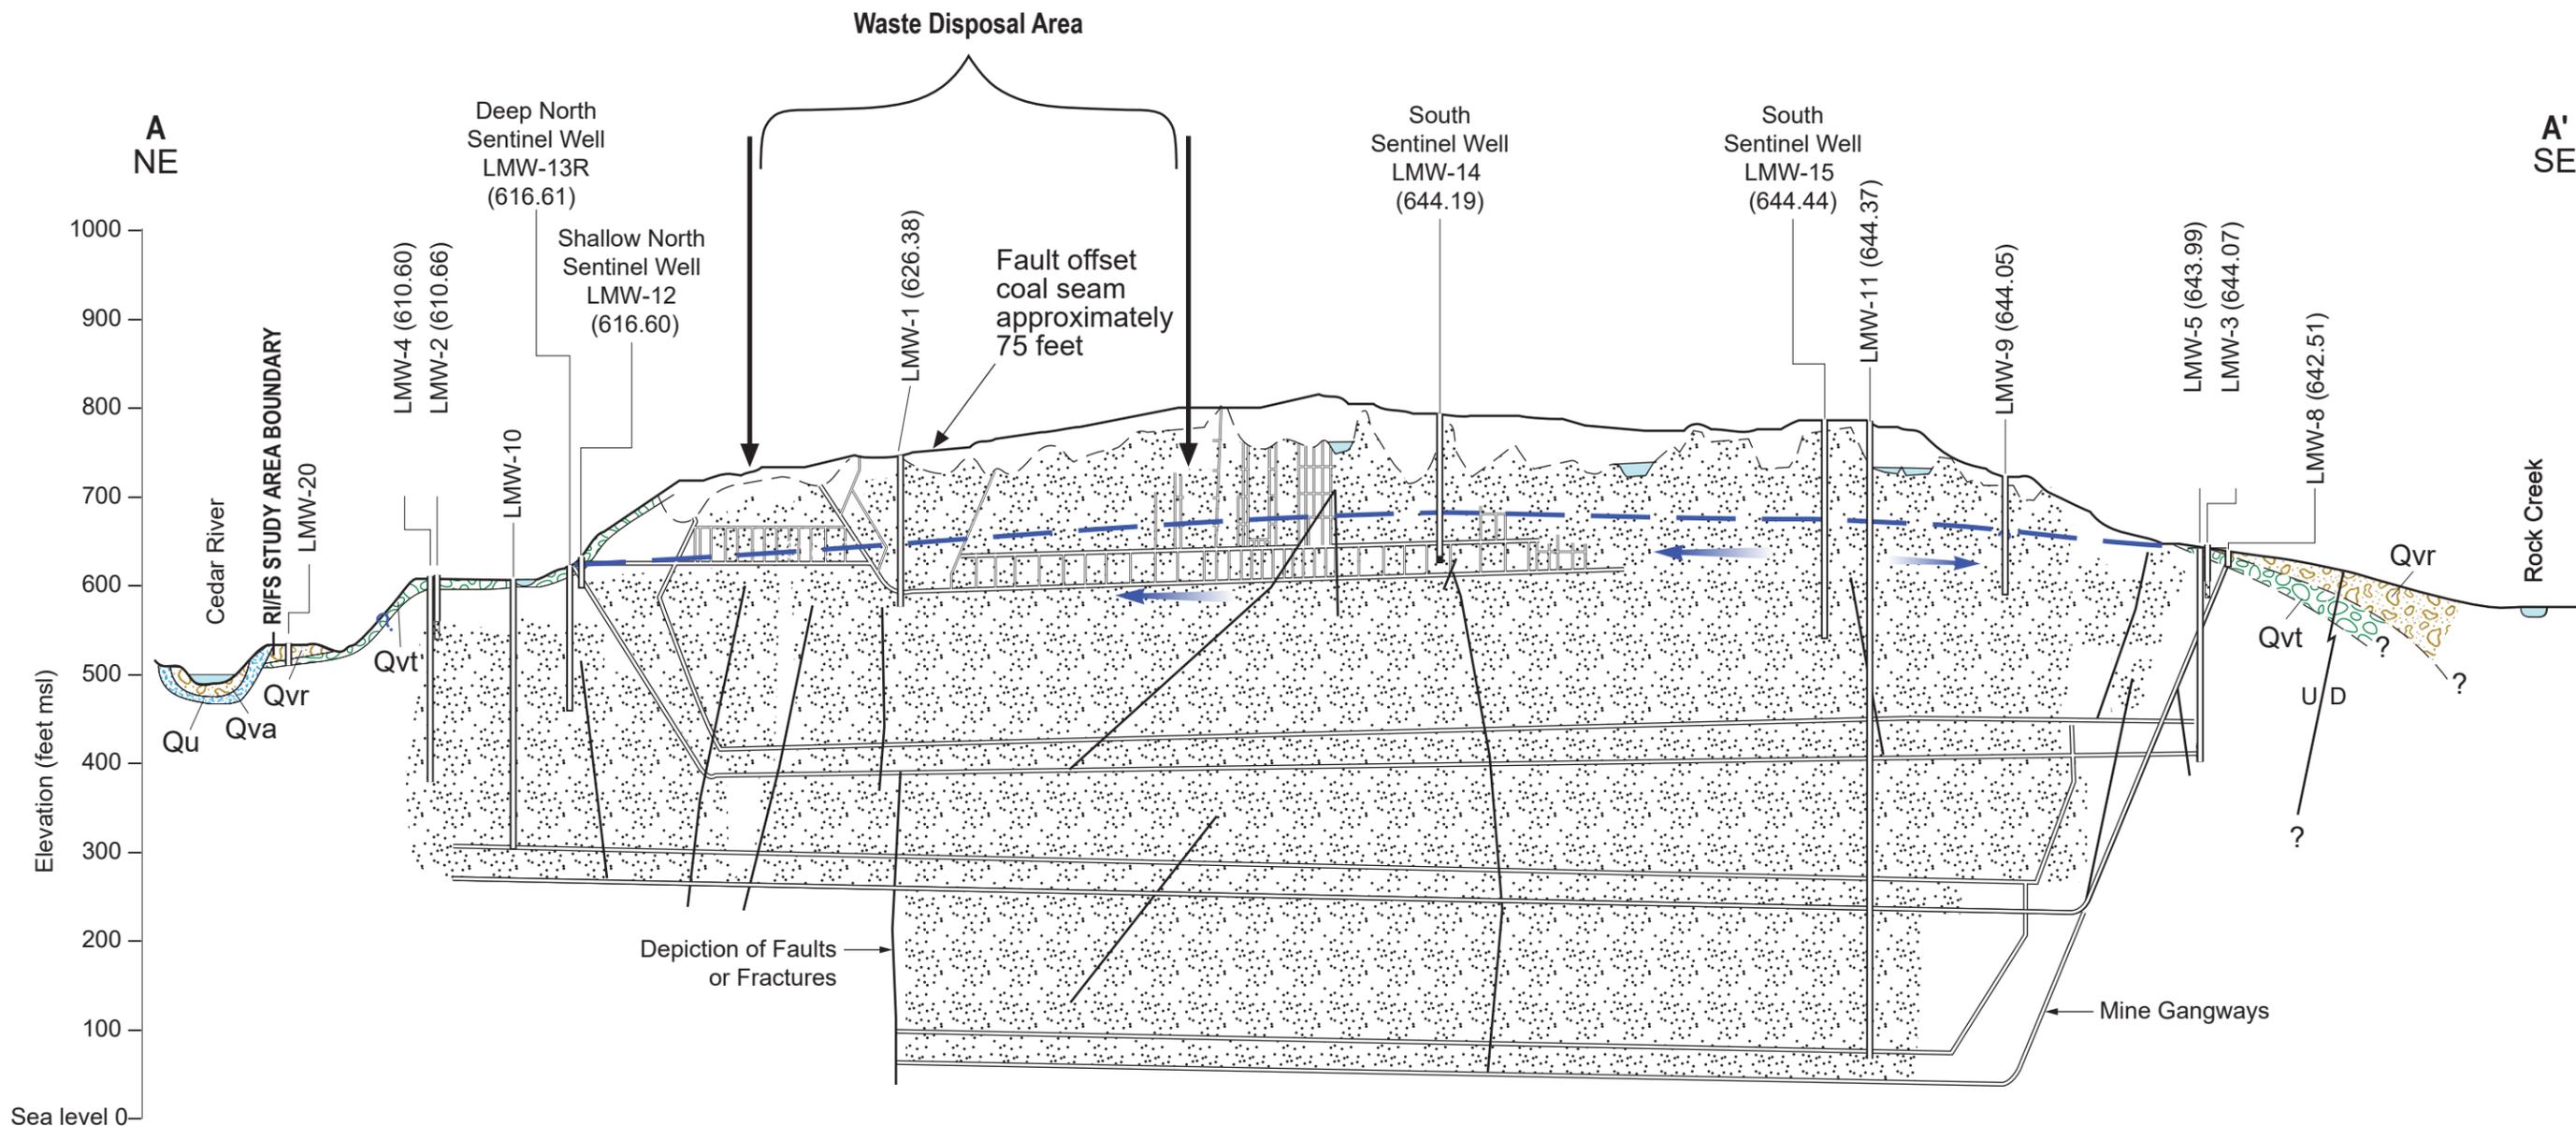
Figure 2: Cross-Section Along Strike at Coal Seam June 2020 Cross-Section A-A'

CLIENT	LANDSBURG PLP GROUP		PROJECT	LANDSBURG MINE SITE	
CONSULTANT	YYYY-MM-DD	2020-08-17	TITLE	CROSS-SECTION ALONG STRIKE AT COAL SEAM JUNE 2020 CROSS-SECTION A-A'	
	PREPARED	REDMOND	PROJECT No.	923-1000-006	PHASE
	DESIGN				2020
	REVIEW				
	APPROVED
