**Lower Duwamish Waterway  
RM 1.7 to 2.0 East  
(Slip 2 to Slip 3)**

**Source Control Action Plan**

**June 2009**

Publication No. 09-09-085

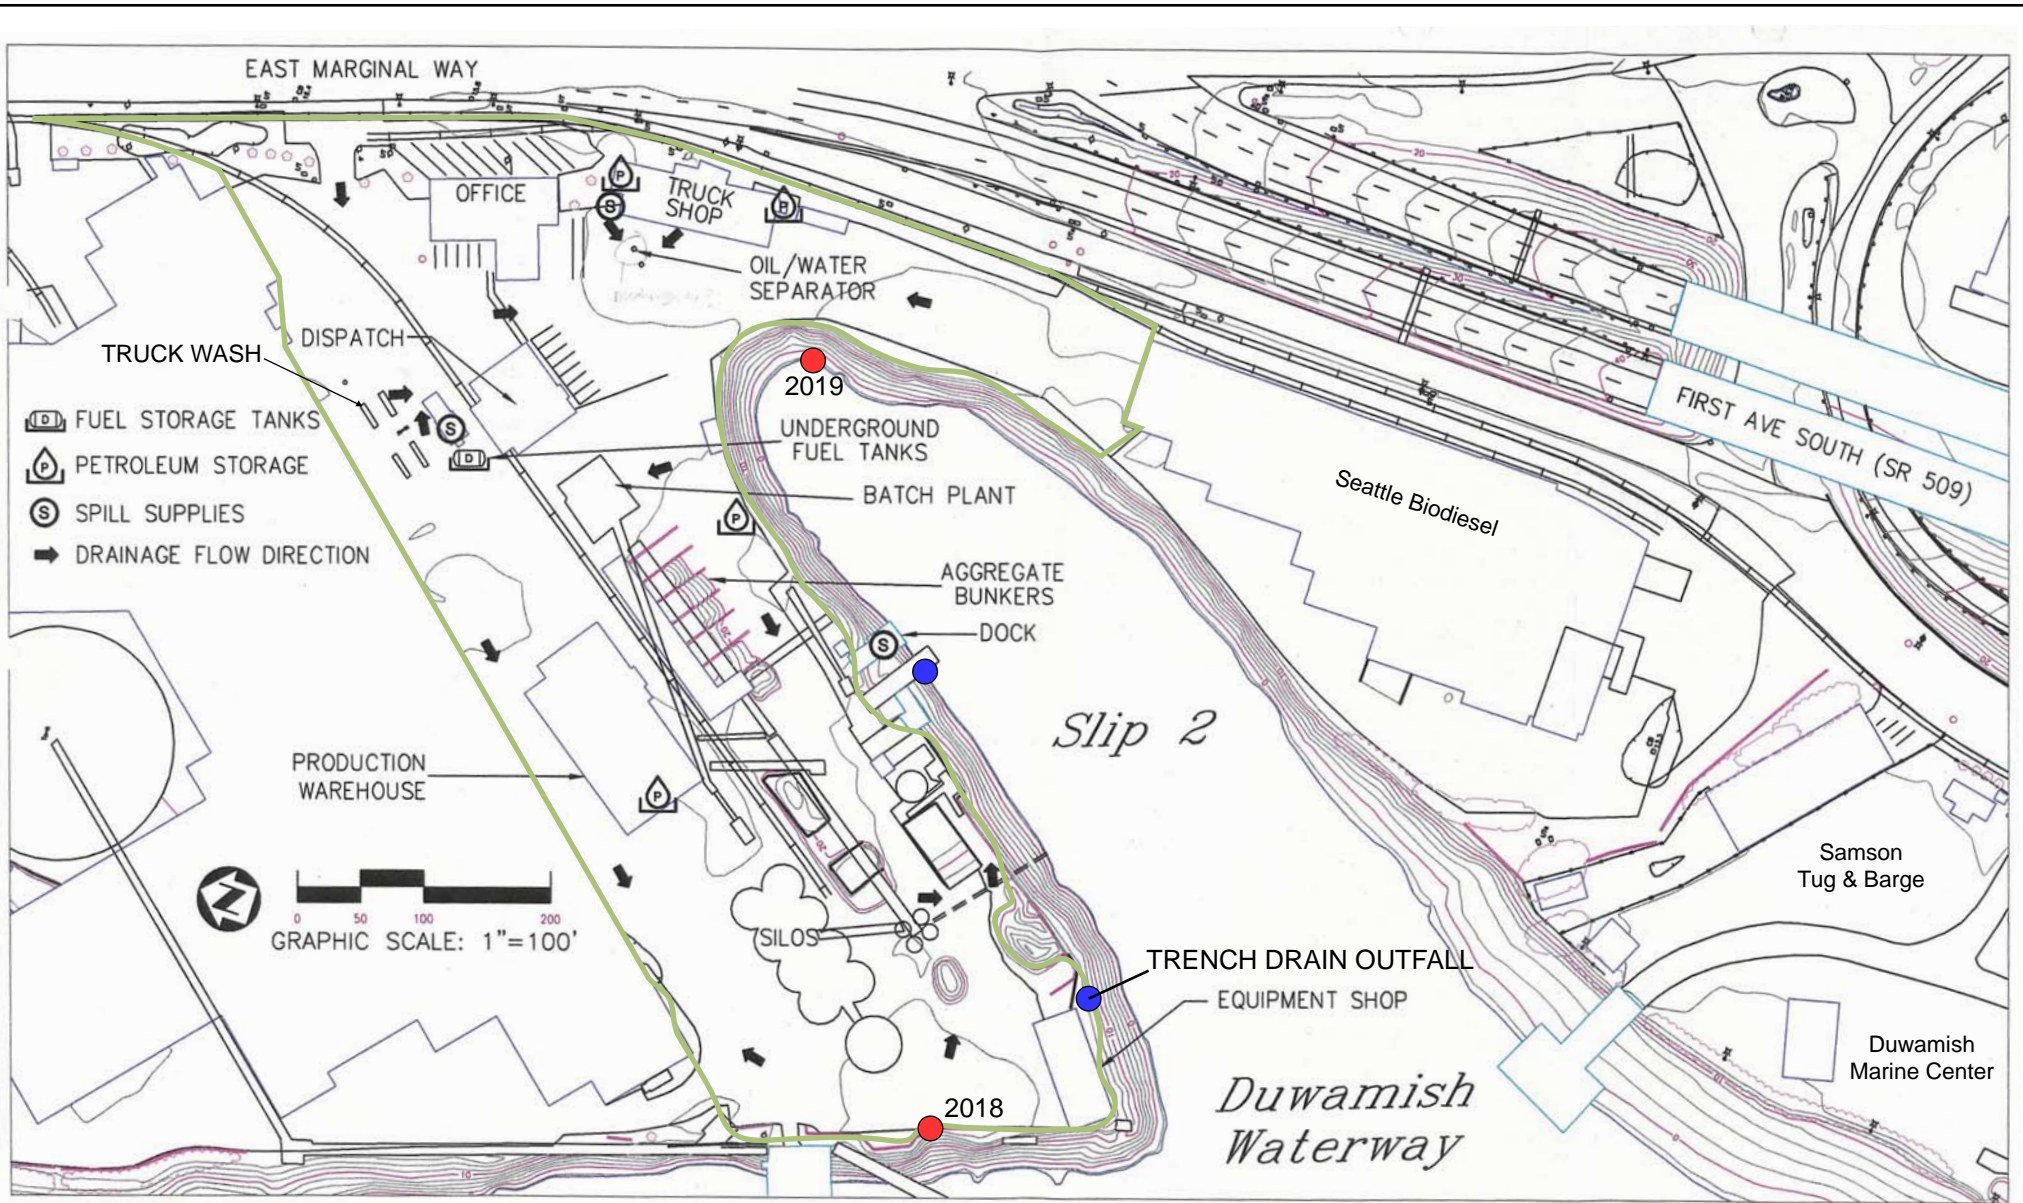
Figure 8. Glacier Northwest Facility Plot Plan

- Glacier Northwest Facility Boundary (approximate)
- Private Outfall
- Possible Outfall Location (approximate)

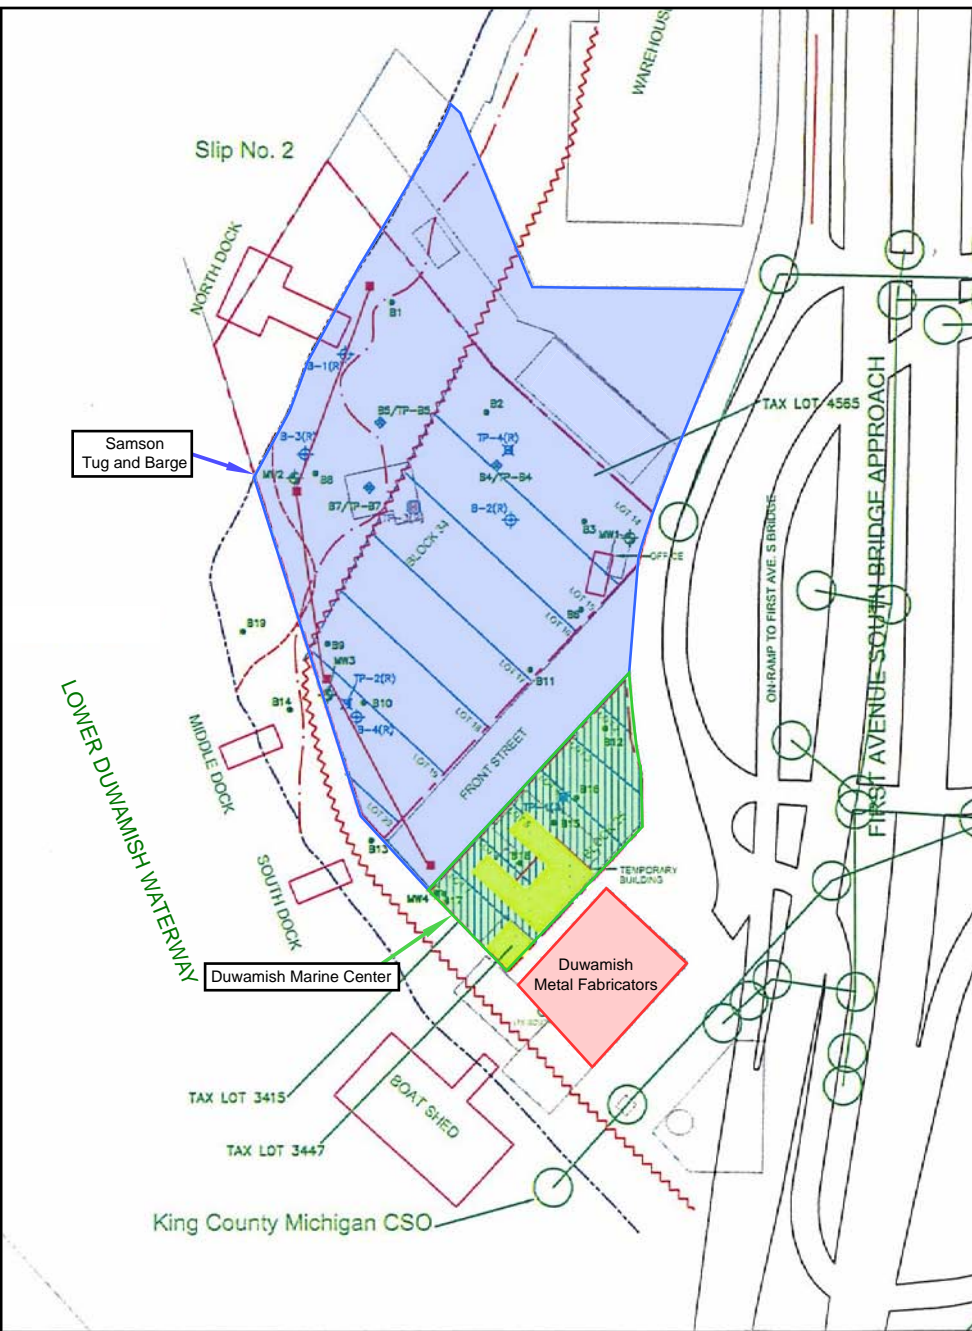
Figure 9. Duwamish Marine Center Facility Plan

TP-1(R) [Symbol]	TEST PIT 7/17/2000 (THE RILEY GROUP)
B-1(R) [Symbol]	BORING 8/3/2000 (THE RILEY GROUP)
B1 [Symbol]	BORING 3/13-14/2002 (FARALLON)
MW-4 [Symbol]	MONITORING WELL 3/18/2002 (FARALLON)
TP-B7 [Symbol]	TEST PIT 5/13/02 (FARALLON)
TP-3(R) [Symbol]	TEST PIT IN AREA EXCAVATED FOR INTERIM ACTION
[Symbol]	AREA EXCAVATED FOR INTERIM ACTION MAY 2002
[Symbol]	CONCRETE PADS
[Symbol]	CATCH BASIN AND DRAINAGE LINE
[Symbol]	SITE BOUNDARY
[Symbol]	APPROXIMATE CURRENT SHORELINE
[Symbol]	APPROXIMATE SHORELINE 1982
[Symbol]	APPROXIMATE SHORELINE 1966
[Symbol]	APPROXIMATE SHORELINE 1924/1936
[Symbol]	LOT BOUNDARY AND LOT NUMBER

Site Plan  
 Gilmur/Hale Family Trust Property  
 6165 First Avenue South  
 Seattle, Washington

Plans to install storm drain lines on the Duwamish Marine Center property were prepared in August 1985 (Environmental Associates 2000). As of 2002, the stormwater system had apparently not been installed (Farallon Consulting 2002). A 2007 sampling plan mentions that stormwater is discharged to the LDW; however, the accompanying figure (Figure 9) does not indicate the discharge point(s) (Pacific Crest Environmental 2007).

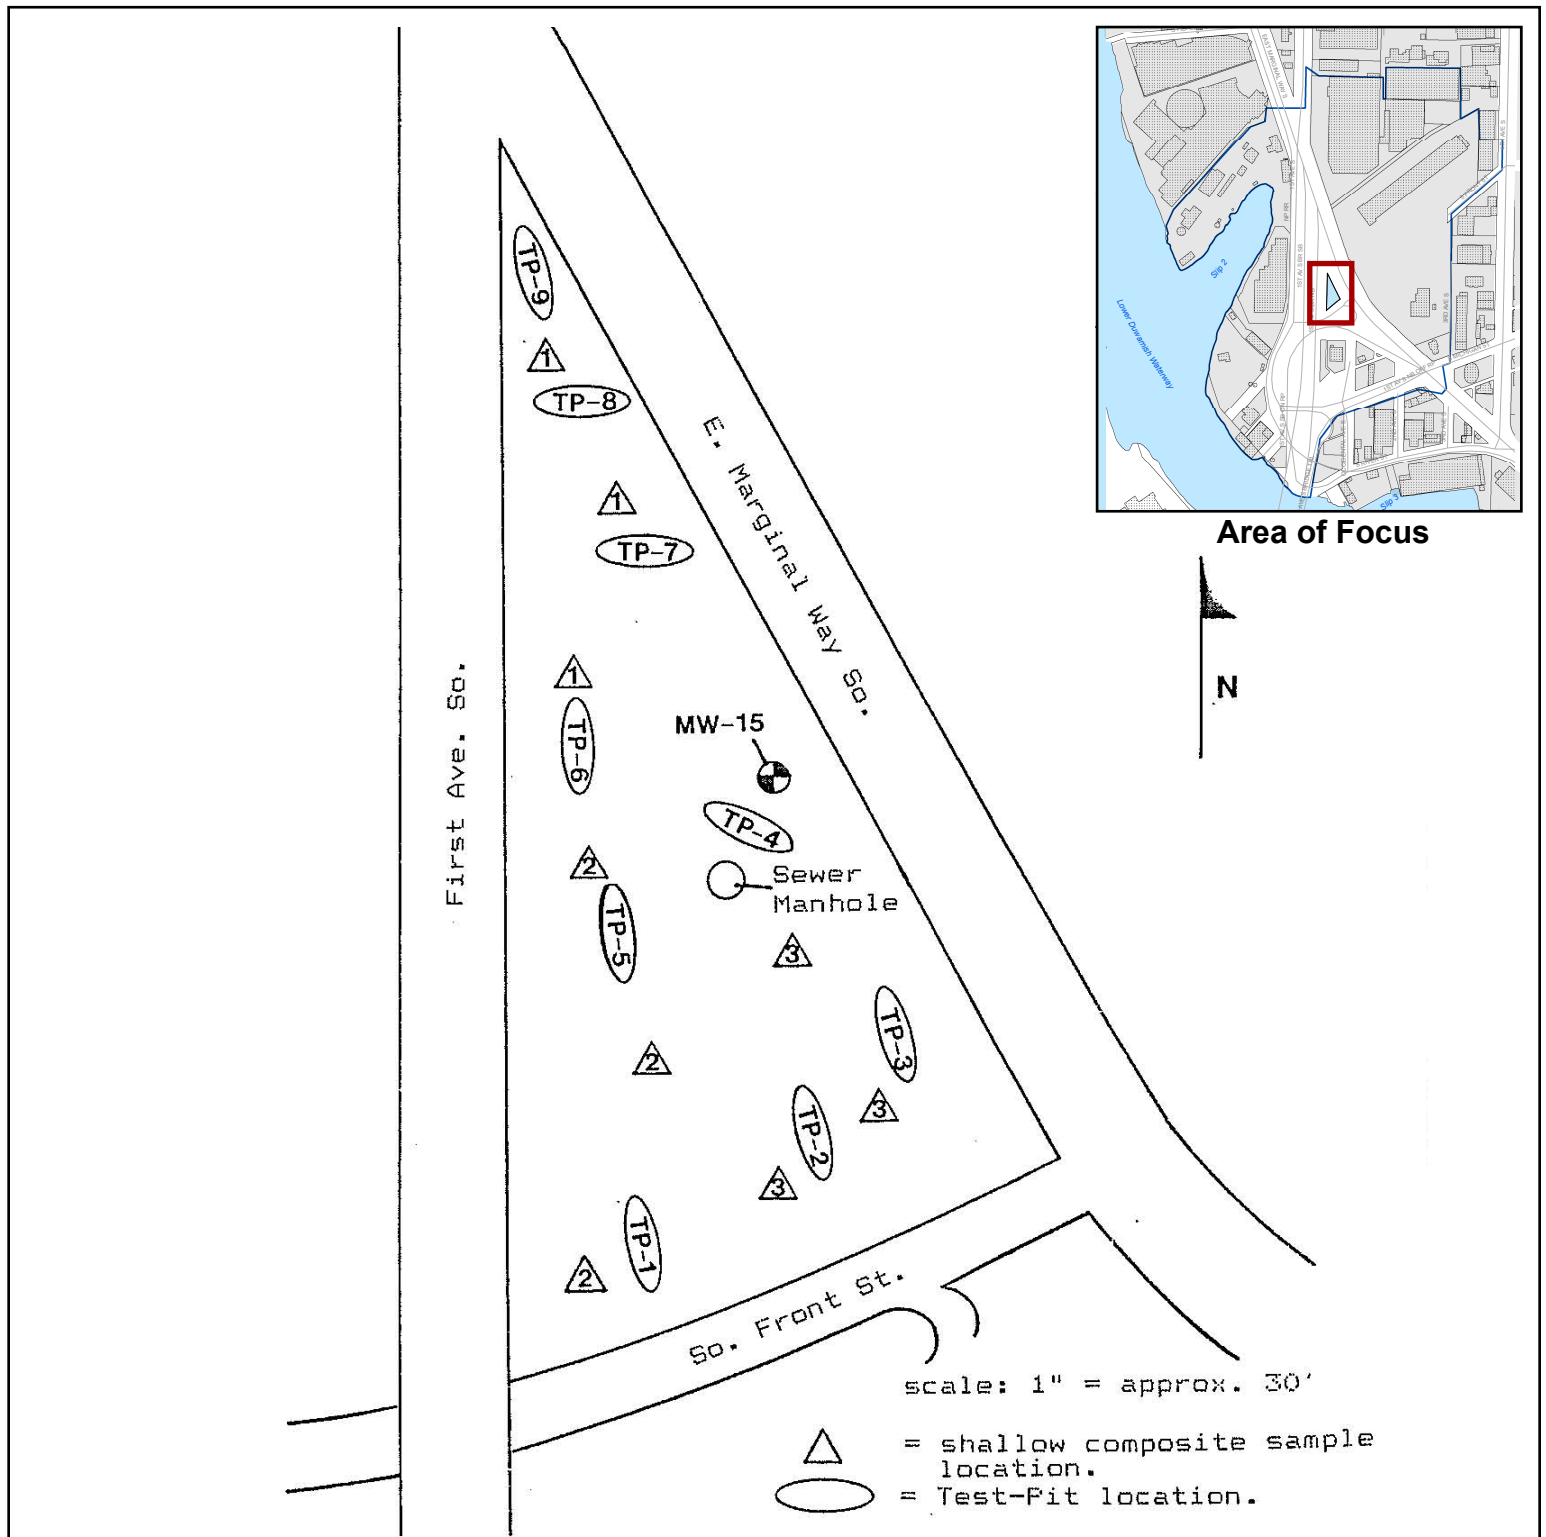
Figure 10. Former Frank's Used Cars Property Exploration Plan

SITE EXPLORATION PLAN  
 Vacant Parcel of Property  
 6305 East Marginal Way South  
 Seattle, Washington

Frank’s Used Cars previously operated on this small, triangular-shaped parcel that is located immediately east of the northbound lanes of the 1st Avenue S Bridge. The parcel is bordered by S Front Street to the southeast and East Marginal Way S to the northeast (Figure 10).

This location is currently a vacant lot with a large AK Media advertising billboard located in the center of the property. As-built plans from the 2001 1st Avenue S bridge crossing project show a drainage ditch running along the east side of this property which connects to the 1st Avenue S Bridge storm drain system and discharges to Outfall 2503 (Figure 5) (SPU 2001 as cited in Schmoyer 2008b). Runoff from this parcel most likely enters that ditch. There are no catch basins on the property and no connections to the combined sewer system (Schmoyer 2008b).
