**RE: Final Summary of Existing Information and Identification of Data Gaps
Report, Lower Duwamish Waterway Early Action Area 7**

**Lower Duwamish Waterway
Early Action Area 7
Final Summary of Existing
Information and Identification of
Data Gaps
Report**

**Contract No. C0700036
Work Assignment No. EANE001**

September 2007

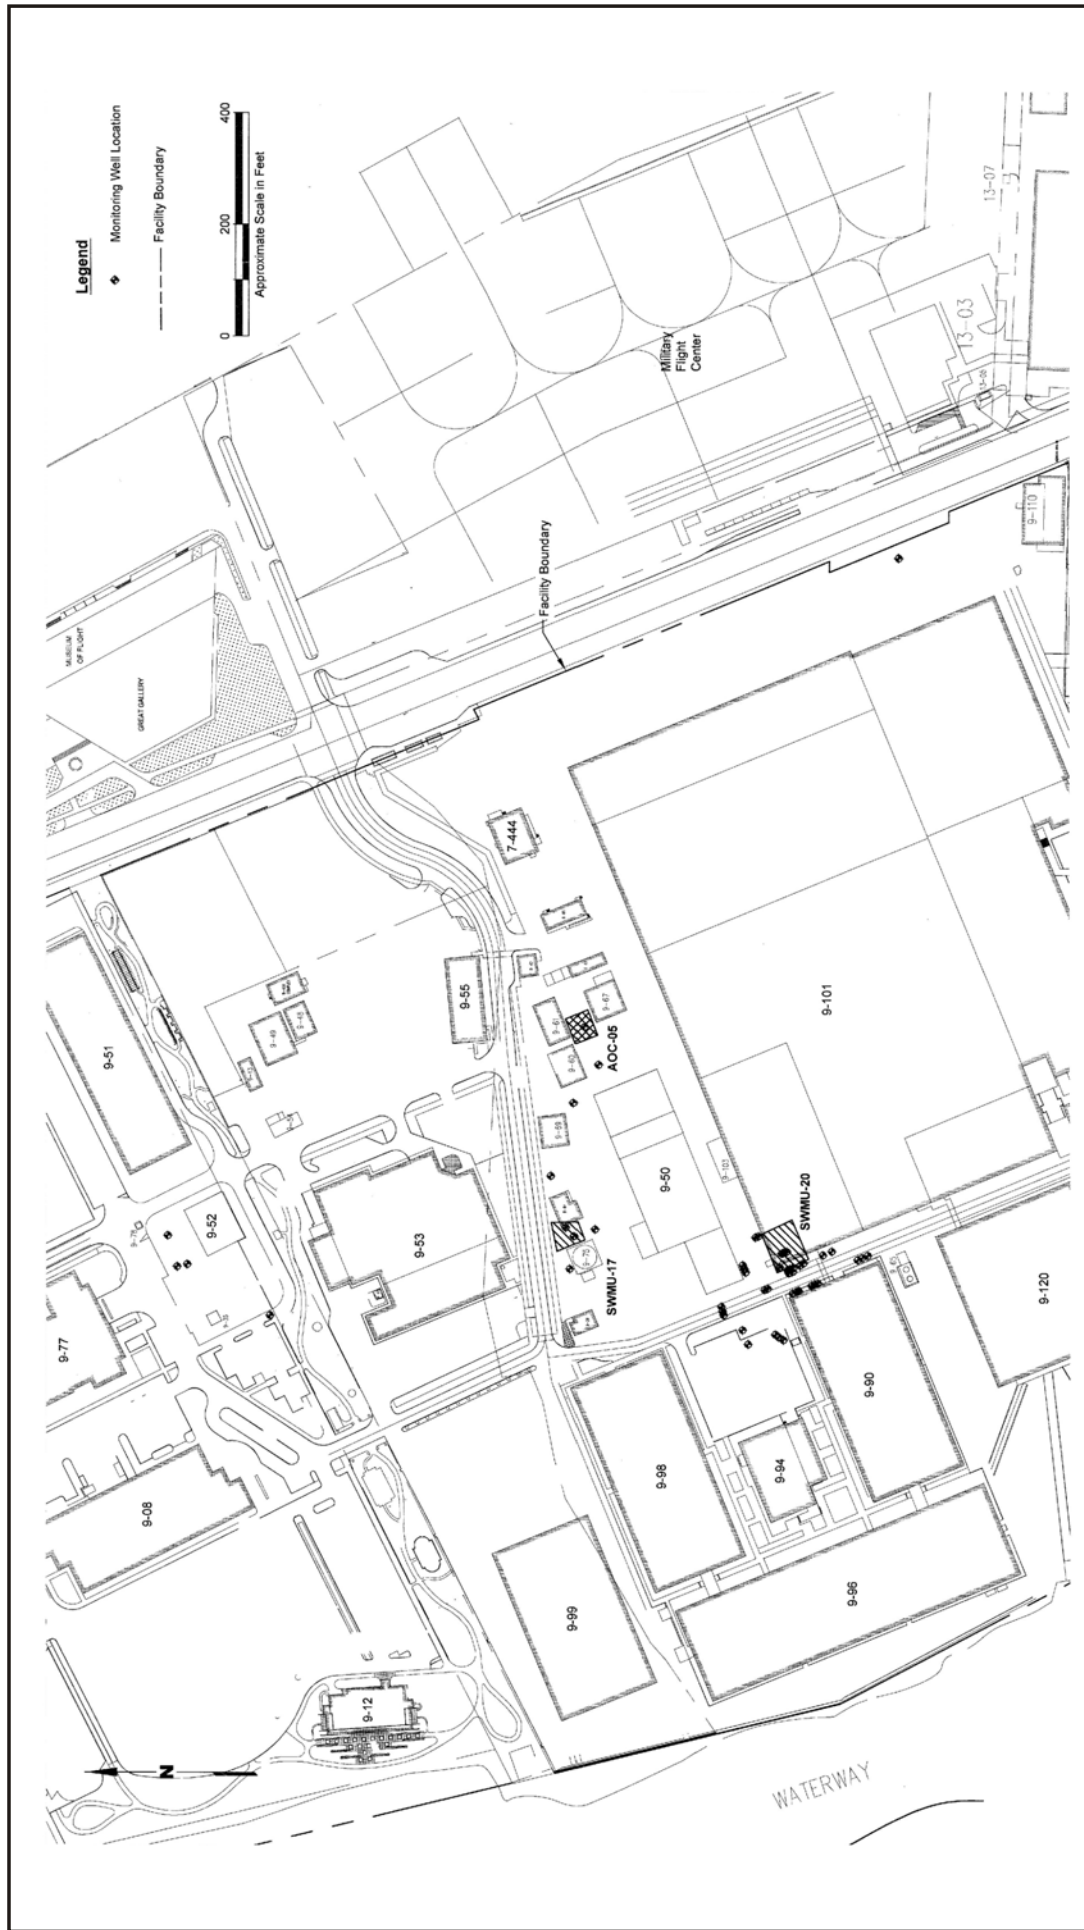
Figure 17
BOEING DEVELOPMENTAL CENTER
 SMWU-17, SMWU-20, AND AOC-05 LOCATIONS
