Lower Duwamish Waterway RM 3.7-3.9 East Early Action Area 6

Summary of Existing Information and Identification of Data Gaps

Science Applications International Corporation
18912 North Creek Parkway, Suite 101
Bothell, WA 98011

May 2008

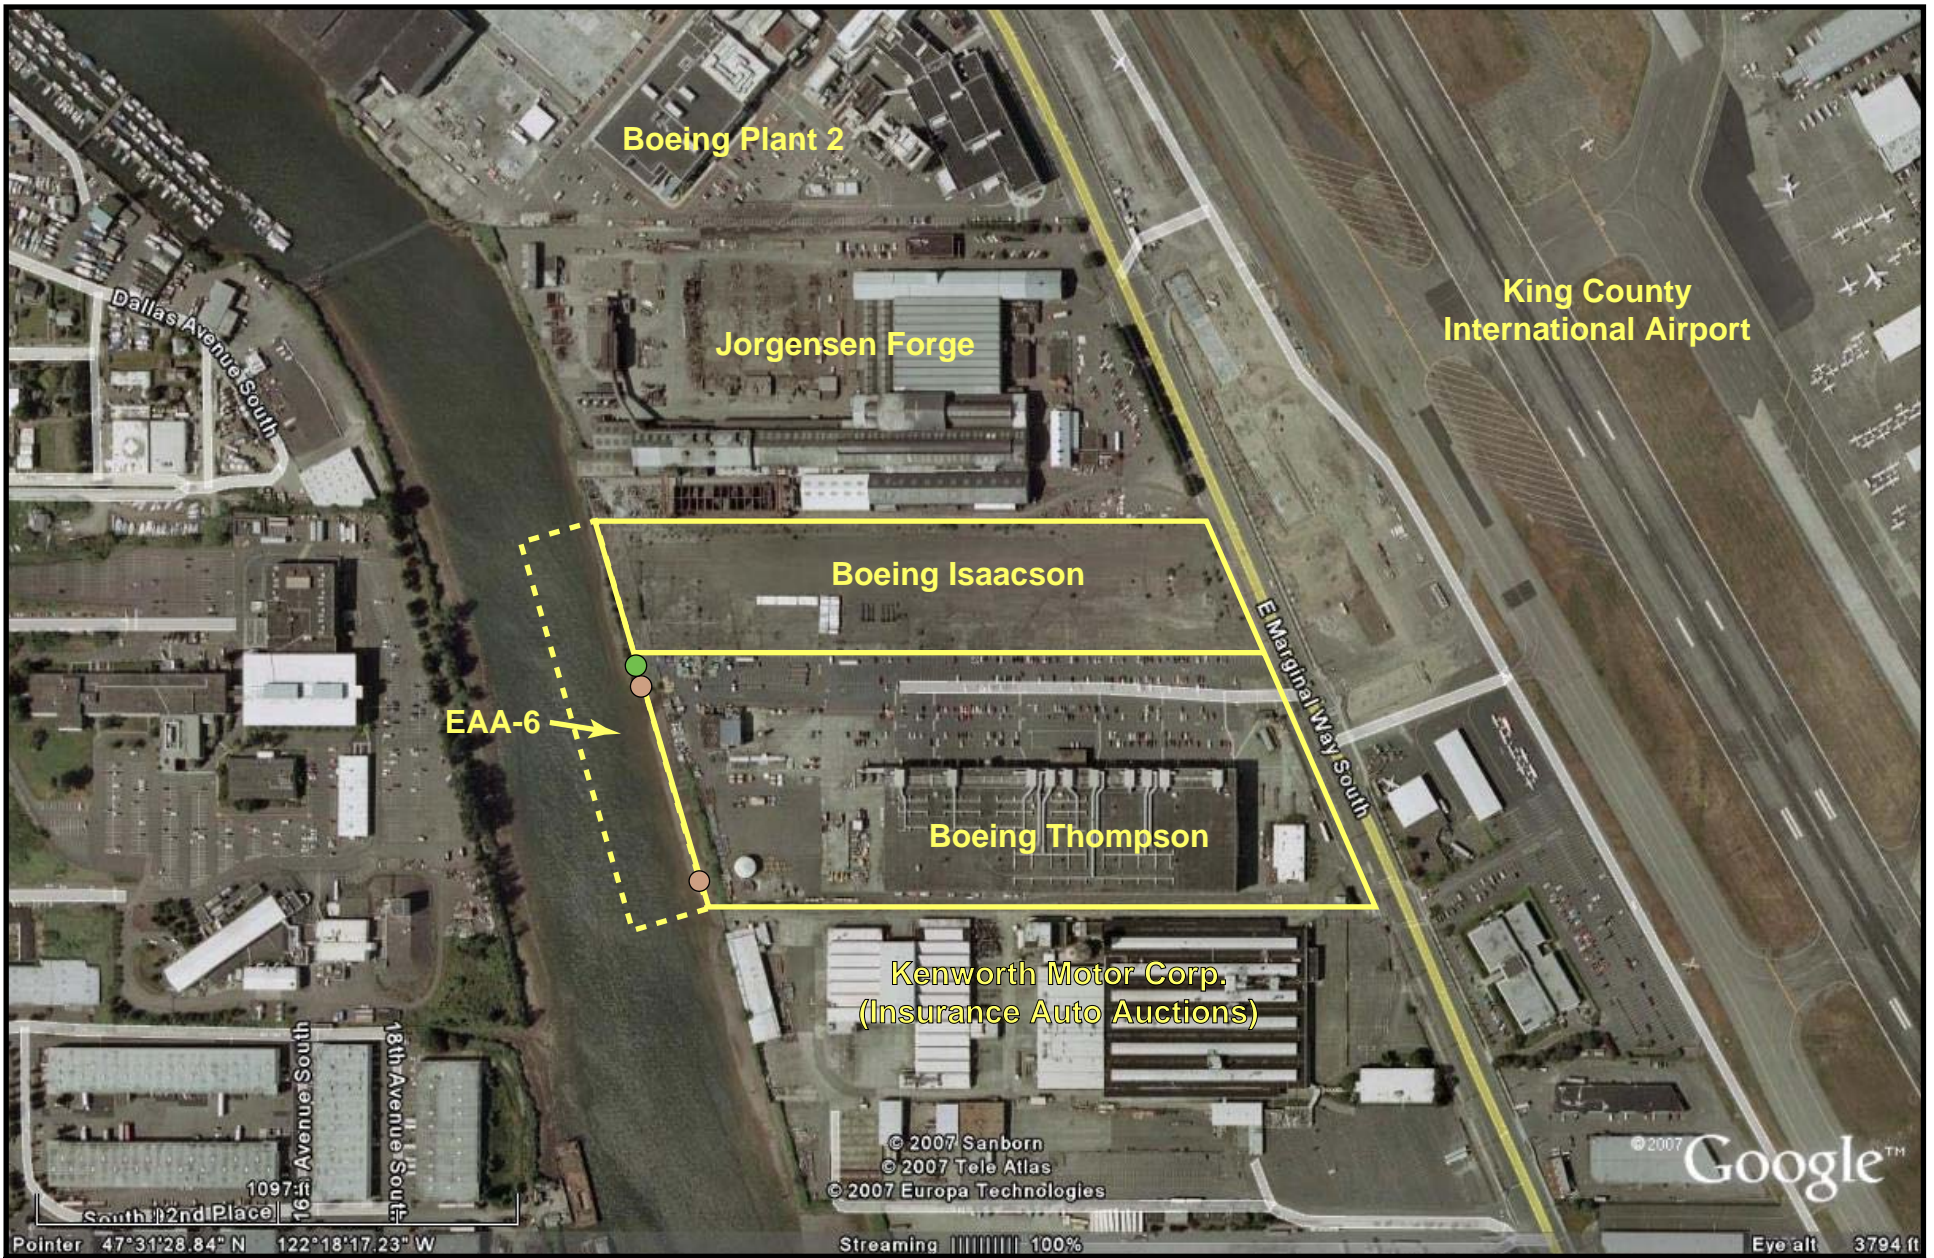
Figure 2. EAA-6 Adjacent Properties

- Public Storm Drain Outfall/EOF
- Private Storm Drain Outfall

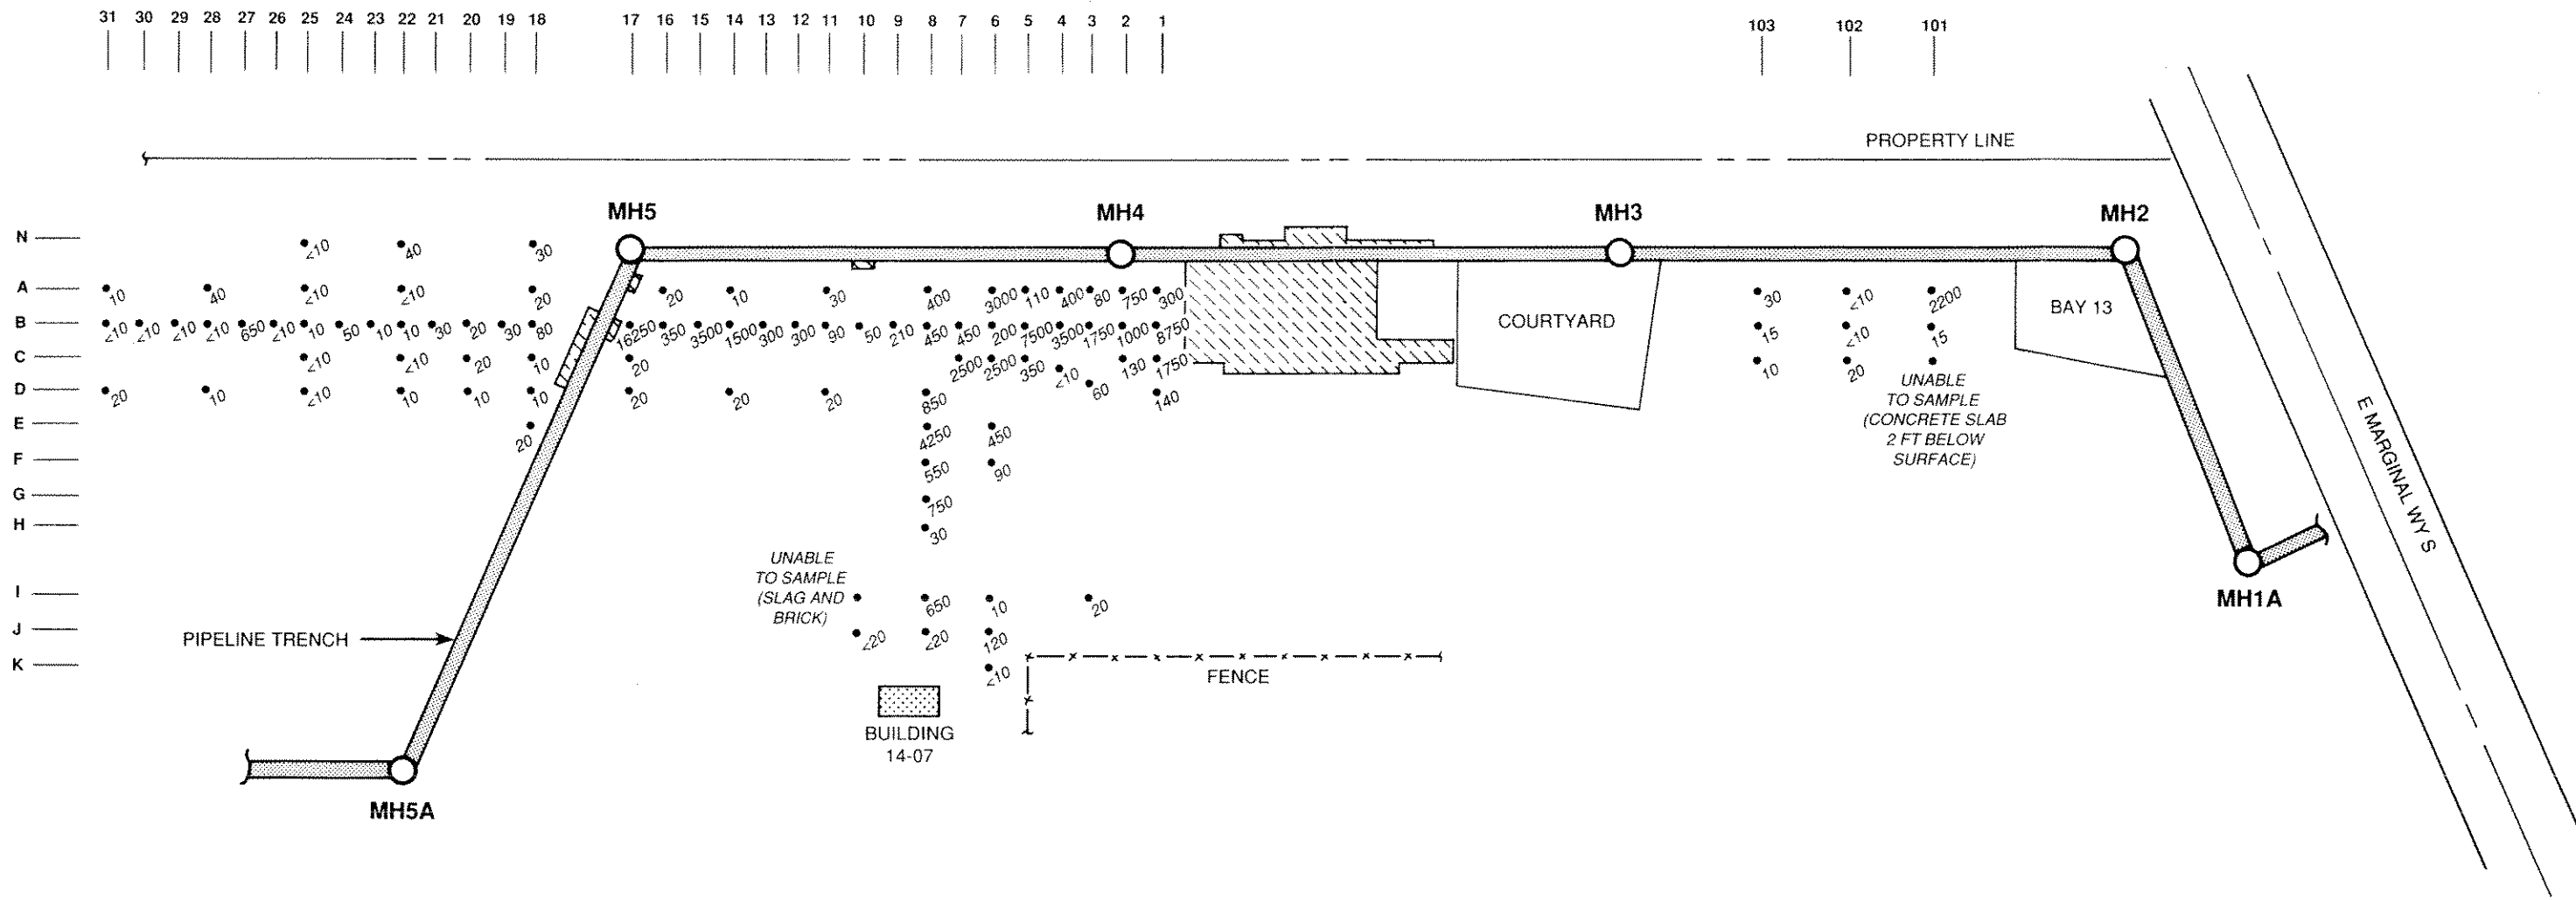
Figure 9.
A Series Test Pits
3 to 5 Foot Depth

- 2000 Test Pit Location and Arsenic Value (ppm) Screen Test Values
- ▨ Excavated Area
