SWMU and AOC Pre –Remedial Investigation Summary Report and 2009 SWMU and AOC Figures

# Solid Waste Management Units and Areas of Concern Pre-Remedial Investigation Summary Boeing Auburn Facility Auburn, Washington

February 9, 2017

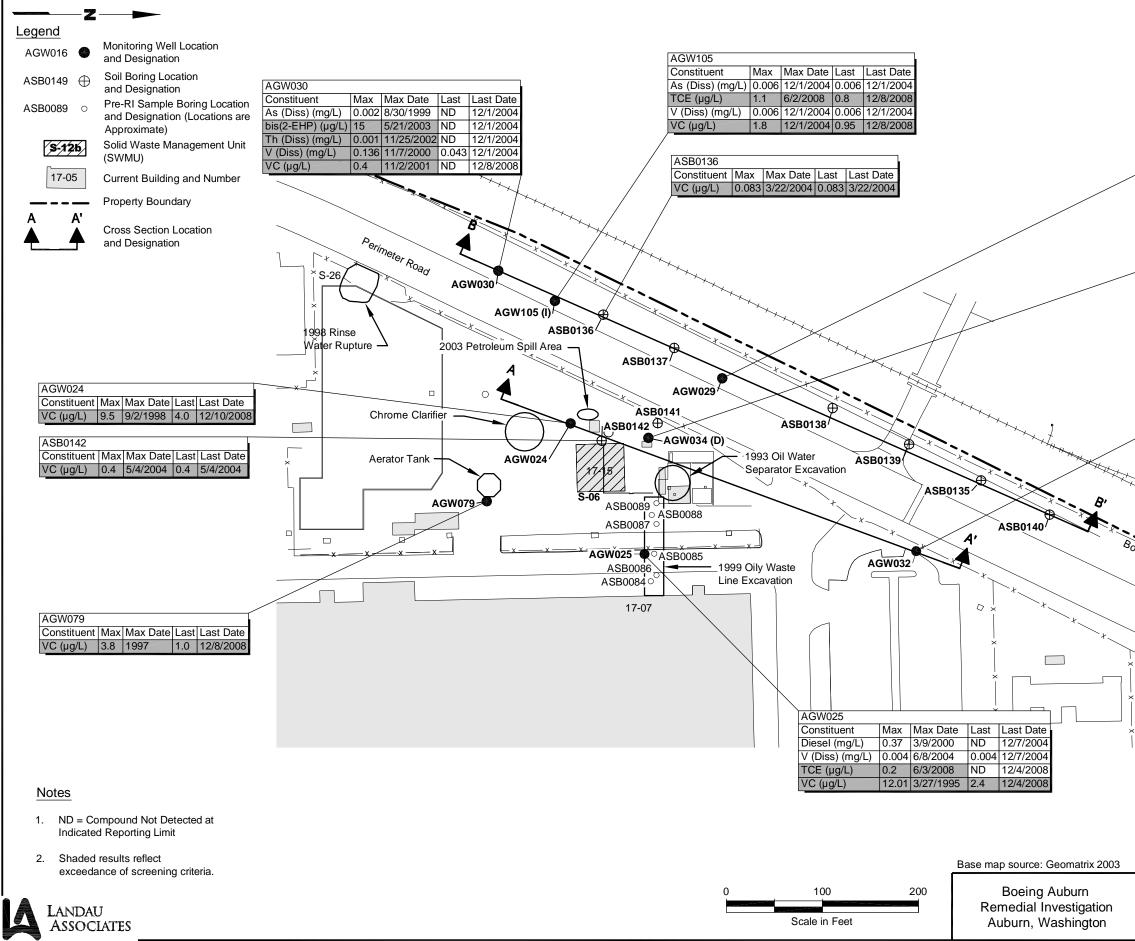
#### SWMU S-06 Groundwater Plan View

AGW029						
Constituent	Max	Max Date	Last	Last Date		
As (Diss) (mg/L)	0.004	3/14/2000	ND	12/1/2004		
bis(2-EHP) (µg/L)	1.4	11/7/2000	ND	12/1/2004		
Th (Diss) (mg/L)	0.001	11/7/2000	ND	12/1/2004		
V (Diss) (mg/L)	0.039	9/3/1998	0.025	12/1/2004		
VC (µg/L)	0.5	9/10/1997, 12/5/2005	0.088	12/8/2008

AGW034						
Constituent	Max	Max Date	Last	Last Date		
As (Diss) (mg/L)	0.001	12/11/1995, 9/9/1997	0.001	12/7/2004		
bis(2-EHP) (µg/L)	48	9/2/1998	48	9/2/1998		
TCE (µg/L)	2.6	3/19/1998	2.4	12/5/2005		
VC (µg/L)	0.026	6/8/2004	ND	12/5/2005

AGW032						
Constituent	Max	Max Date	Last	Last Date		
As (Diss) (mg/L)	0.072	5/20/2002	0.014	12/7/2004		
bis(2-EHP) (µg/L)	3.9	9/2/1998	1.8	12/7/2004		
Diesel (mg/L)	1.4	3/13/2000	ND	12/7/2004		
Jet-A (mg/L)	0.91	3/13/2000	ND	11/7/2000		
TCE (µg/L)	0.7	9/9/1997	ND	12/4/2008		
Th (Diss) (mg/L)	0.001	2/16/1999	ND	12/7/2004		
V (Diss) (mg/L)	0.043	6/8/2004	0.019	12/7/2004		
VC (µg/L)	5.2	8/30/1999	0.88	12/4/2008

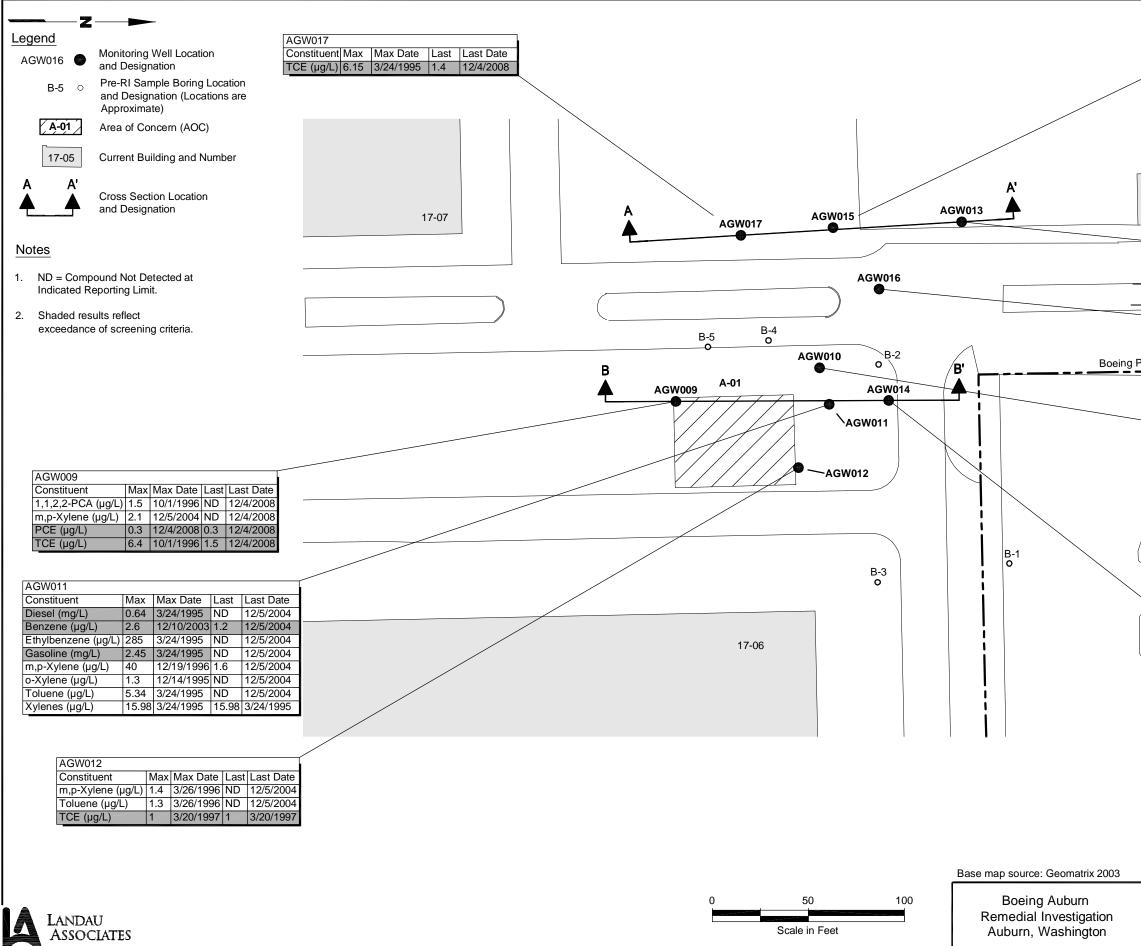
/	AGW015				
	Constituent	Max	Max Date	Last	Last Date
	Diesel (mg/L)	0.59	12/5/2004	ND	12/4/2008
	Benzene (µg/L)	1.6	10/1/1996	0.2	12/4/2008
	Ethylbenzene (µg/L)	7.6	12/5/2006	ND	12/4/2008
	m,p-Xylene (µg/L)	19	12/5/2006	ND	12/4/2008
	o-Xylene (µg/L)	4.4	12/5/2006	ND	12/4/2008
	Toluene (µg/L)	1.6	3/20/1997	ND	12/4/2008
	TCE (µg/L)	1.5	3/24/1995	ND	12/4/2008
	TCA (µg/L)	1.6	6/5/2008	ND	12/4/2008
	AGW013				
		lax Dat		ast Dat 21/199	-

-	TCE (µg/L) 1.3 1	2/13/19	995 ND 3/	21/199	7
Property	AGW016 Constituent Benzene (µg/L) Ethylbenzene (µg/L) m,p-Xylene (µg/L) Toluene (µg/L)	Max 14 13 2 0.3	Max Date 12/19/1996 12/19/1996 12/19/1996 9/4/1998	ND	Last Date 3/13/2000 12/5/2004 12/5/2004 12/5/2004

0.010/04.0				
	AGW010 Constituent	Max	Max Date	Last	Last Date
		1.1		ND	12/4/2008
		3.3		ND	12/4/2008
		18.7		ND	12/4/2008
		5250		21	12/4/2008
		3600		3100	12/4/2008
		120	8/26/1999	58	12/4/2008
	Jet-A (mg/L)	8.8	8/26/1999	5.1	6/7/2006
		11000	8/26/1999	8000	12/4/2008
		4300		2000	12/4/2008
<	, , , , , , , , , , , , , , , , , , , ,	12		ND	12/4/2008
		15000		66	12/4/2008
$\frown$		4		ND	12/4/2008
	Xylenes (µg/L)	13199	3/24/1995	13199	3/24/1995
17-05	AGW014	lov Dot		at Date	_
		ax Dat		st Date 20/200/	
Area Shown — Boeing Auburn Plant Map					
AOC A-01 Groundwater Plan View					Figure M-12e

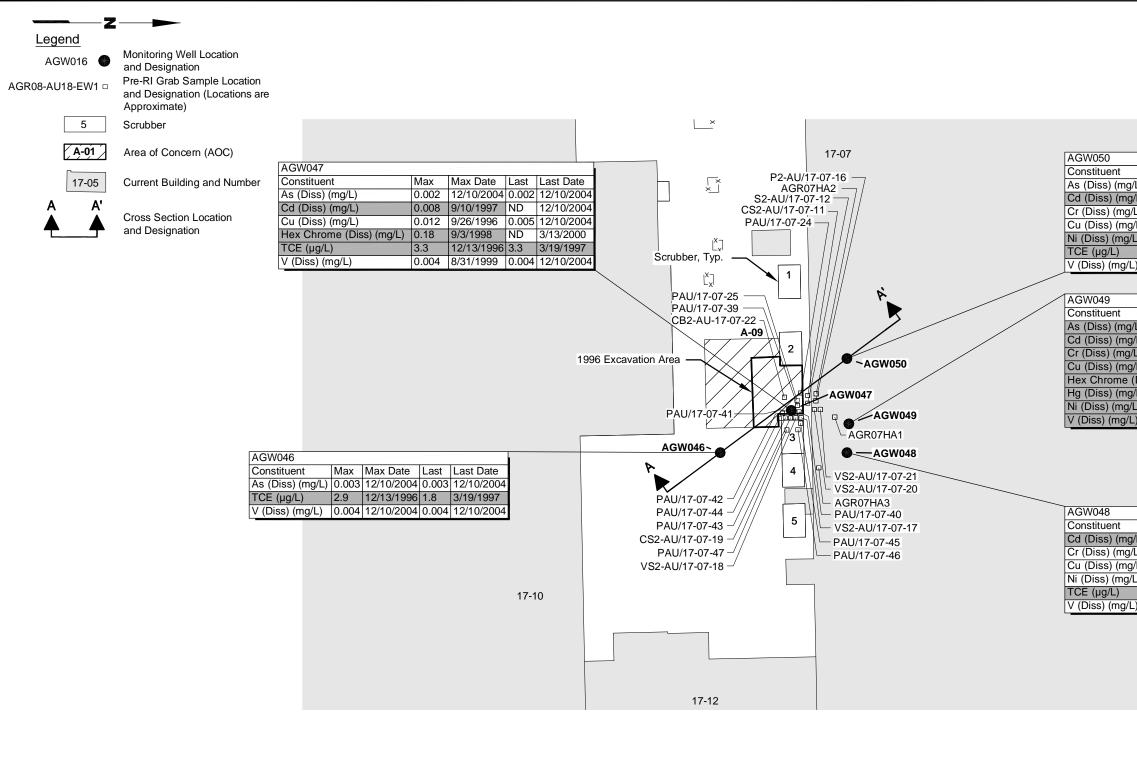
Figure M-21d

Max	Max Date	Last	Last Date
/L)	0.001		-	12/10/2004
/L)	0.038	6/13/2006	0.008	12/15/2008
/L)	0.009	6/16/2004	0.008	12/10/2004
I/L)	0.039	9/26/1996	0.021	12/10/2004
Ľ)	0.14	9/26/1996		12/15/2008
	3.2	3/19/1997	3.2	3/19/1997
_)	0.006	6/16/2004	0.006	12/10/2004

Max	Max Date	Last	Last Date
/L)	0.014	9/10/1997	0.003	12/10/2004
g/L)	10	12/14/2007		12/15/2008
/L)	0.263	9/10/1997	0.007	12/10/2004
g/L)	28.3	9/10/1997	1.47	12/10/2004
(Diss) (mg/L)	0.13	9/3/1998	ND	3/13/2000
g/L)	0.0036	9/10/1997	0.0002	12/10/2004
/L)	2.06	9/26/1996	0.08	12/15/2008
L)	0.432	9/3/1998	0.026	12/10/2004

Max	Max Date	Last	Last Date
g/L)	0.01	9/26/1996	0.003	12/15/2008
/L)	0.005	9/26/1996	ND	12/10/2004
g/L)	0.392	9/26/1996	0.01	12/10/2004
′L)	0.03	9/26/1996	ND	12/15/2008
	4.9	3/19/1997	4.9	3/19/1997
L)	0.003	6/16/2004	0.003	12/10/2004

## AOC A-09 Groundwater Plan View

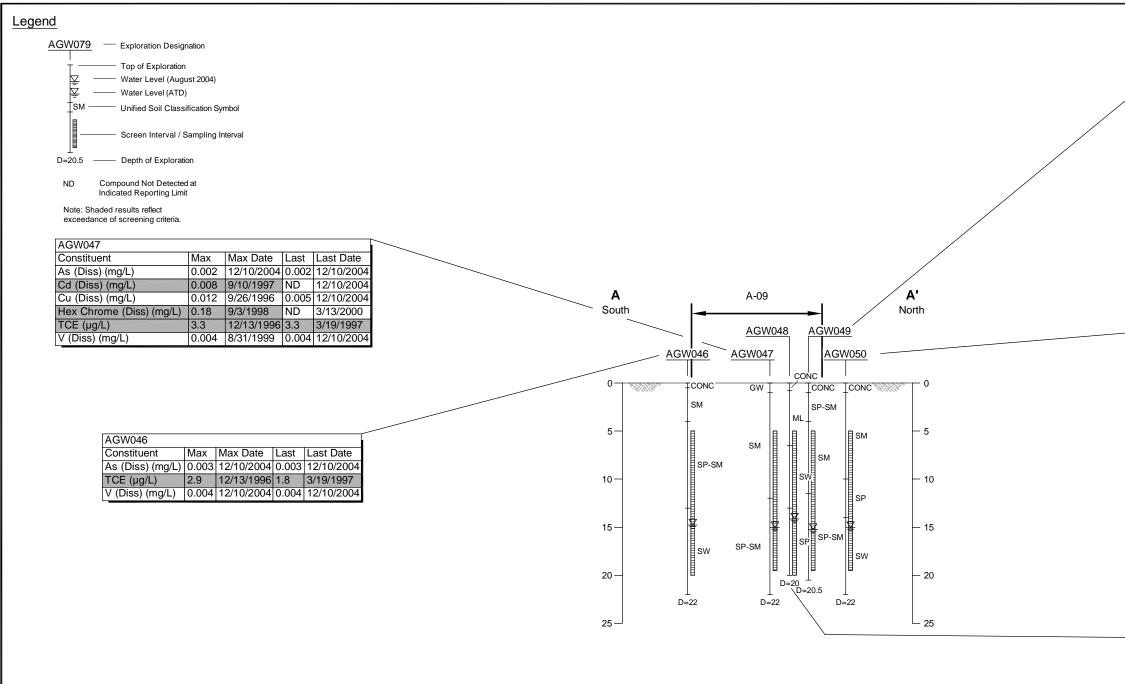
Horizontal Scale: 1" = 50'
 Vertical Scale: 1" = 10'

AGW049						
Constituent	Max	Max Date	Last	Last Date		
As (Diss) (mg/L)	0.014	9/10/1997	0.003	12/10/2004		
Cd (Diss) (mg/L)	10	12/14/2007	0.005	12/15/2008		
Cr (Diss) (mg/L)	0.263	9/10/1997	0.007	12/10/2004		
Cu (Diss) (mg/L)	28.3	9/10/1997	1.47	12/10/2004		
Hex Chrome (Diss) (mg/L)	0.13	9/3/1998	ND	3/13/2000		
Hg (Diss) (mg/L)	0.0036	9/10/1997	0.0002	12/10/2004		
Ni (Diss) (mg/L)	2.06	9/26/1996	0.08	12/15/2008		
V (Diss) (mg/L)	0.432	9/3/1998	0.026	12/10/2004

AGW048						
Constituent	Max	Max Date	Last	Last Date		
Cd (Diss) (mg/L)	0.01	9/26/1996	0.003	12/15/2008		
Cr (Diss) (mg/L)	0.005	9/26/1996	ND	12/10/2004		
Cu (Diss) (mg/L)	0.392	9/26/1996	0.01	12/10/2004		
Ni (Diss) (mg/L)	0.03	9/26/1996	ND	12/15/2008		
TCE (µg/L)	4.9	3/19/1997	4.9	3/19/1997		
V (Diss) (mg/L)	0.003	6/16/2004	0.003	12/10/2004

AOC A-09 Groundwater Section A-A' View Figure M-21e Boeing\Remedial Investigation Report | V:\025\164\050\055\D\RI Report 2009\FIG\_AOCs - SE PLAN.dwg (A) "7-11a" 3/30/2009

There were 20 soil compliance samples collected as part of the 1996 excavation of impacted soil (AGI 1996a). A follow up groundwater investigation was also conducted. Five shallow groundwater wells (AGW046, AGW047, AGW048, AGW049, and AGW050) were installed upgradient and downgradient of the leak. Three soil borings (between 3 and 6 ft bgs) were also advanced near the leak (AGR07HA1, AGR07HA2, and AGR07HA3) (AGI 1996b).
