Cleanup Action Plan

Brookdale Golf Course 1802 Brookdale Road East Tacoma, Washington

March 18, 2019

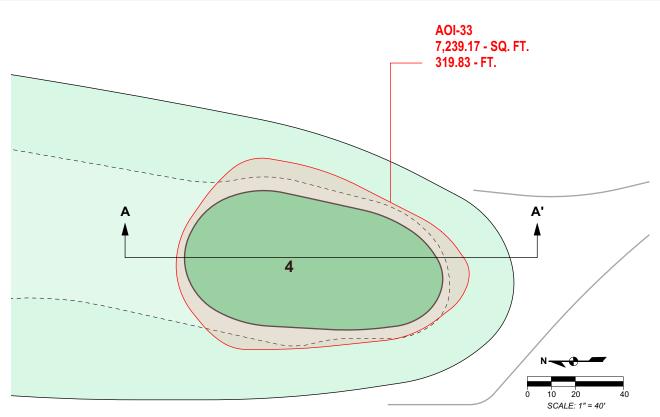
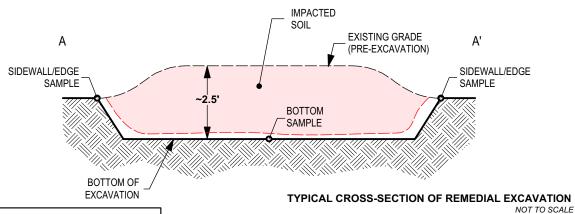
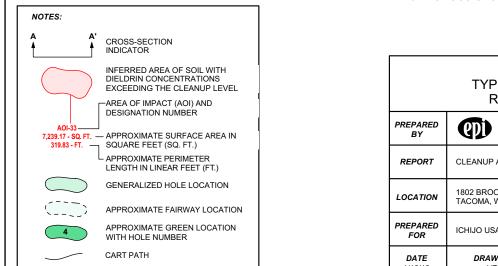
FIGURE 18 TYPICAL CROSS-SECTION OF REMEDIAL EXCAVATION

TYPICAL AREA OF IMPACT (PLAN VIEW)

Once the initial limits of each remedial excavation are achieved, performance soil samples will be collected from the sidewalls or edges, and base of each remedial excavation area. One performance soil sample will be collected for every 600 square feet of remedial excavation base. Sidewall or edge samples will be collected at minimum from each cardinal direction (north, east, south, and west). For larger excavations, one sample will be collected from each 50 linear feet of sidewall or edge. These samples will be used to characterize the vertical distribution of dieldrin-impacted soil. Figure 18 illustrates a typical cross-section of a remedial excavation area.
