October 22, 2018 SES-LTM/OM-9011-18-0628

SUBJECT: FINAL TECHNICAL MEMORANDUM: 2018 NAVAL BASE KITSAP KEYPORT INSTITUTIONAL CONTROLS INSPECTION RESULTS

Reference: Contract N44255-14-D-9011, Long Term Monitoring, Operations, and Maintenance Contract

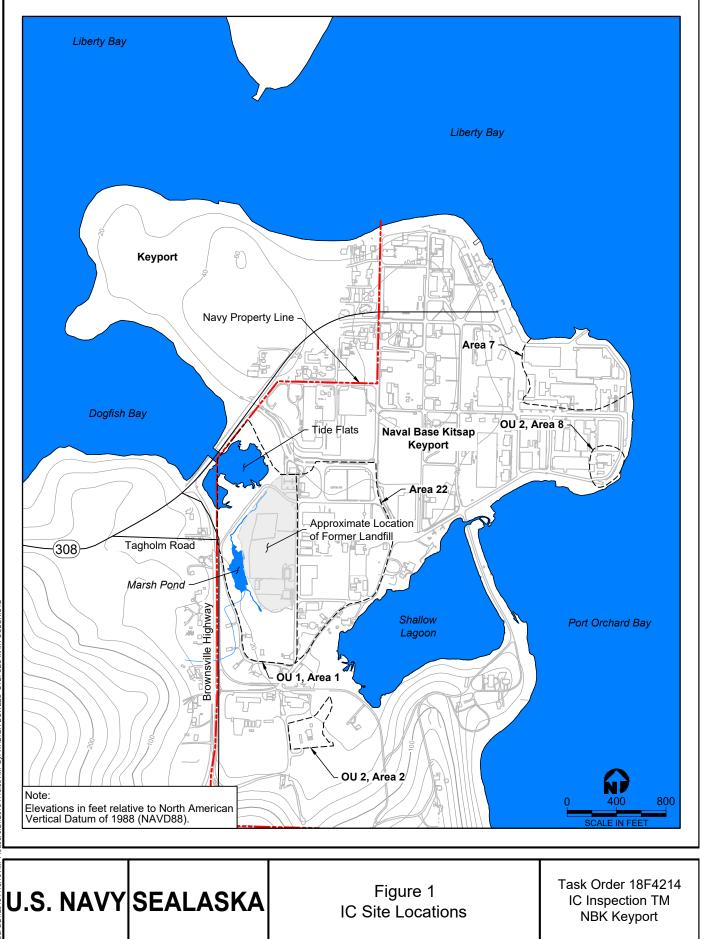
This technical memorandum has been prepared by Sealaska Environmental Services, LLC (Sealaska) to document the findings of the 2018 institutional controls (IC) inspections conducted at Naval Base Kitsap (NBK) Keyport. The inspections were completed per the *Institutional Controls Plan, Operable Unit 1, Operable Unit 2, and Areas 22 and 7* (Navy 2017) and included Operable Unit (OU) 1 Area 1, OU 2 Area 2 and Area 8, Area 22, and Area 7. Figure 1 showing all IC site locations is provided as Attachment A.

OU 1 Area 1, the former Installation landfill (see Figure 1, Attachment A), is covered by asphalt- and gravel-surfaced parking areas, two phytoremediation plantations, equipment and material laydown areas, several storage structures, a motorcycle training area, a marsh system and marsh pond, tide flats, vegetated areas, and nature trails. Land use is primarily light industrial and open space, consistent with past inspections.
