## **King County**

Department of Natural Resources and Parks  
Wastewater Treatment Division

**Re:** Hanford Street Regulator / Outfall Station, December 29, 2017 – January 1, 2018  
Revised - This report is an update to a previous document that we had inadvertently omitted clarification on the sequence of events and the proposed improvements that are in process that, once implemented, will help to minimize similar future occurrences.

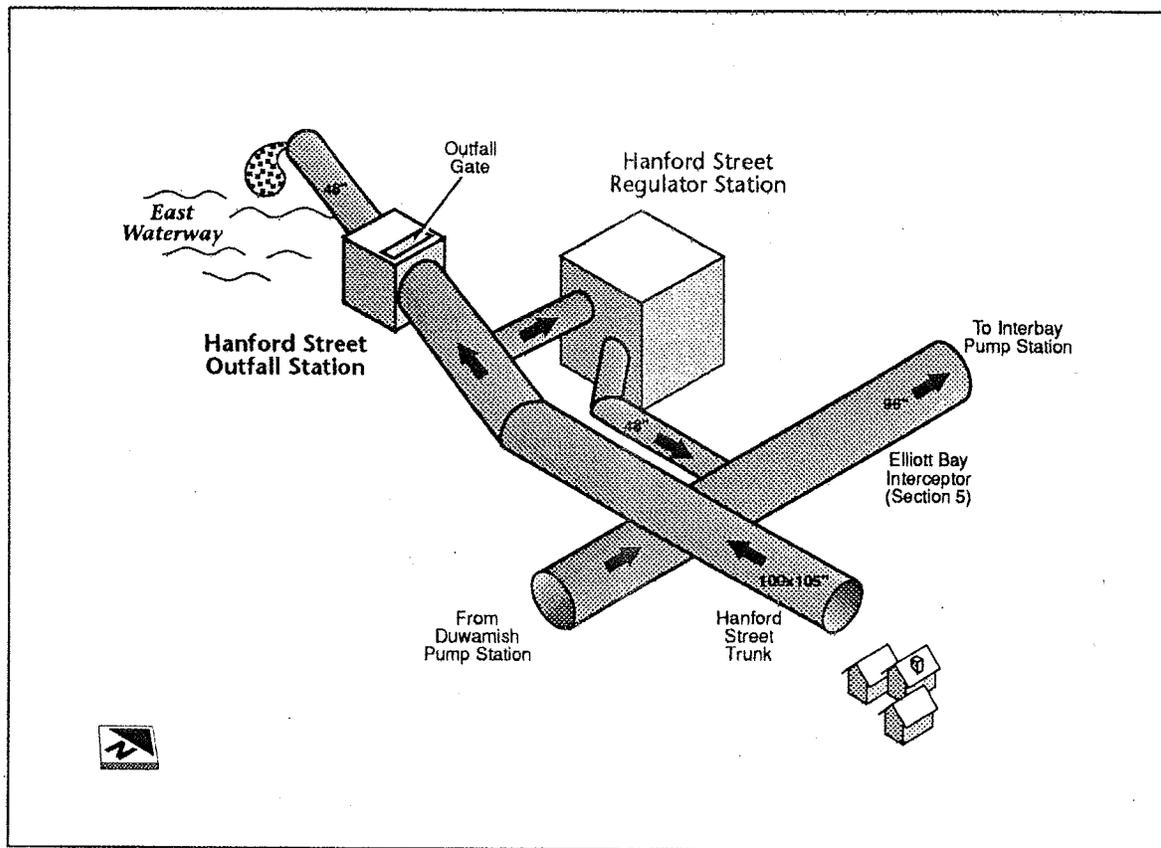
Flow Schematic

### System Relationship

The Hanford Regulator Station is located at 2999 East Marginal Way South, and the Hanford Outfall Station is located at 2999-1/2 East Marginal Way South. A system flow schematic for that location has been attached for your reference.
