Lower Duwamish Waterway RM 1.2-1.7 East (Saint Gobain to Glacier Northwest)

Source Control Action Plan Final Report

June 2009

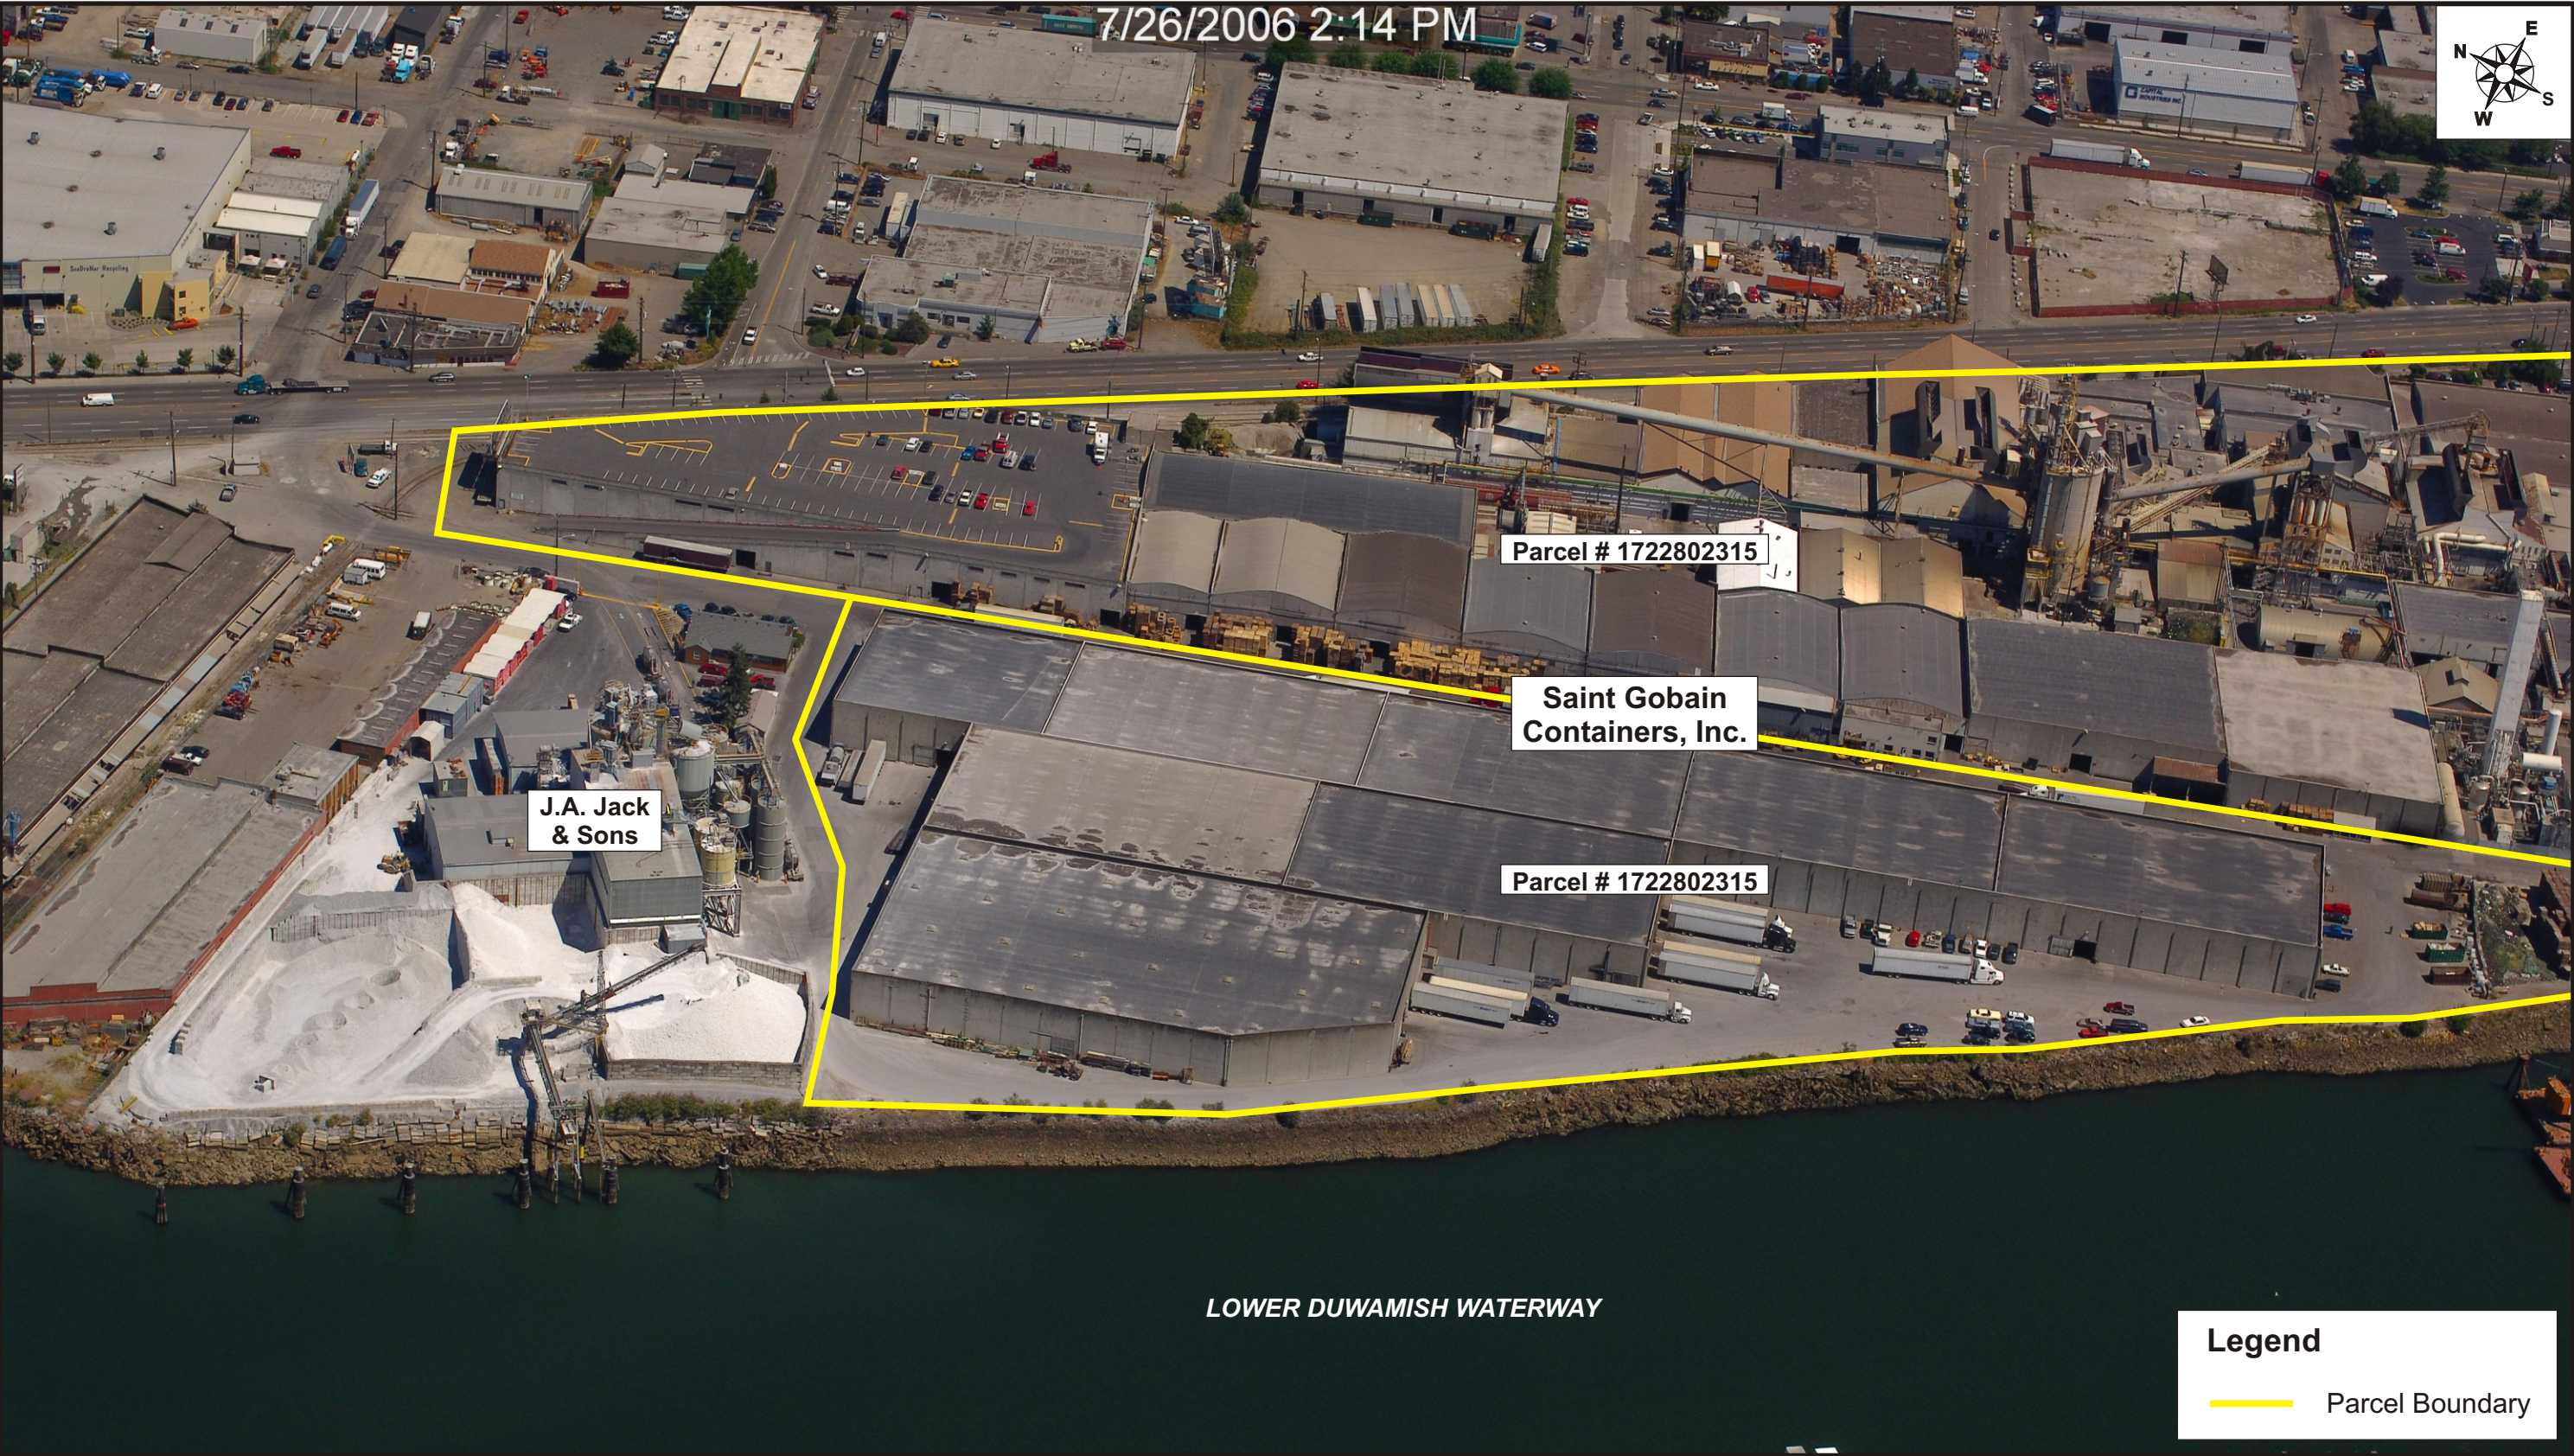
Figure 6
AERIAL PHOTOGRAPH OF SAINT GOBAIN

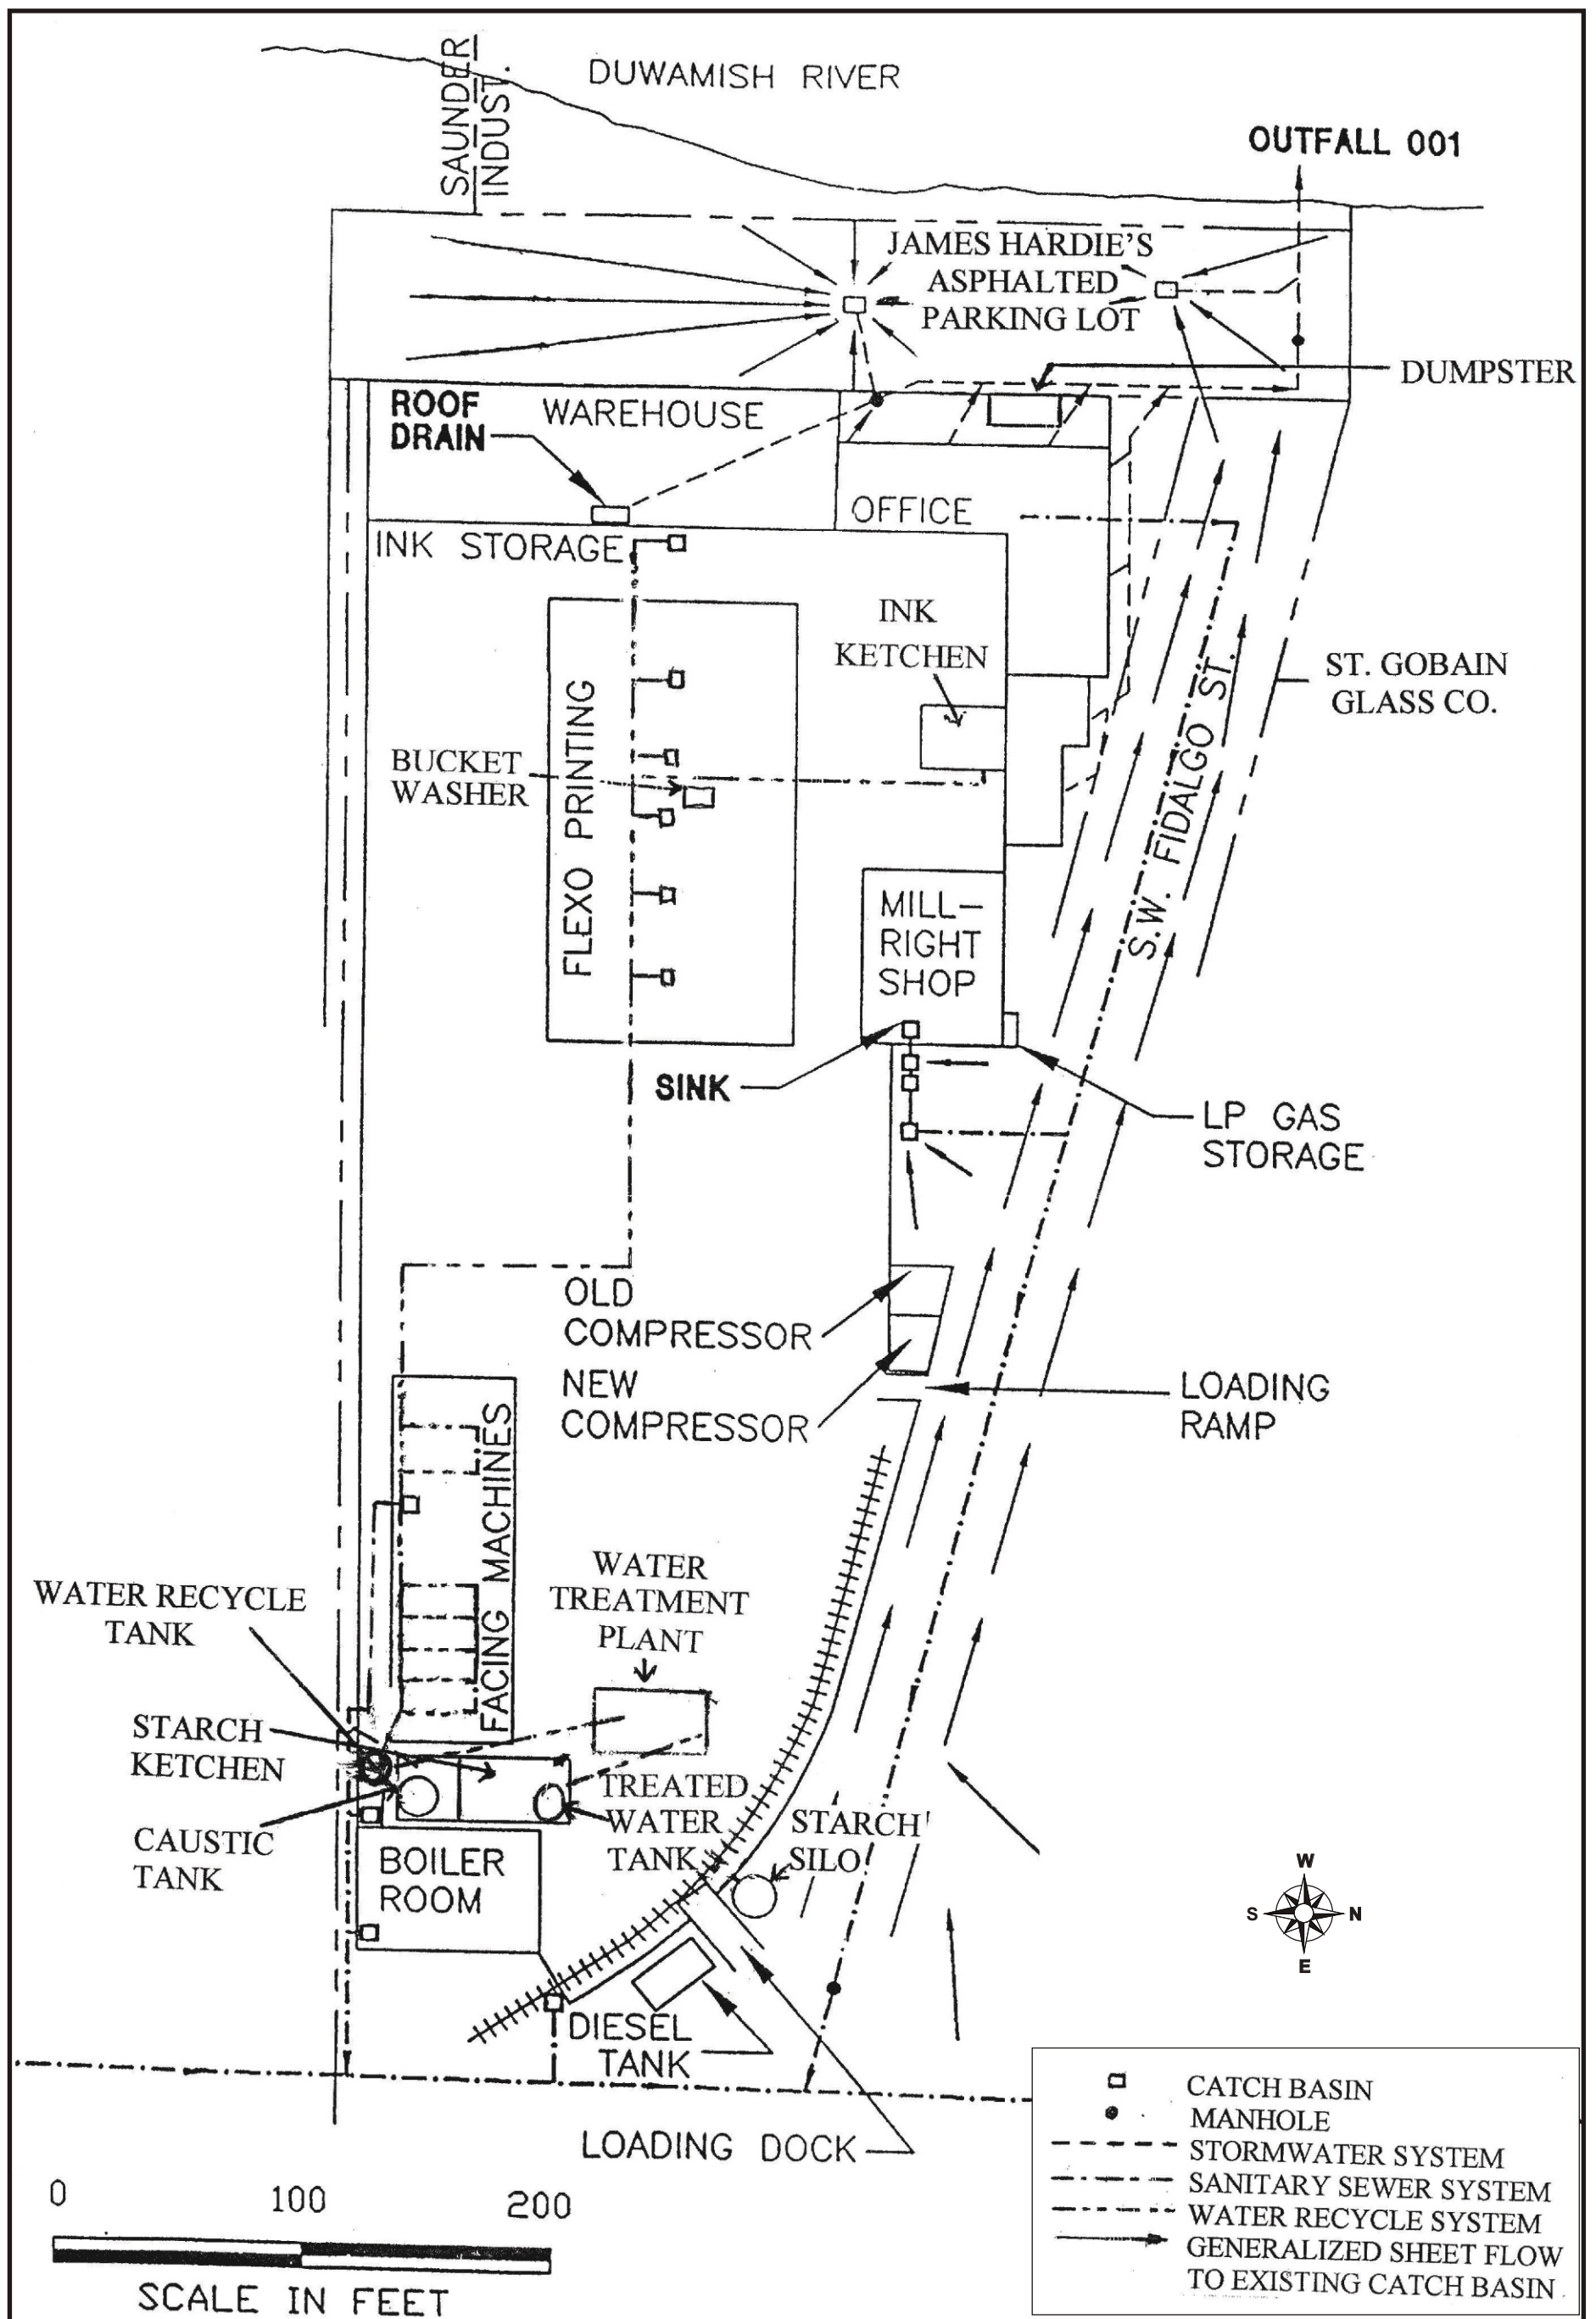
Figure 12
SANITARY SEWER SYSTEM AND SITE LAYOUT
FOR LONGVIEW FIBRE

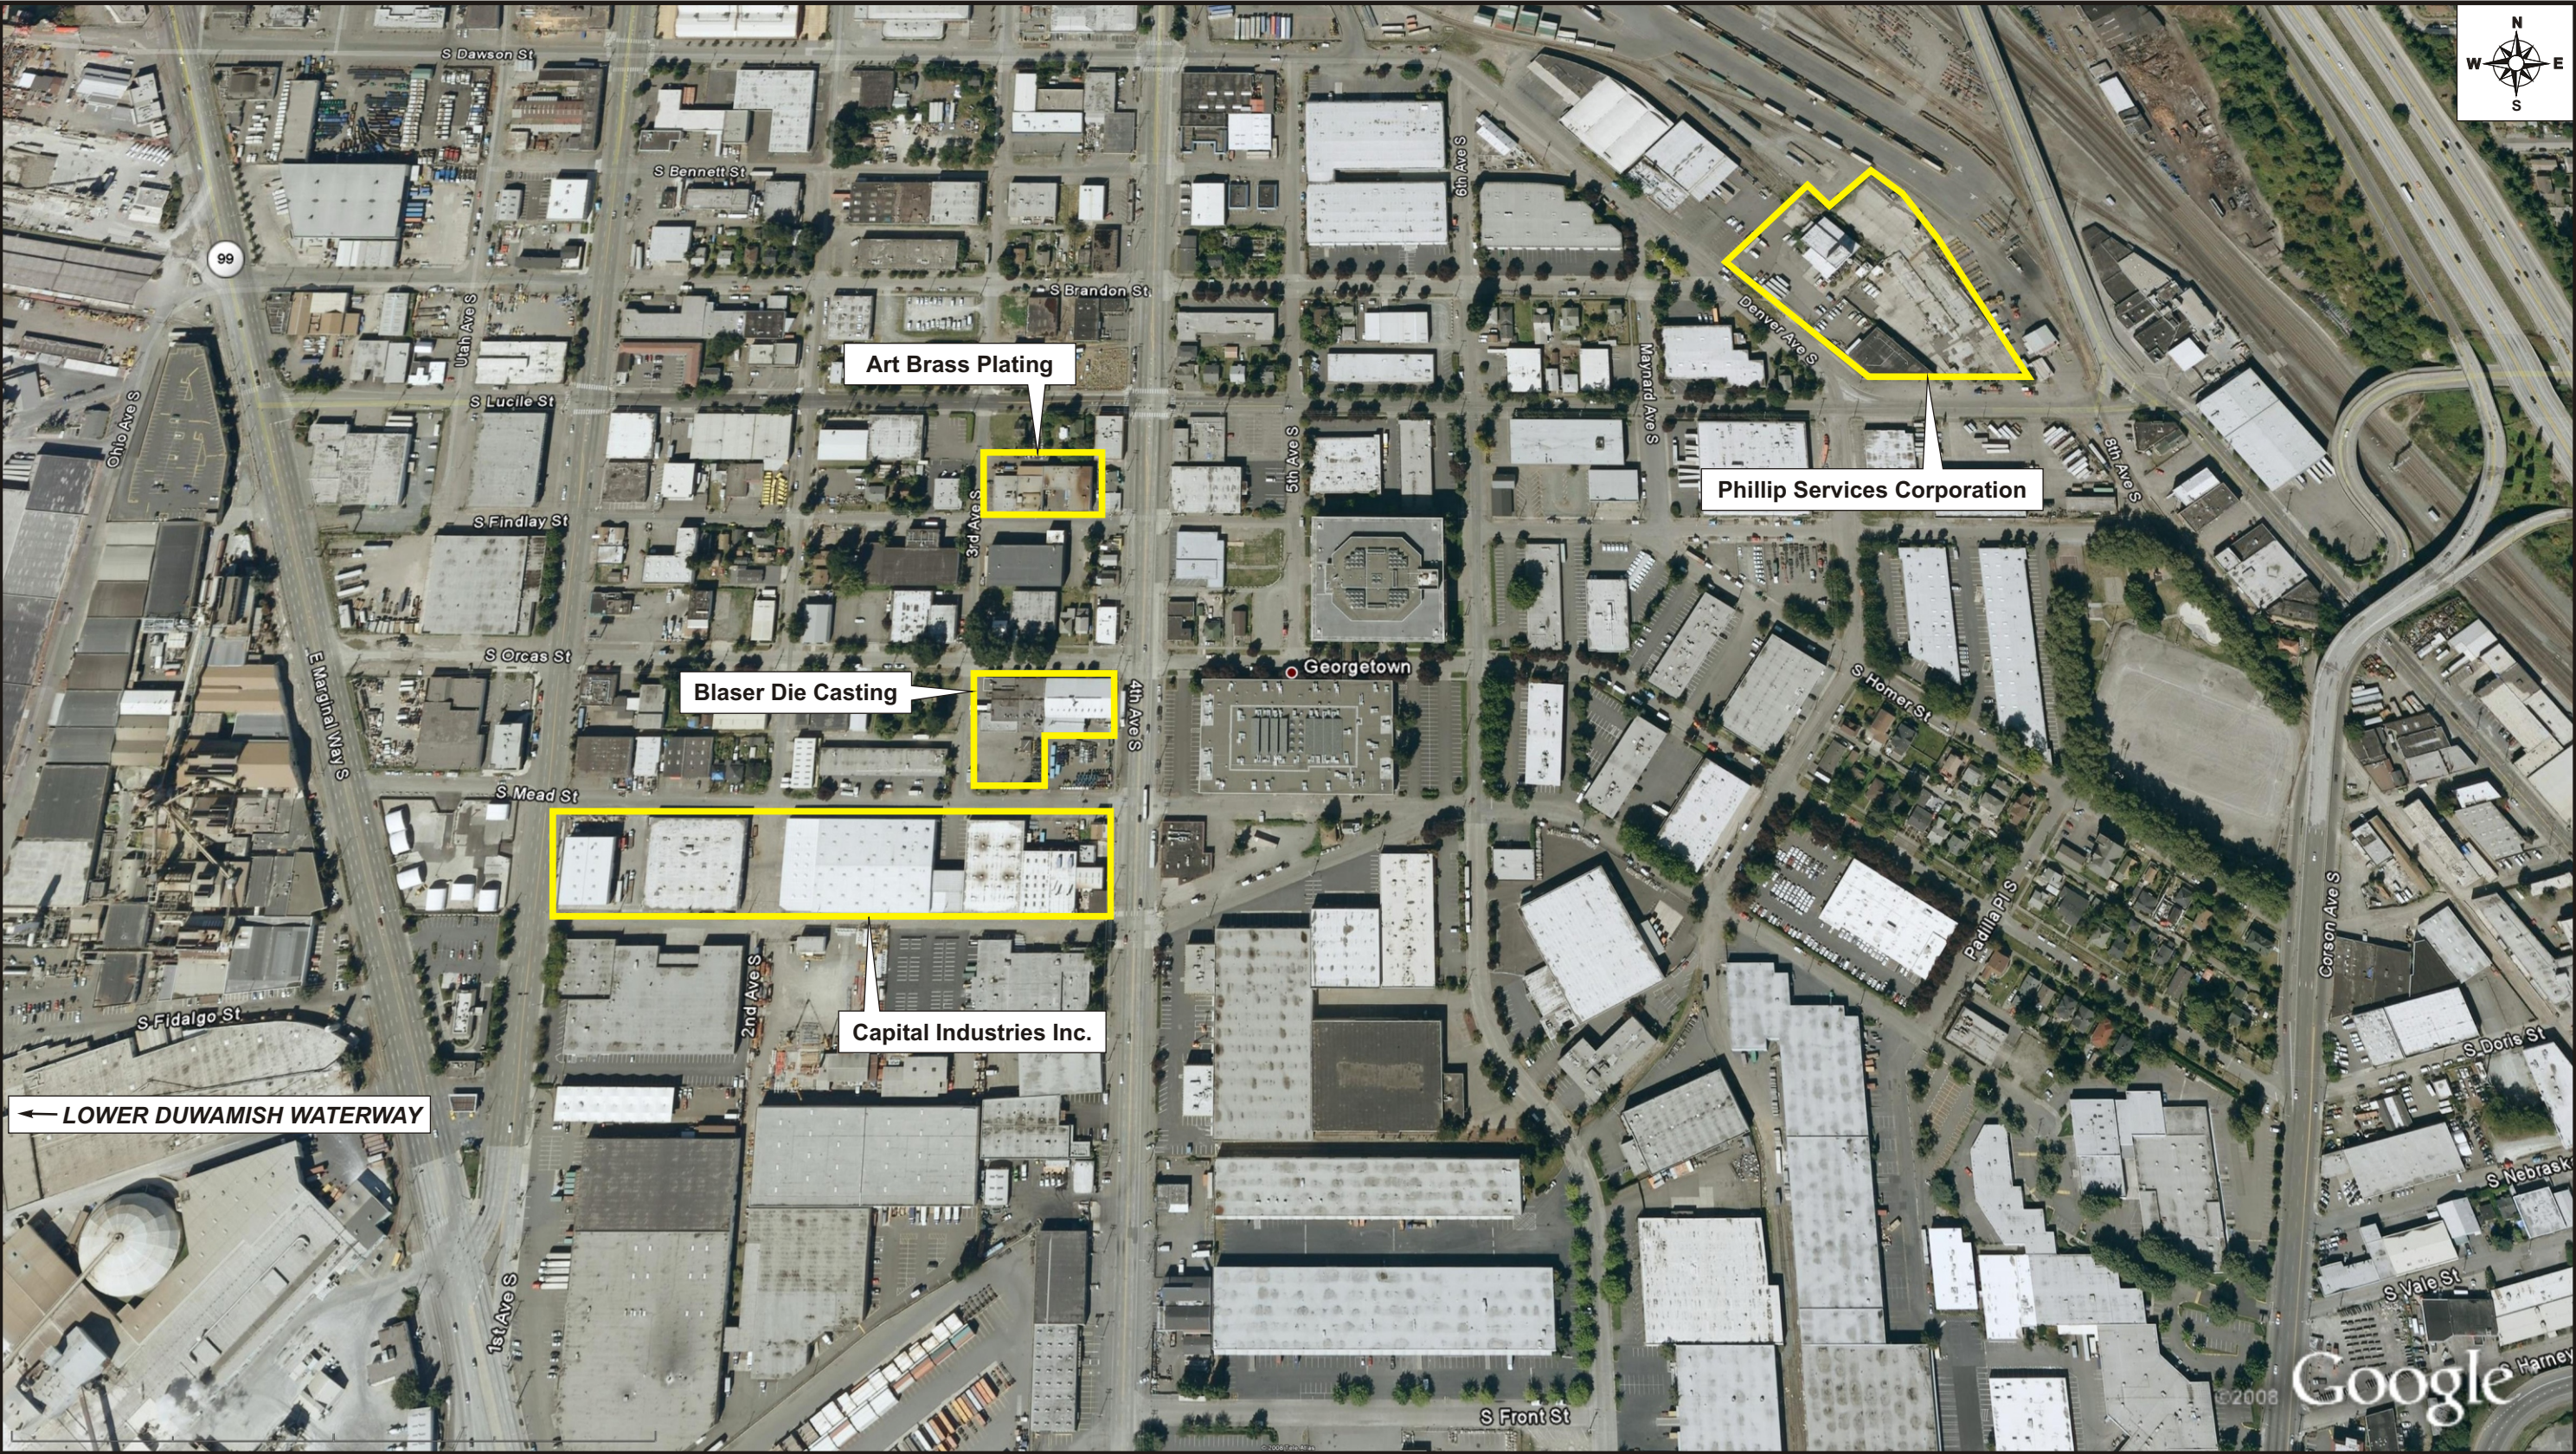
Figure 15
SITE LOCATIONS OF UPLAND PROPERTIES

The following facilities have been included in this report due to concerns about significant groundwater contamination within the RM 1.2-1.7 East Source Control Area (Figure 15). Results

Art Brass Plating Inc. is upland of the LDW, on the east side. The property is bordered to the north by a vacant office building and to the south by South Findlay Street. Fuji's Teriyaki and wholesale fish retail store borders the property to the east, and 3rd Avenue South borders it to the west (Figure 15).

Blaser Die Casting (Blaser) is east of the LDW, and is bordered on the north by South Orcas Street and on the south by South Mead Street. Capital Industries borders the property to the southeast and 3rd Avenue borders the property to the east (Figure 15).
