# **Lower Duwamish Waterway Source Control Action Plan for the Terminal 117 Early Action Area**

July 2005

Publication No. 05-09-093

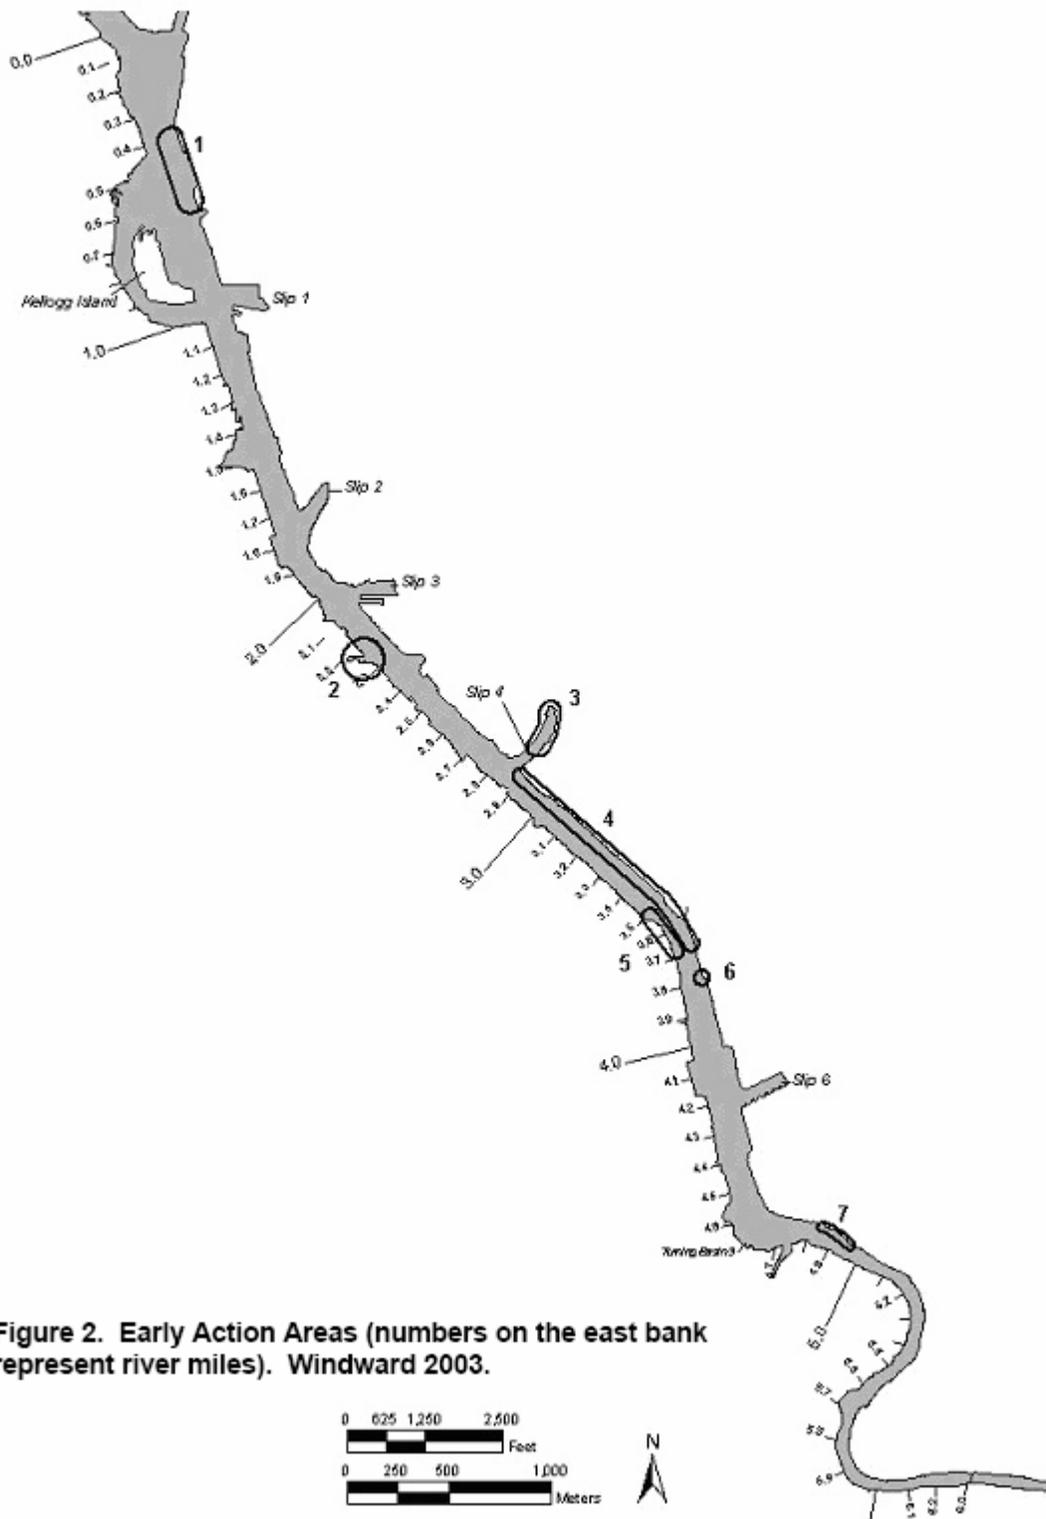
Figure 2. Early Action Areas (numbers on the east bank represent river miles). Windward 2003.

In June 2003, the Technical Memorandum: Data Analysis and Candidate Site Identification, Final (Windward 2003b) was issued. Seven candidate sites for early action were recommended (Figure 2). The sites are:

Terminal 117 is located on the west side of the Lower Duwamish Waterway (Figure 2) from approximately RM 3.5 to 3.7, as measured from the southern tip of Harbor Island. The Terminal covers approximately 2.9 acres including a 50-foot- to 60-foot-wide section of land adjacent to the shoreline, which is owned by the Port of Seattle as successor in interest to the King County Commercial Waterway District No. 1. In 1999, the Port of Seattle acquired the additional inland parcels owned by the Malarkey Asphalt Company. These properties were consolidated to form the present-day Terminal 117 property.
