**Lower Duwamish Waterway
RM 3.7-3.9 East
(Early Action Area 6)**

Source Control Action Plan

March 2009

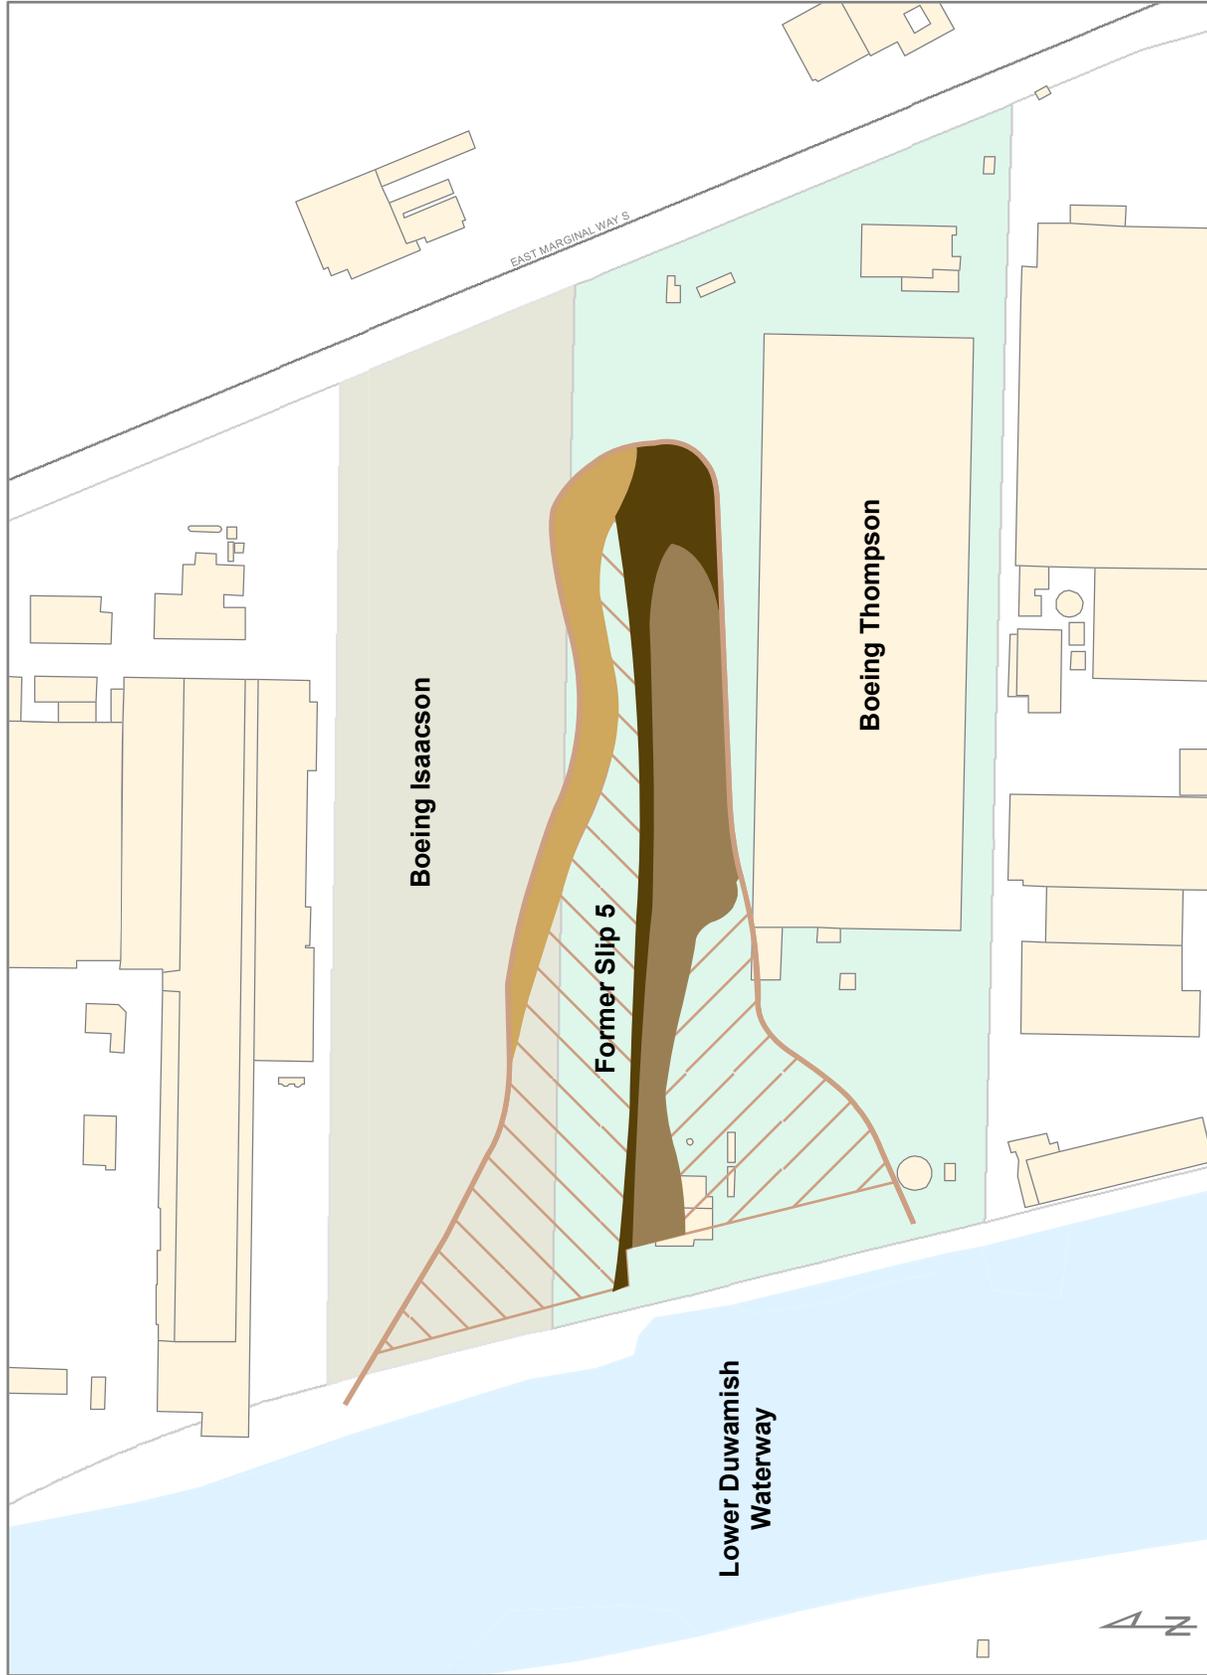
Figure 3. Slip 5 Fill History
 Source: Landau 1990
