Lower Duwamish Waterway RM 2.2 to 3.4 West (Riverside Drive)

Source Control Action Plan

August 2012

Toxics Cleanup Program
Northwest Regional Office
Washington State Department of Ecology
Bellevue, Washington

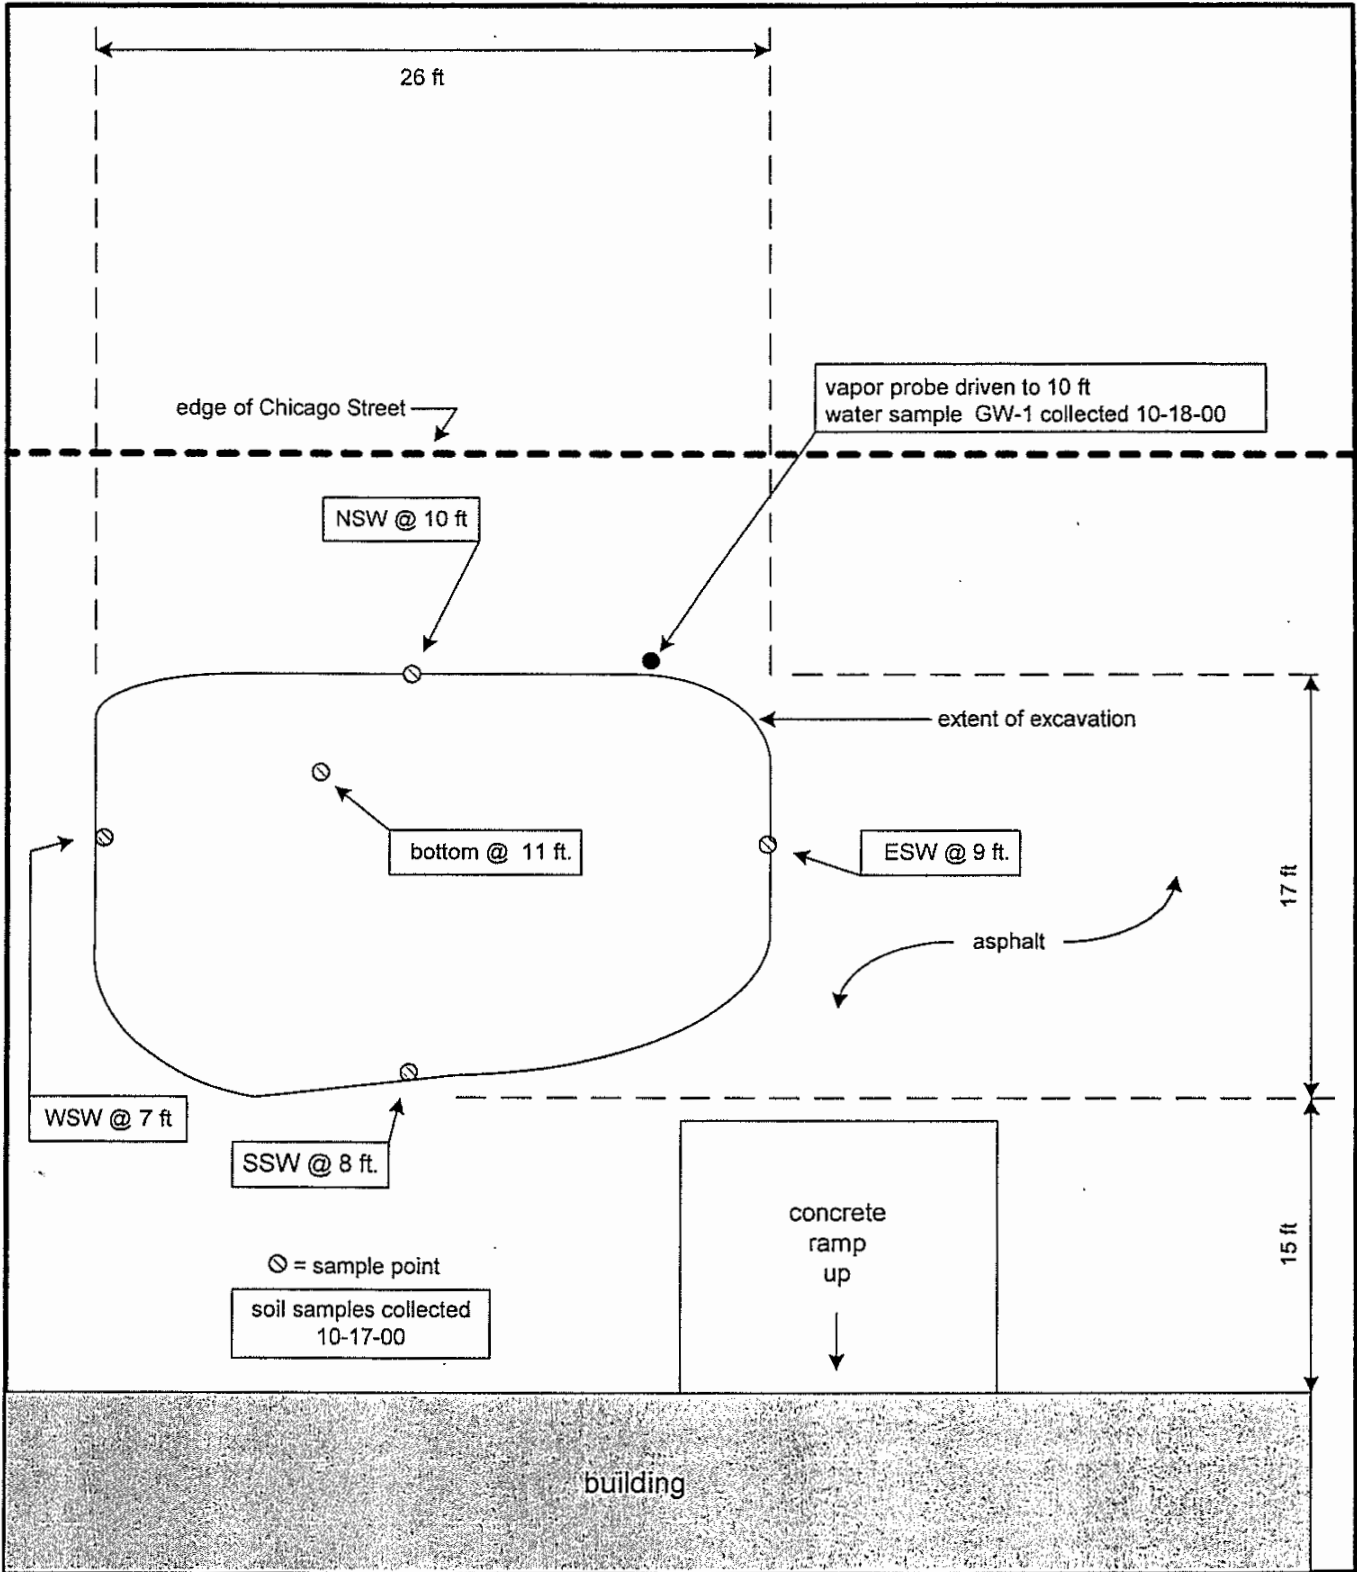
Figure 11. Olympic Steel Door Facility Map

Sampling Diagram
Olympic Steel Door
7800 7th Ave. S
Seattle, Washington
10-17/18-00 not to scale

In October 2000, 245 tons of petroleum-contaminated soil was excavated from the former UST location. One bottom and four sidewall soil samples were collected from the excavation (Figure 11). The samples were analyzed for gasoline-range hydrocarbons and BTEX. Analytical results indicated that some gasoline-contaminated soil remained along the southern sidewall of the excavation. Gasoline-range hydrocarbons and BTEX concentrations in an additional sample collected from the south sidewall were not detected or were below MTCA Method A cleanup levels. The excavation was backfilled with clean recycled concrete rubble and smaller gravel.

In February 2002, two push probe soil borings and groundwater samples were collected from beneath the Olympic Steel Door building and the asphalt parking lot on the northwest portion of the property. A groundwater sample was collected from a previously installed monitoring well, MW-3. Soil and groundwater samples were analyzed for gasoline-range hydrocarbons and BTEX. Gasoline-range hydrocarbons and BTEX were not detected in soil samples and were not detected or were below MTCA Method A cleanup levels in groundwater samples (Environmental Associates 2002). Sampling locations are presented in Figure 11.
