DEPARTMENT OF
ECOLOGY
State of Washington

Lower Duwamish Waterway RM 3.8 to 4.2 West (Sea King Industrial Park)

Source Control Action Plan

August 2013

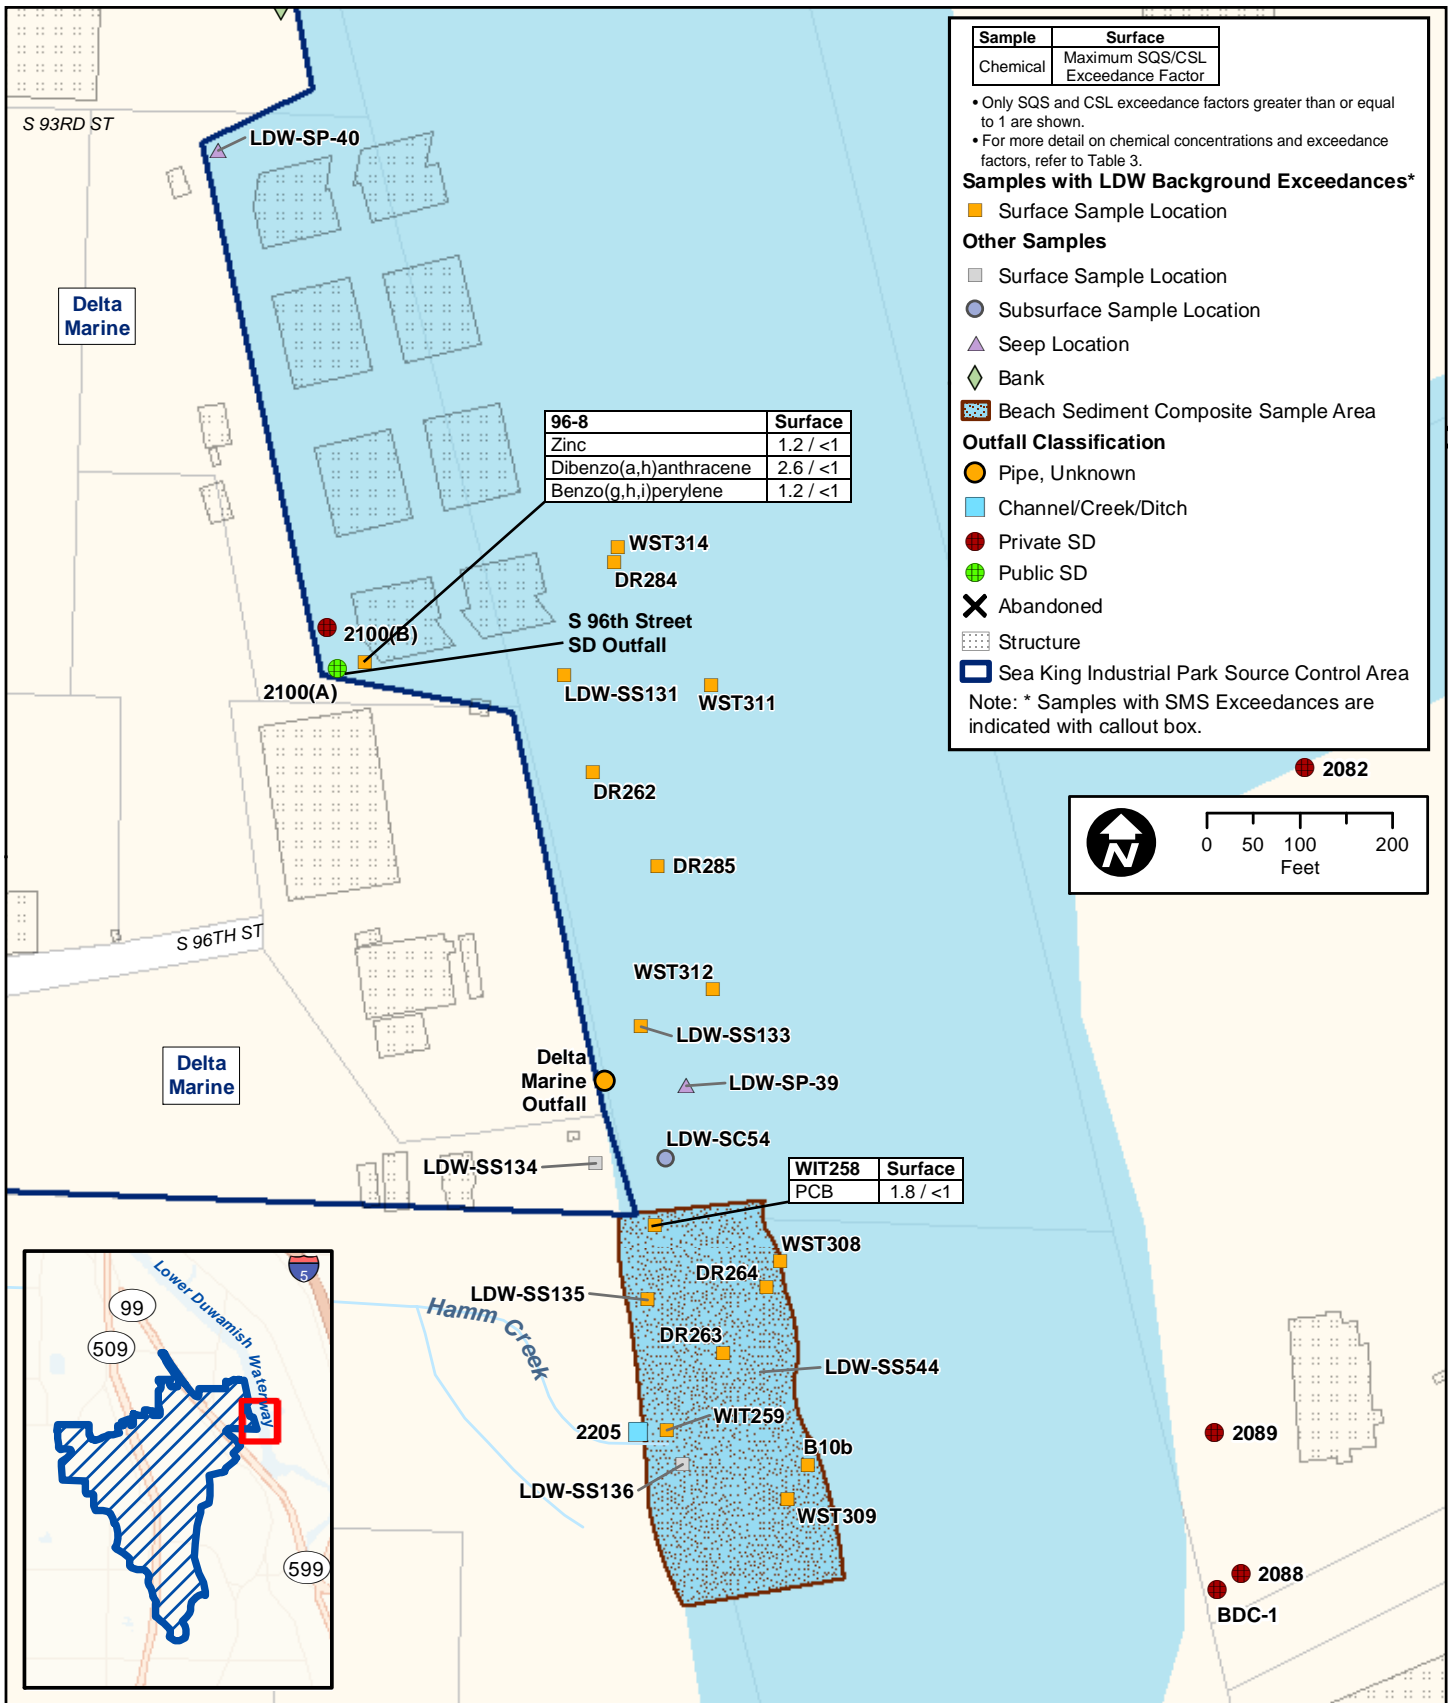
Sample	Surface
Chemical	Maximum SQS/CSL Exceedance Factor

- Only SQS and CSL exceedance factors greater than or equal to 1 are shown.
- For more detail on chemical concentrations and exceedance factors, refer to Table 3.

Note: * Samples with SMS Exceedances are indicated with callout box.

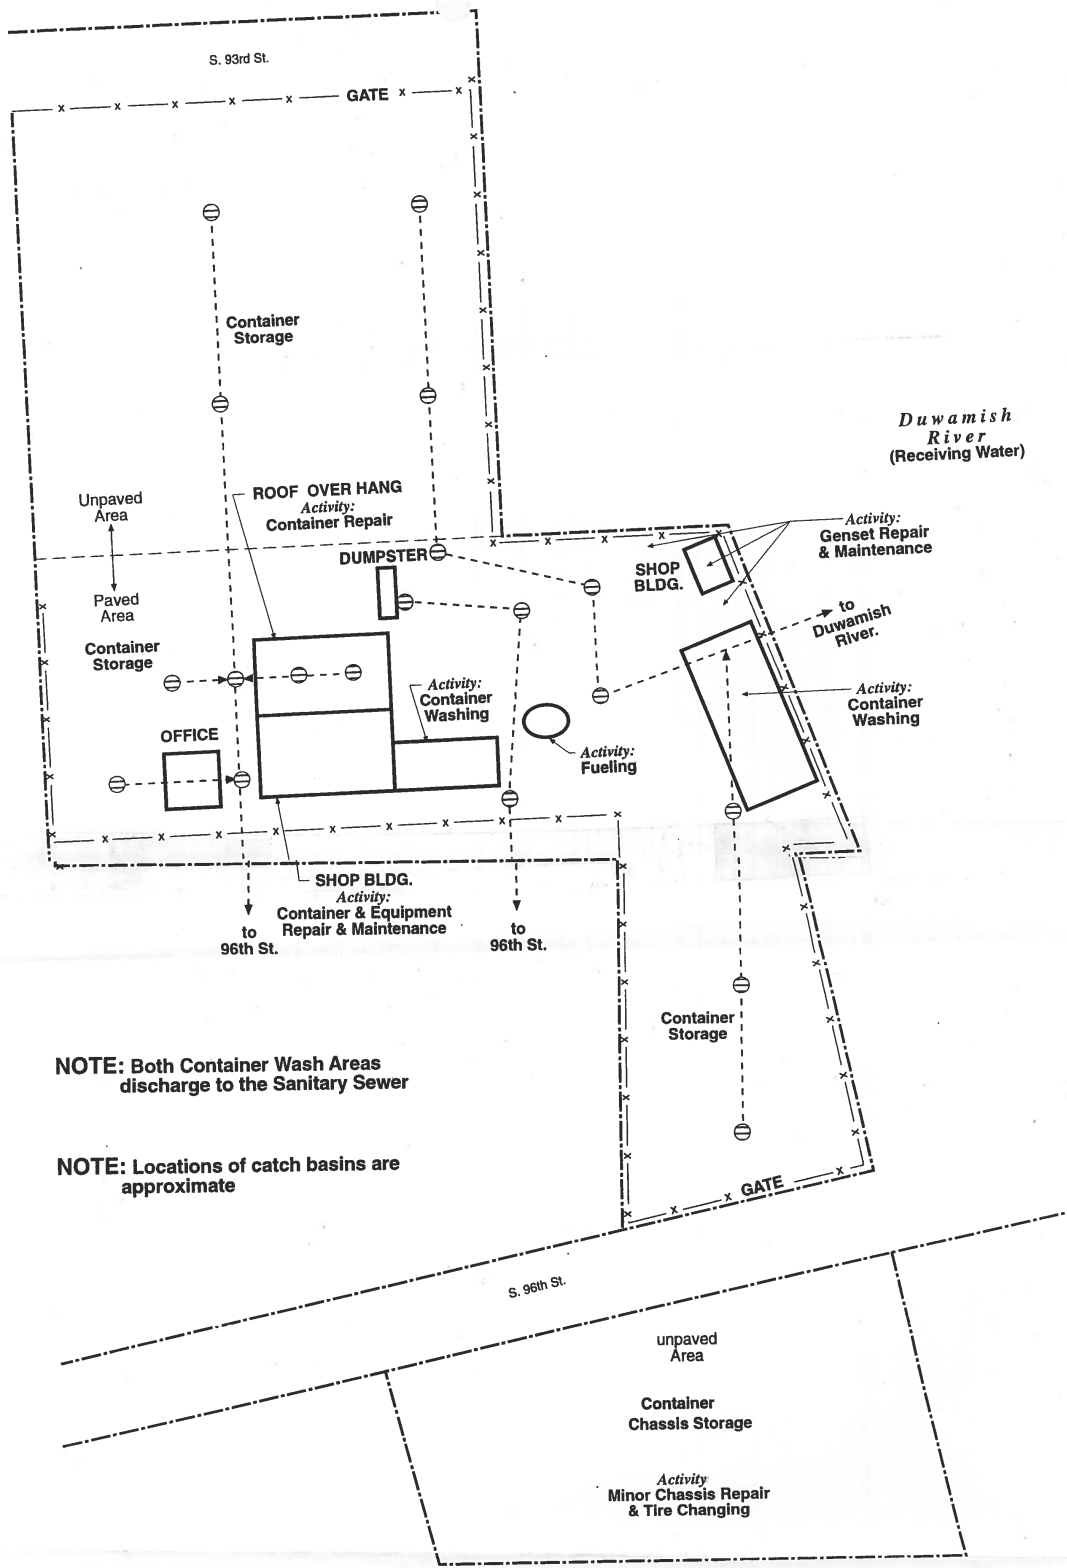
Figure 17a. Former Global Intermodal Facility Drainage Map

NOTE: Both Container Wash Areas discharge to the Sanitary Sewer

NOTE: Locations of catch basins are approximate
