Standard Operating Procedure EAP112, Version 1.1

Assessing Bank Erosion Vulnerability

April 2019 Publication 19-03-215 [Approved 2017]

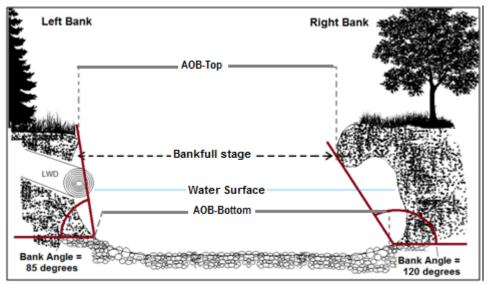
Figure 2. An example of a vertical bank angle (left) and of an overhung bank (right).

- 3.1 AOB-Top: Top angle observation boundary. This is the upper observation boundary at each bank of a major transect. Normally, this occurs at the first terrace at or above the bankfull stage. Exceptions are described within this SOP (Figures 2, 3, 4, and 5). Where no terrace is present, the AOB-Top is at 50 cm above the bankfull channel.

- 3.2 AOB-Bottom: Bottom angle observation boundary. This is the lower observation boundary at each bank of a major transect. Normally this occurs at the junction of the streambed and streambank. Exceptions are described within this SOP (Figures 2, 3, 4, and 5).

6.3 **Bank Angle** 6.3.1 **Identify the AOB-Top** on each bank. This will vary with bank type (see Figures 2, 3, and 4). 6.3.1.1 Where terraces occur within 50 cm of the bankfull margin: set the AOB-Top at the first flat depositional feature at or above the bankfull margin. 6.3.1.2 Where no terrace is present, set the **AOB-Top** at 50 cm above the bankfull channel. 6.3.1.3 Where there is an undercut bank (overhung bank), position the **AOB-Top** at the most streamward edge of the bank. 6.3.1.4 On depositional banks (e.g., point bars) where unconsolidated sediment obscures the terrace or bankfull margin, set the **AOB-Top** at the estimated bankfull margin, on the sediment pile (Figure 4, right side). 6.3.1.5 For depositional banks without an obscured bankfull margin (Figure 4, left side), set the **AOB-Top** normally (as in 6.3.1.1 and 6.3.1.2) 6.3.2 Identify the AOB-Bottom on each bank (Figures 2, 3, and 4). It will always be below the bankfull margin. 6.3.3 For most banks, The **AOB-Bottom** will normally be where the streambed meets the streambank. Use available clues such as: 6.3.3.1 Change in slope from relatively flat (streambed) to relatively vertical (streambank) 6.3.3.2 Change in substrate from relatively coarse (streambed) to relatively fine (streambank). 6.3.4 On depositional banks, where deposited sediment obscures the streambed/streambank transition (Figure 4), either 6.3.4.1 Set the **AOB-Bottom** on top of the deposition pile (if the pile is fully below the bankfull margin), or

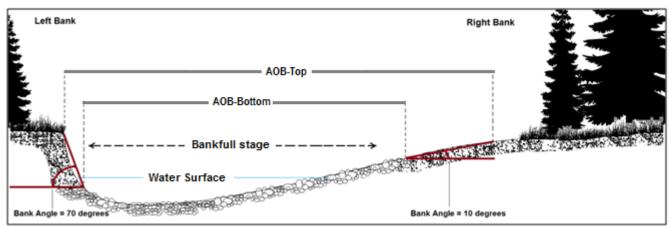
Figure 3. An example of a moderate bank (left) and a low bank (right).

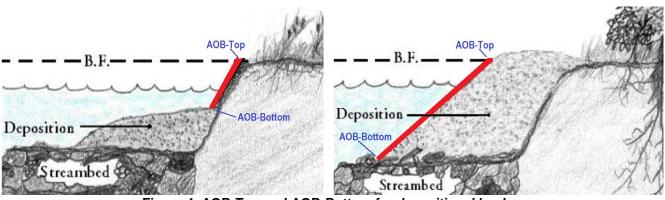
Figure 4. AOB-Top and AOB-Bottom for depositional banks.

| 3.7 | Cobble: Rocks of diameter size $>64 \text{ mm} - 250 \text{ mm}$. |
|---|---|
| 3.8 | Depositional banks: Banks with fresh fluvial deposits such as point bars. For this SOP, depositional banks are treated differently depending upon the size. When below the bankfull margin, the deposits are treated as part of the streambed. When deposits cover the terrace at or above bankfull margin, they are treated as part of the streambank (Figure 4). |

- 6.3.4.2 Set the **AOB-Bottom** on the streambed, adjacent to the pile (if pile extends above the bankfull margin or first terrace).
- 6.3.5 **Draw an imaginary line** from **AOB-Top** to **AOB-Bottom**, on each bank. Then imagine how each line intersects a horizontal plane.
- 6.3.6 **Estimate the angle** of this line relative to a horizontal plane. Record the bank angle (Figures 2, 3, and 5) according to the following categories:
- 6.3.6.1 Low (0–45°),
- 6.3.6.2 Moderate (46–80°),
- 6.3.6.3 Vertical (81–100°),
- 6.3.6.4 Overhung (>100°).

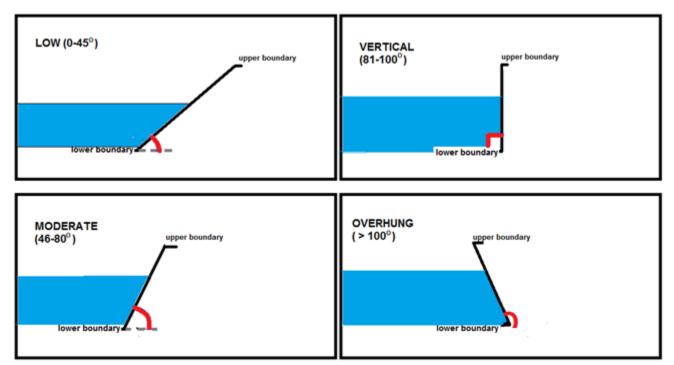
Figure 5. Bank angle categories.

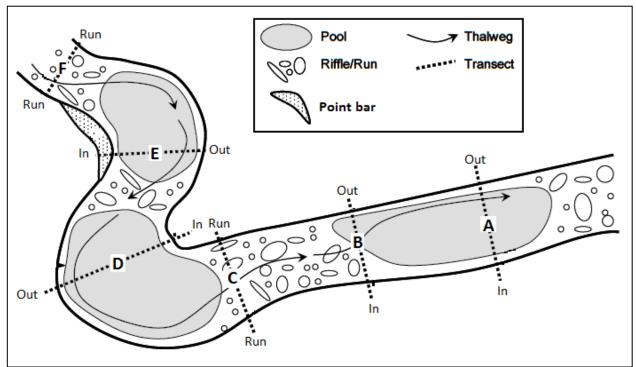
Figure 6. Hypothetical bank locations for six transects (A–F).

- 6.4 <u>Bank Location</u>: **In**, **Out**, or **Run**
- 6.4.1 Determine whether or not each major transect crosses a pool of any type.
- 6.4.2 If the transect does not cross a pool, record **Run** for both banks
- 6.4.3 If the transect crosses a pool, then determine which bank is closer to the thalweg.
- 6.4.3.1 The bank that is closer to the thalweg should be marked as **Out**, meaning the outside (erosional) part of a river bend (Figure 6).
- 6.4.3.2 The bank that is further from the thalweg should be marked as **In**, meaning the inside (depositional) part of a river bend (Figure 6).

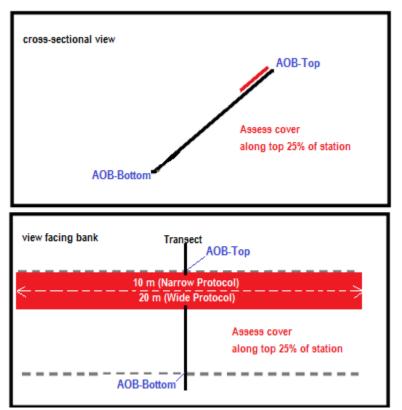
Figure 7. The bank station for assessing bank cover: cross-section view and view facing bank.

- 3.5 Bank station: For this SOP, we are describing an area of the bank that is centered on each major transect at each bank. It extends vertically from the AOB-Top to the AOB-Bottom. For the Narrow Protocol, it extends horizontally 5 meters upstream and downstream of the transect. For the Wide Protocol, it extends 10 meters upstream and downstream from the transect (Figure 7 and 9).

- 6.5 <u>Bank Cover Assessment</u> at top 25% of bank station.
- 6.5.1 At each bank, first establish the limits of the bank station (Figure 7). For the Narrow Protocol, it extends horizontally 5 meters upstream and downstream of the transect. For the Wide Protocol, it extends 10 meters upstream and downstream from the transect.

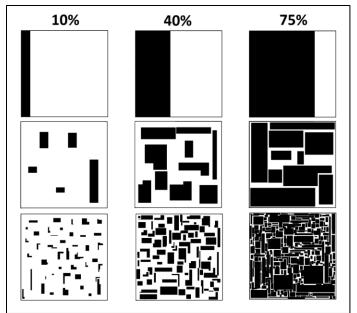
Figure 8. Comparison chart for 10%, 40%, and 75% cover.

- 6.5.2 At each bank along the top 25% of the station, estimate the cumulative percent bank cover (Figure 8) provided by any of the following cover types:
- 6.5.2.1 **Large rocks:** Cobble or larger rocks. Include bedrock and hardpan.
- 6.5.2.2 **Large woody debris:** Pieces should be at least 10 cm diameter and 1 m long (in eastern STRs) or 2 m long (western STRs).
- 6.5.2.3 Live roots or rooted, woody vegetation
- 6.5.3 Record *YES* for bank cover if the cover estimate is greater than 50%.
- 6.5.4 Record *NO* otherwise.

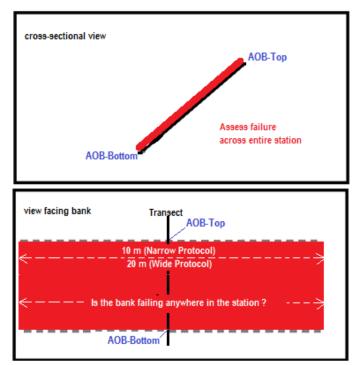
- 6.6 Bank Failure Assessment at full bank station.
- 6.6.1 Refer to the same bank station used for assessing bank cover.
- 6.6.2 Assess the entire station (Figure 9) for signs of bank failure. If you observe that the bank is cracking, fracturing, or slumping record *YES*. Otherwise, record *NO*.
