Underground Storage Tank Removal & Soil Remediation

Pacific Pride Facility (G&W Oil and Wood, Inc.) 903 West First Street Cle Ellum, Washington 98922

June 28, 1999

Assessment and Remediation Consulting Services (ARCS) 475 SE Sycamore Lane Issaquah, Washington 98027 (425) 837-0220 443- 7130

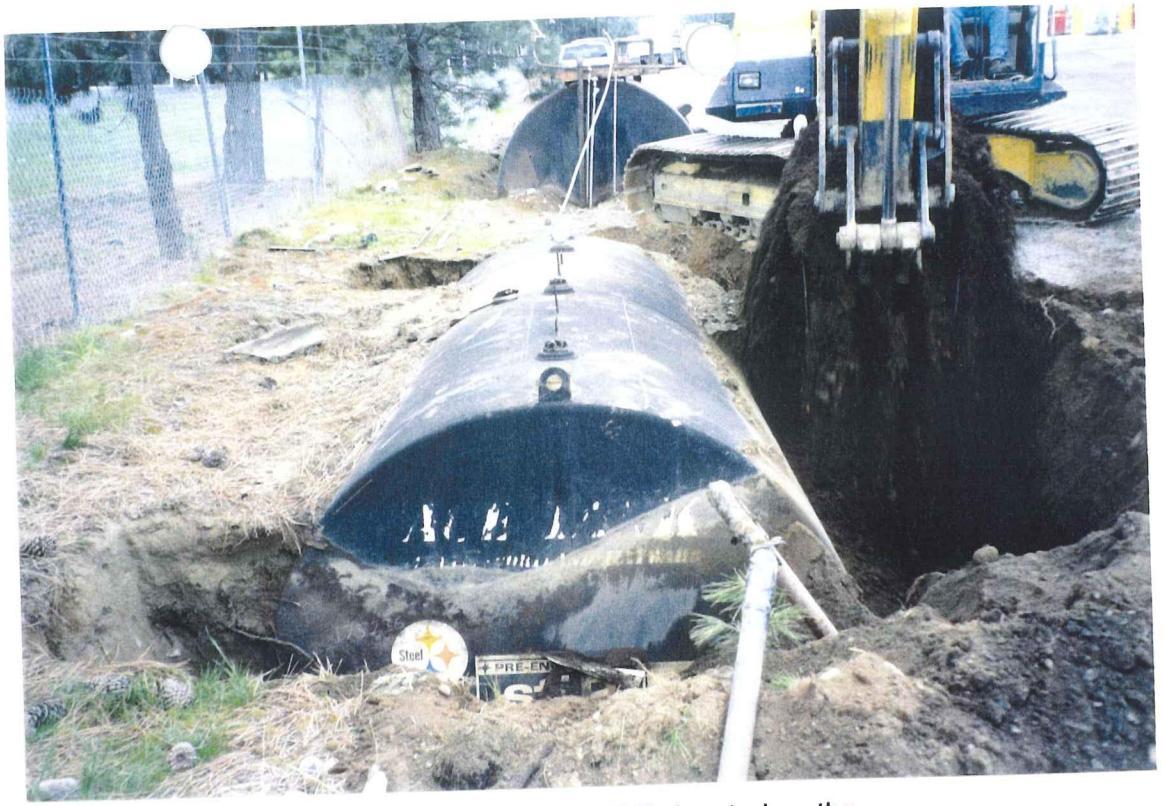
<u>Photograph 1</u>: View of gasoline and diesel USTs located on the east side of the property, looking west.

The 6,000-gallon gasoline tank and 12,000-gallon diesel tank were both partially exposed, with approximately 2/3 of the tank buried below surface grade (see photographs). A track-mounted excavator was used to excavate soil from the north side of each tank to allow for removal. As soils were excavated, a photo-ionization detector (PID) was used to monitor organic vapors. No organic vapors were detected in soils excavated from the sides of the gasoline or diesel USTs. In addition, no staining or petroleum odors were observed in the excavated soils.

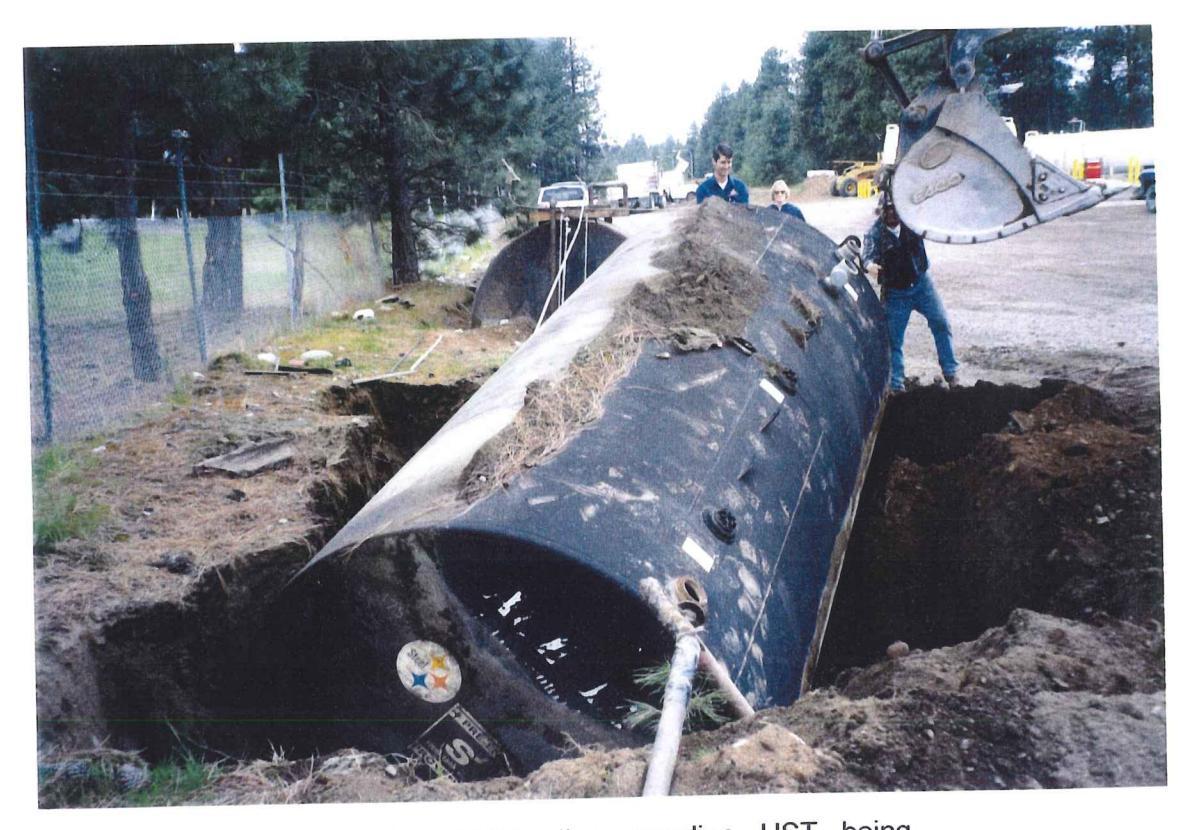
<u>Photograph 2</u>: View of the 6,000-gallon gasoline UST being removed from the excavation, looking west.

The USTs were removed using the excavator and placed on a level area near the excavations. The exteriors of the USTs were visually inspected for indications of holes or corrosion that may have allowed a release of product. No holes or excessive corrosion were observed on the exterior of either UST. The tanks were cut on site and the metal was later taken off-site for disposal.

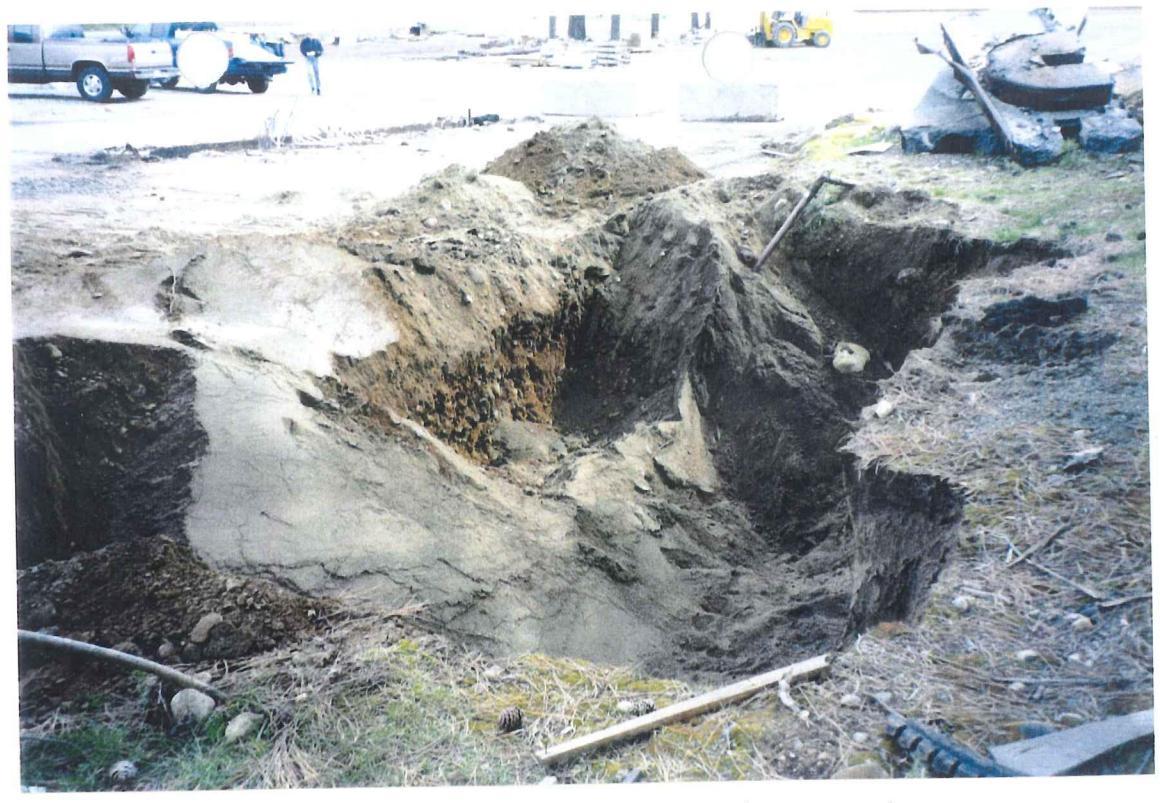
<u>Photograph 3</u>: View of the gasoline UST excavation after removal of the tank.

Soil samples were collected from the base and sidewalls of the UST excavations as described in a later section of this report. No visual or olfactory indications of contamination were observed in the gasoline UST excavation. There were, however, indications of petroleum-contamination in the diesel UST excavation. A further discussion of the extent of contamination is discussed in a separate section of this report.

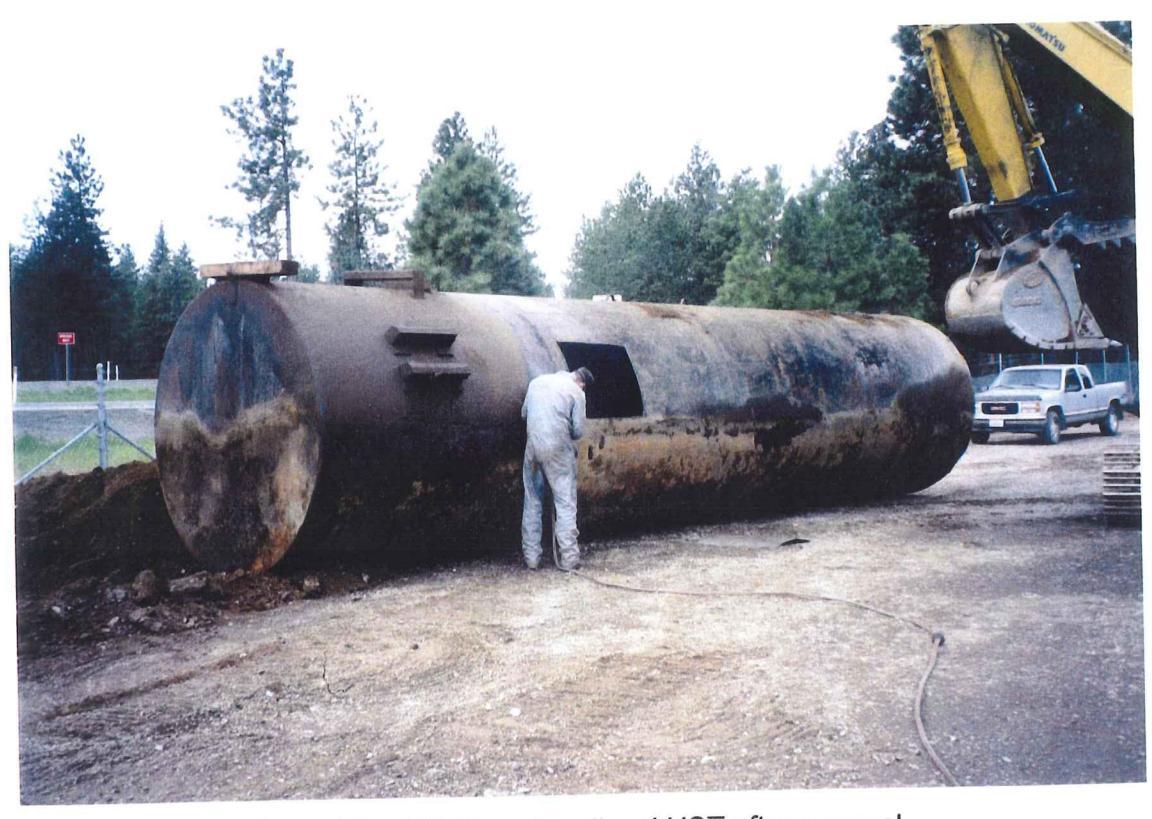
<u>Photograph 4</u>: View of the 12,000-gallon diesel UST after removal from the excavation, looking southwest.

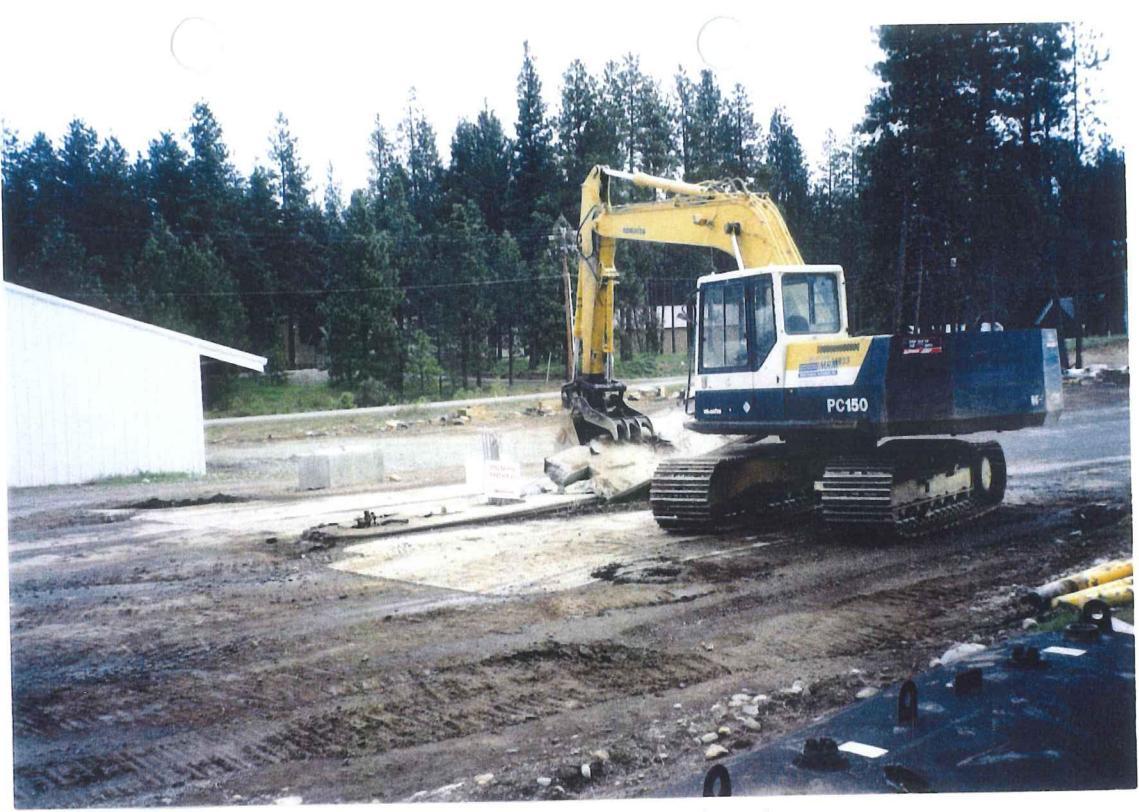
Photograph 5: View of the fueling area looking northeast.

The fueling area consisted of a central island that included three pumps; two pumps for diesel and one for gasoline. There were also two satellite diesel pumps located on either side of the fueling pad (see Site Diagram). The ground surface in the fueling area was covered with asphalt and concrete.

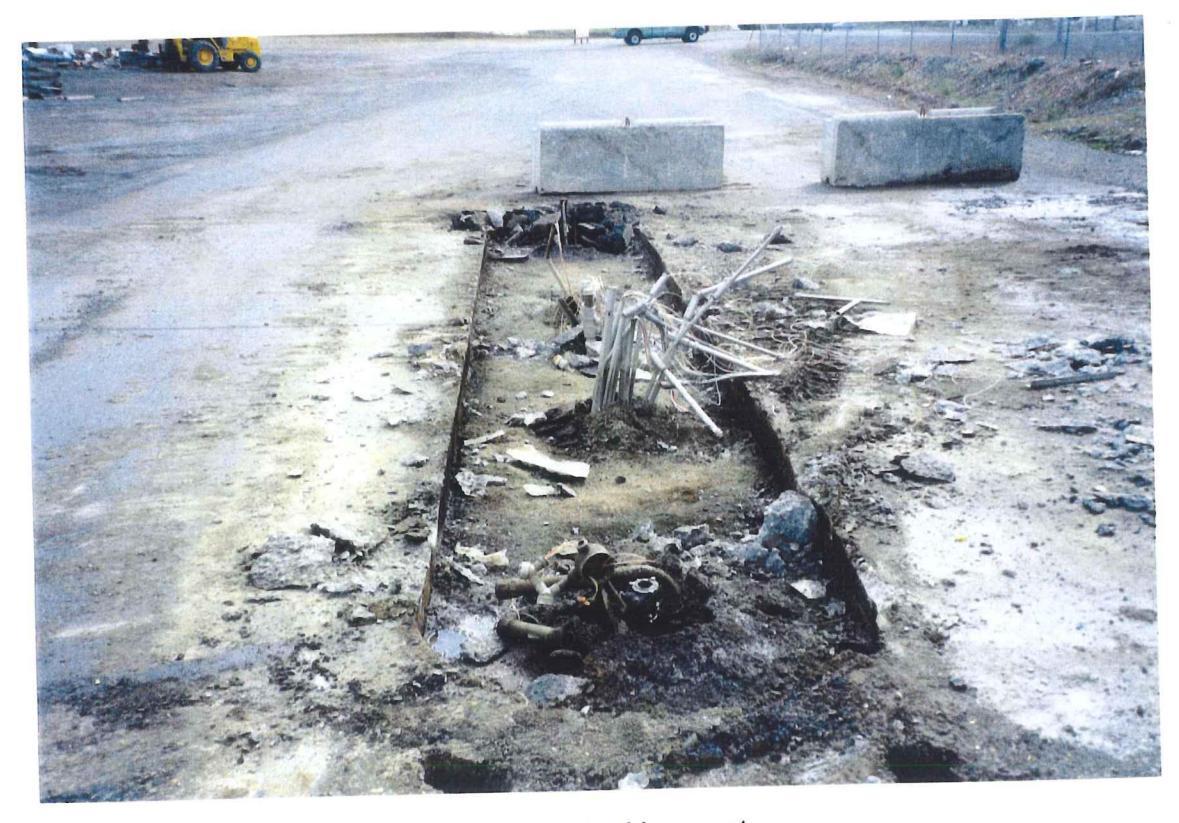
Photograph 6: View of the pump island, looking west..

Soils beneath the center island pumps and satellite pumps exhibited petroleum odors and staining. The contamination appeared to be limited to the area immediately surrounding and beneath the central fuel island, and directly beneath the satellite pumps. The contaminated material was excavated and stockpiled at a separate location on the property for remediation. Soil remediation activities are described in Section 2.4. Site assessment activities associated with the fuel island are described in section 2.5.

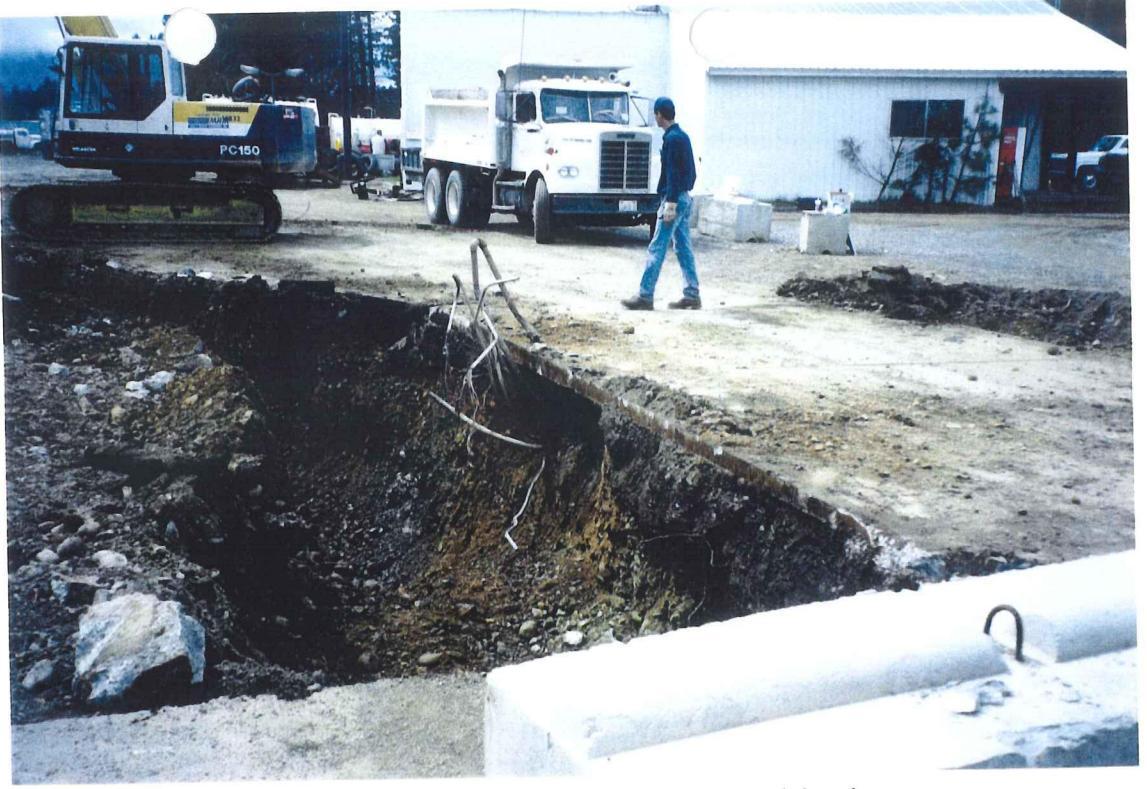
<u>Photograph 7</u>: View of area excavated beneath the pump island, looking northwest.

Soils from the diesel fuel UST area and the fuel island were excavated until indications of contamination diminished. Excavated soils were monitored using a PID and visual observations. Once the limits of contamination were achieved, soil samples were collected from the affected areas and submitted for laboratory analysis, as described in Section 2.5.

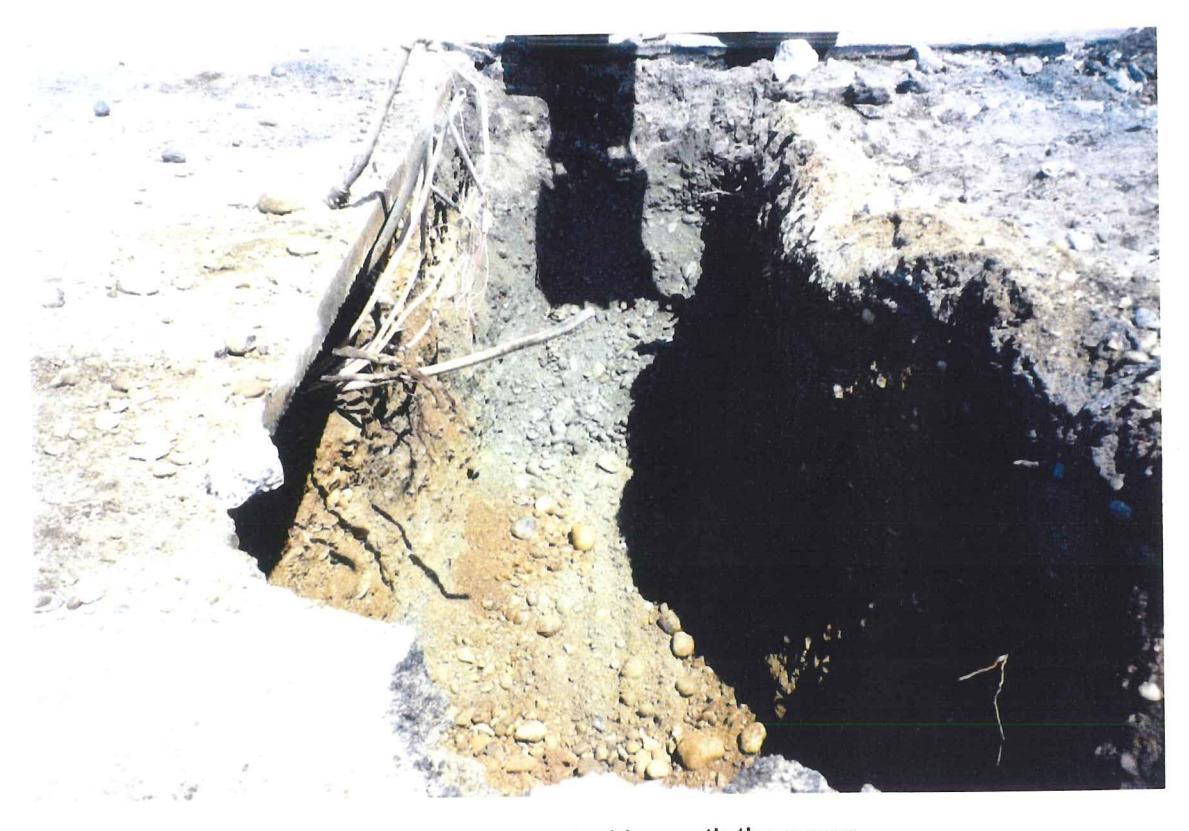
<u>Photograph 8</u>: View of the area excavated beneath the pump island, looking east.

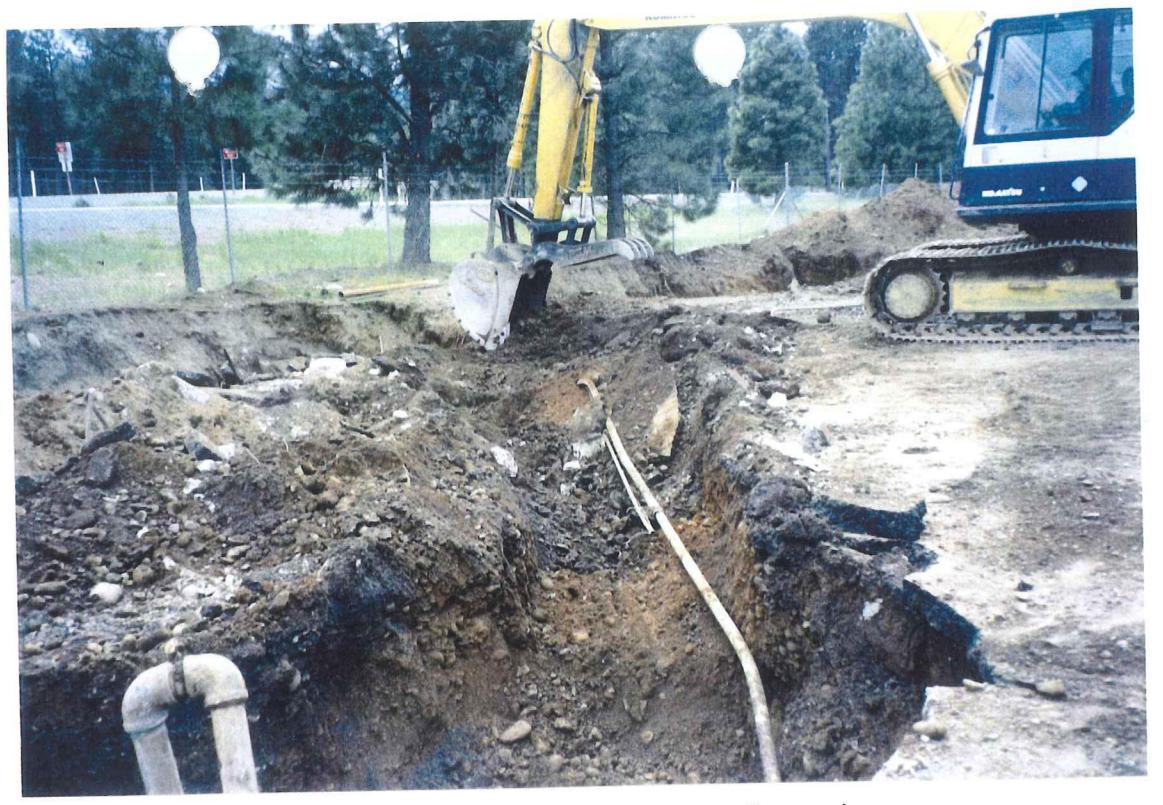
<u>Photograph 9</u>: View of the piping trenches for the gasoline and diesel USTs, looking southwest.

Each UST was connected to the former fuel island via underground piping. The piping from the gasoline UST located in the south side of the property was constructed of fiberglass. Piping connected to the other USTs was constructed of single-wall steel. All accessible piping was removed.

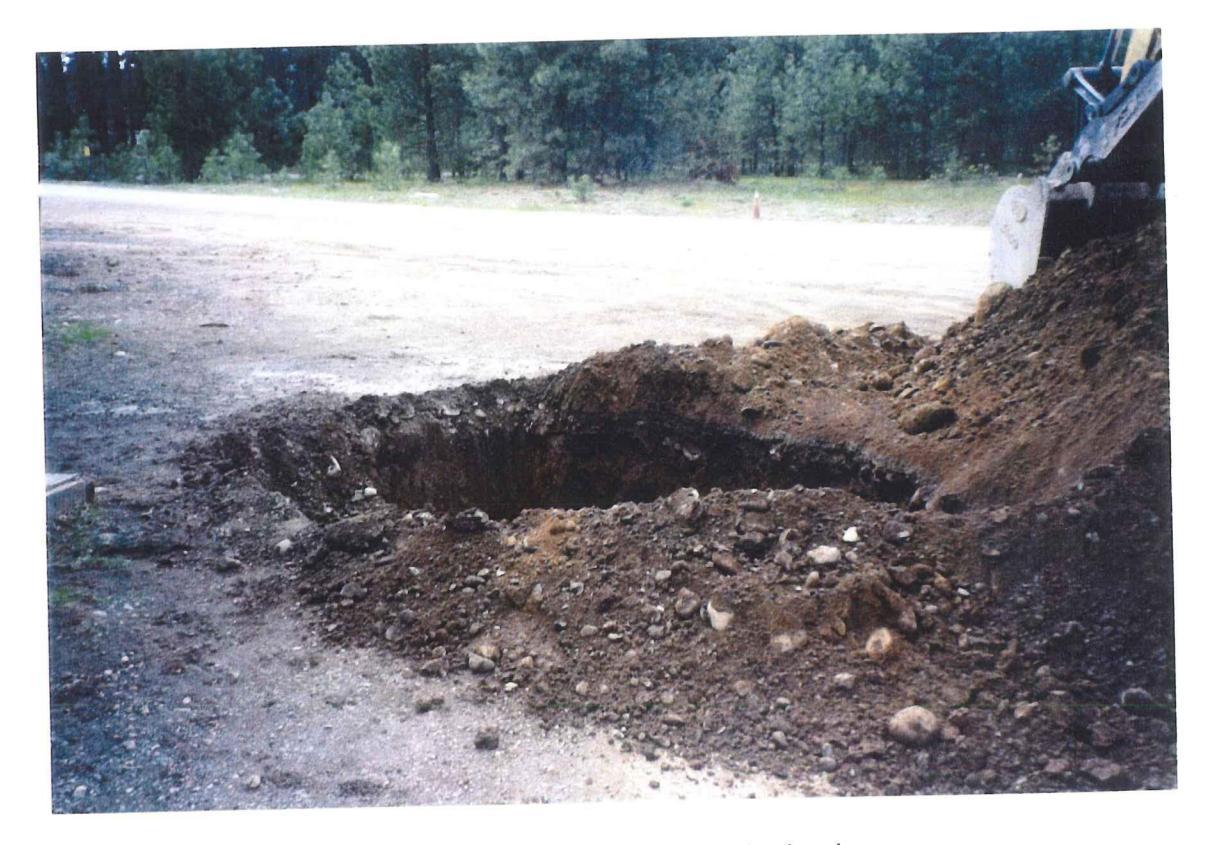
<u>Photograph 10</u>: View of the test pit completed near the in-place UST closures.

Soils near the in-place USTs closures were assessed by advancing test pits near the tanks. The test pits were completed using a track-mounted excavator. Soil samples collected from the test pits were screened for organic vapors using a PID and submitted for laboratory analysis.

The first test pit was advanced on the east side of the USTs, as indicated on the Site Diagram. At approximately 4 feet below surface grade (bsg), the excavator encountered an immovable object that may have been an underground utility, boulder, or one of the USTs. Because of known utilities located south and further east of the tanks, it was not possible to complete another test pit in the area.

The second test pit (GT2-TP) was completed on the north side of the USTs, approximately 2 feet from the fill tubes. The test pit was advanced to a depth of 8 feet bsg. A discreet soil sample was collected from between 7 and 8 feet bsg. No organic vapors were detected in the sample. One sample (GT2-TP-7) was submitted for laboratory analysis. The soil sample was collected following the procedure described previously. Laboratory analytical methods and results are presented in Section 3.0.
