#### **Re:** Sundance Golf Course – VCP Update

Fulcrum Environmental Consulting, Inc. (Fulcrum) has been retained by the owner of the former Sundance Golf Course to assist in environmental characterization and remediation of the site as it transitions to a residential development. The site is located at 9725 North Nine Mile Road in Nine Mile Falls, Washington, and is approximately 89 acres in size. Fulcrum has provided the following environmental services in support of site development.

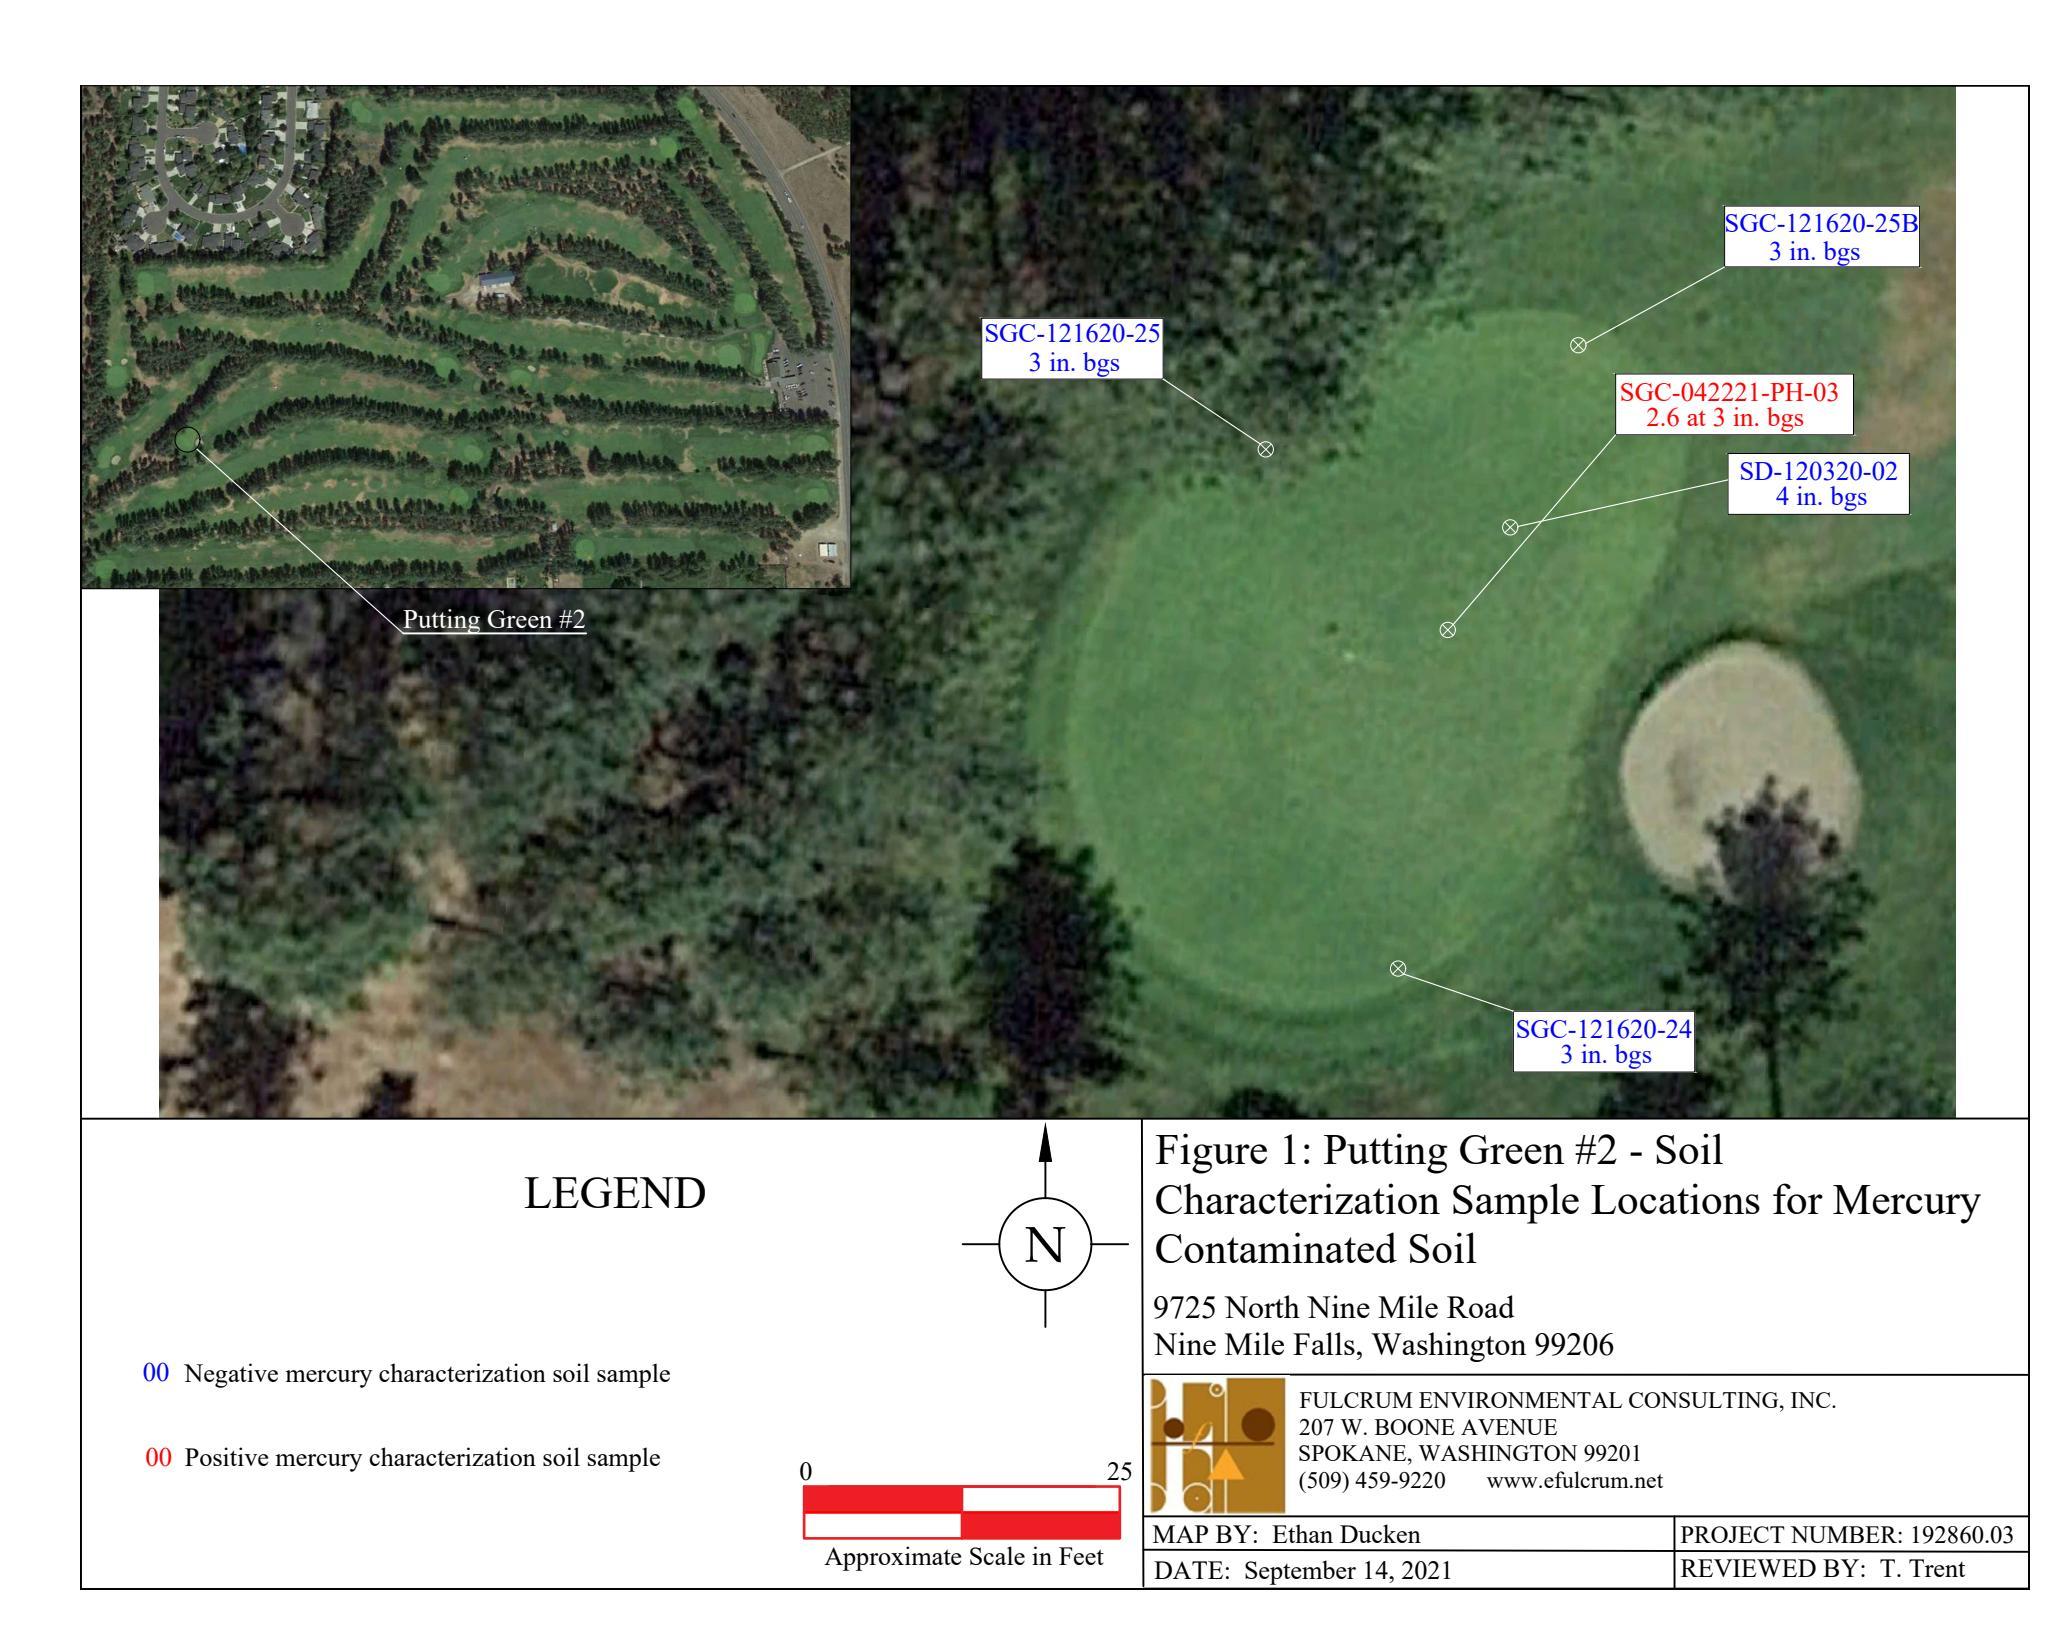
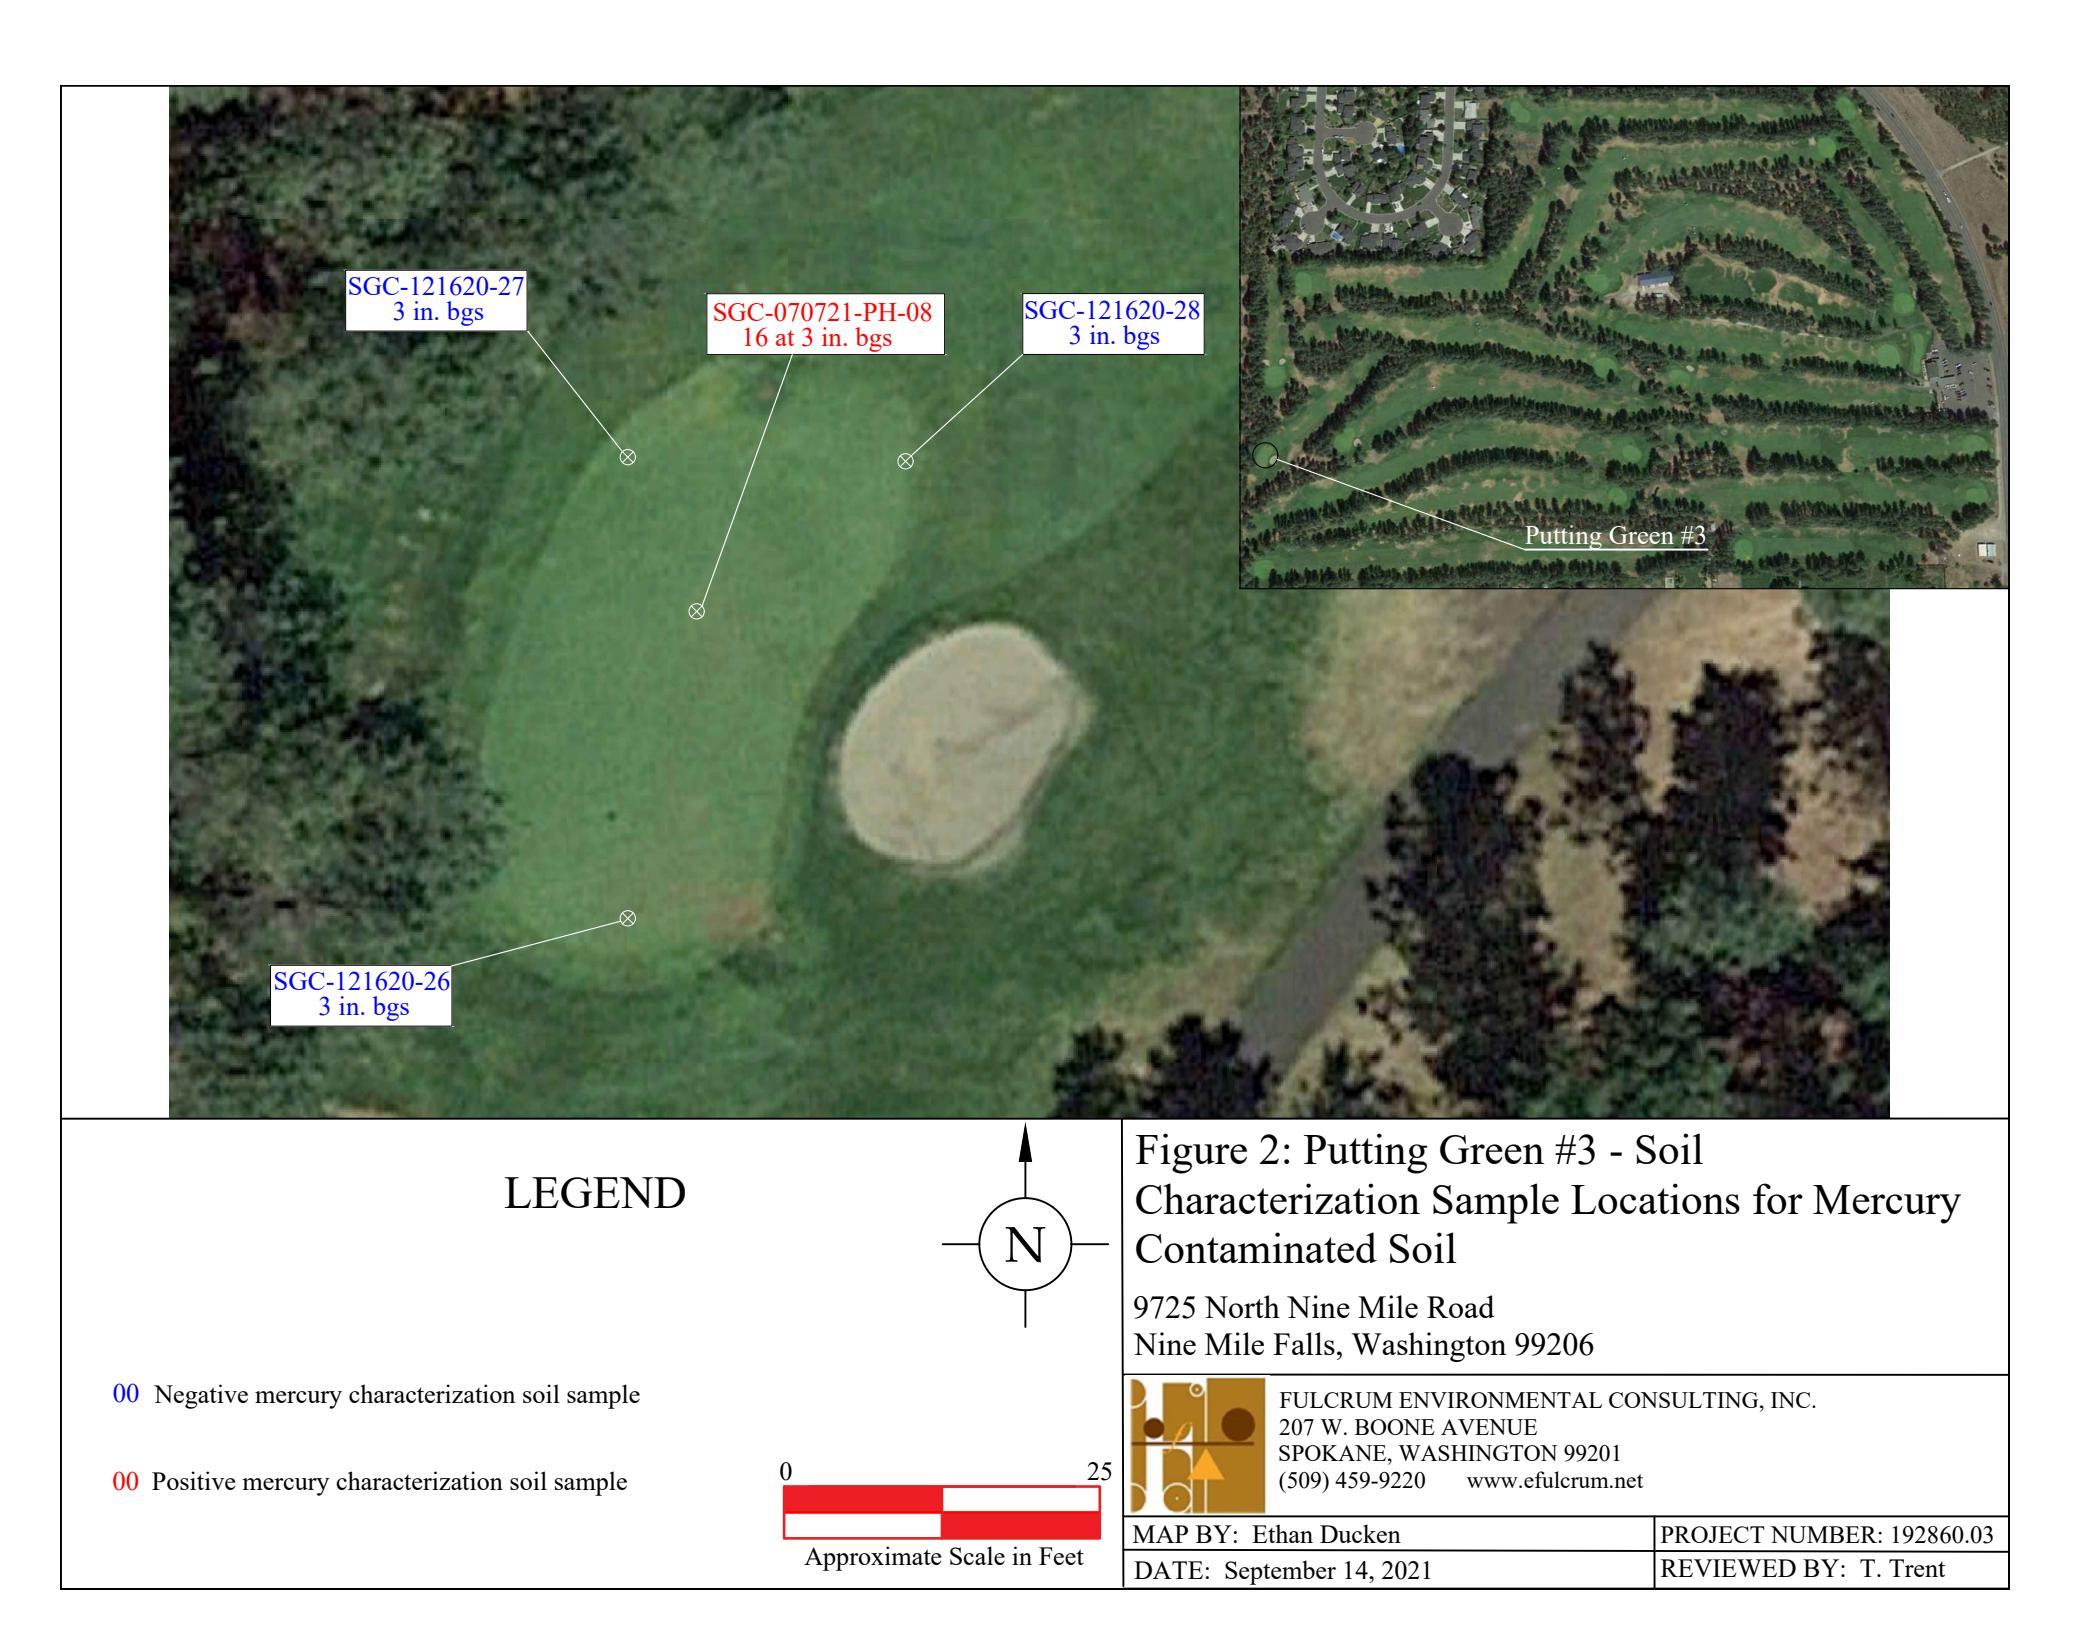
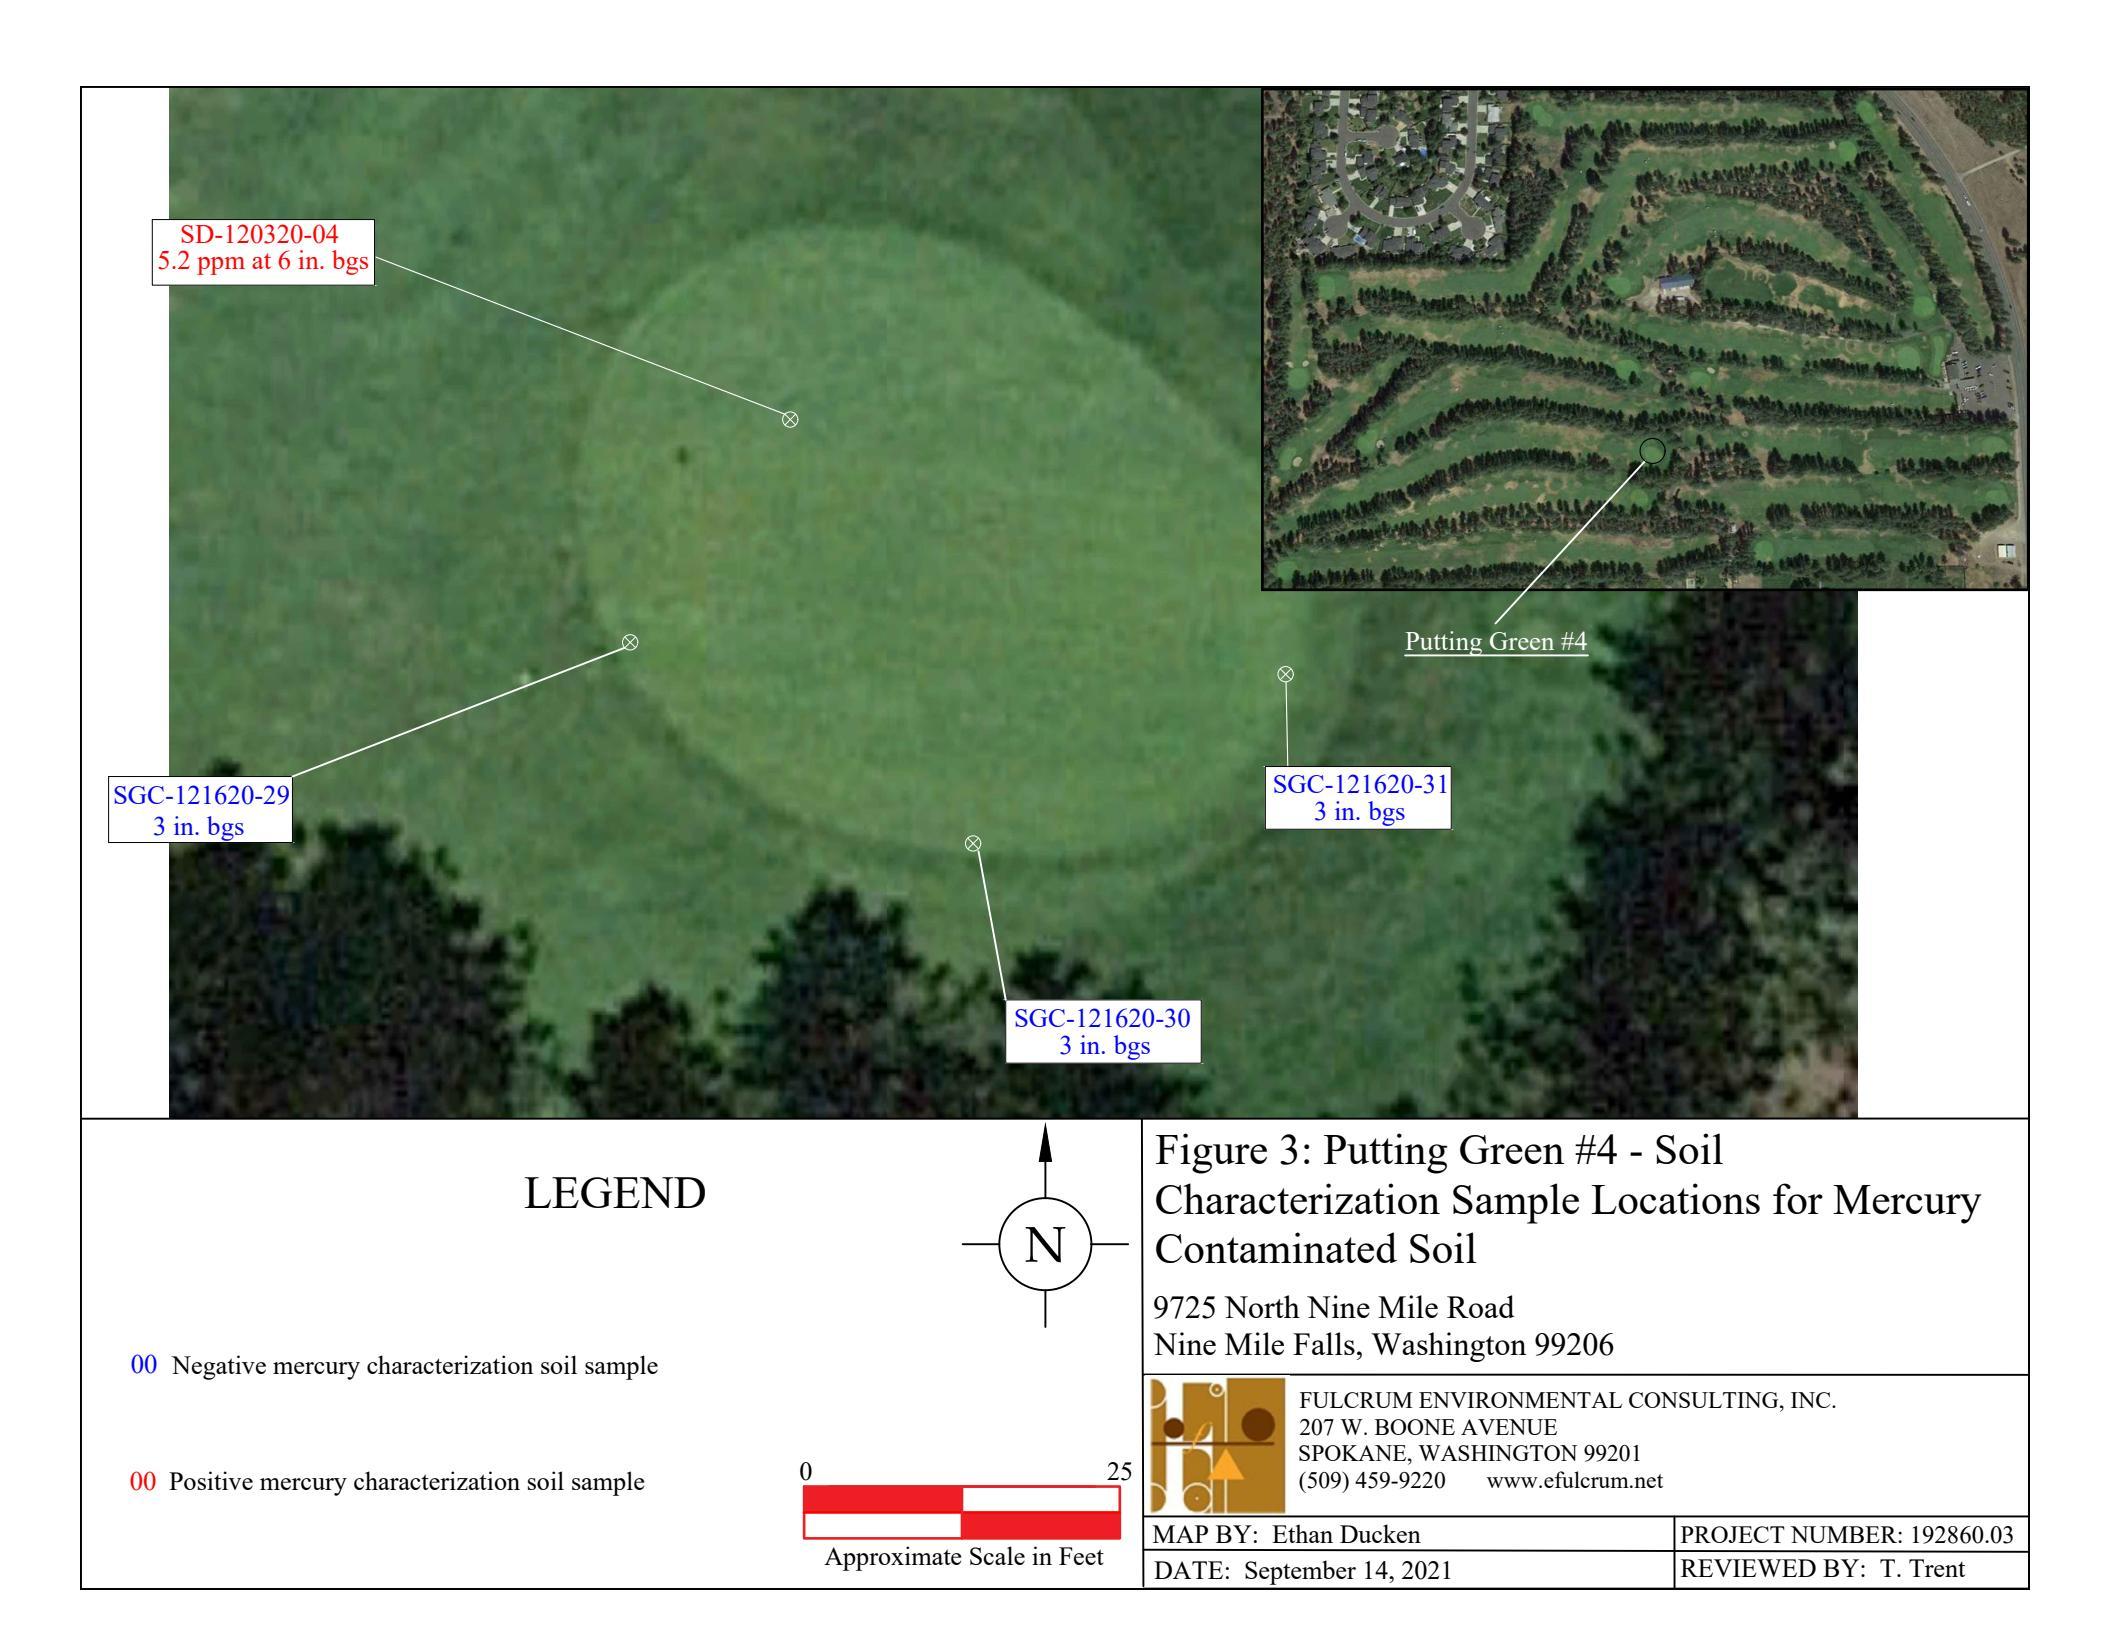
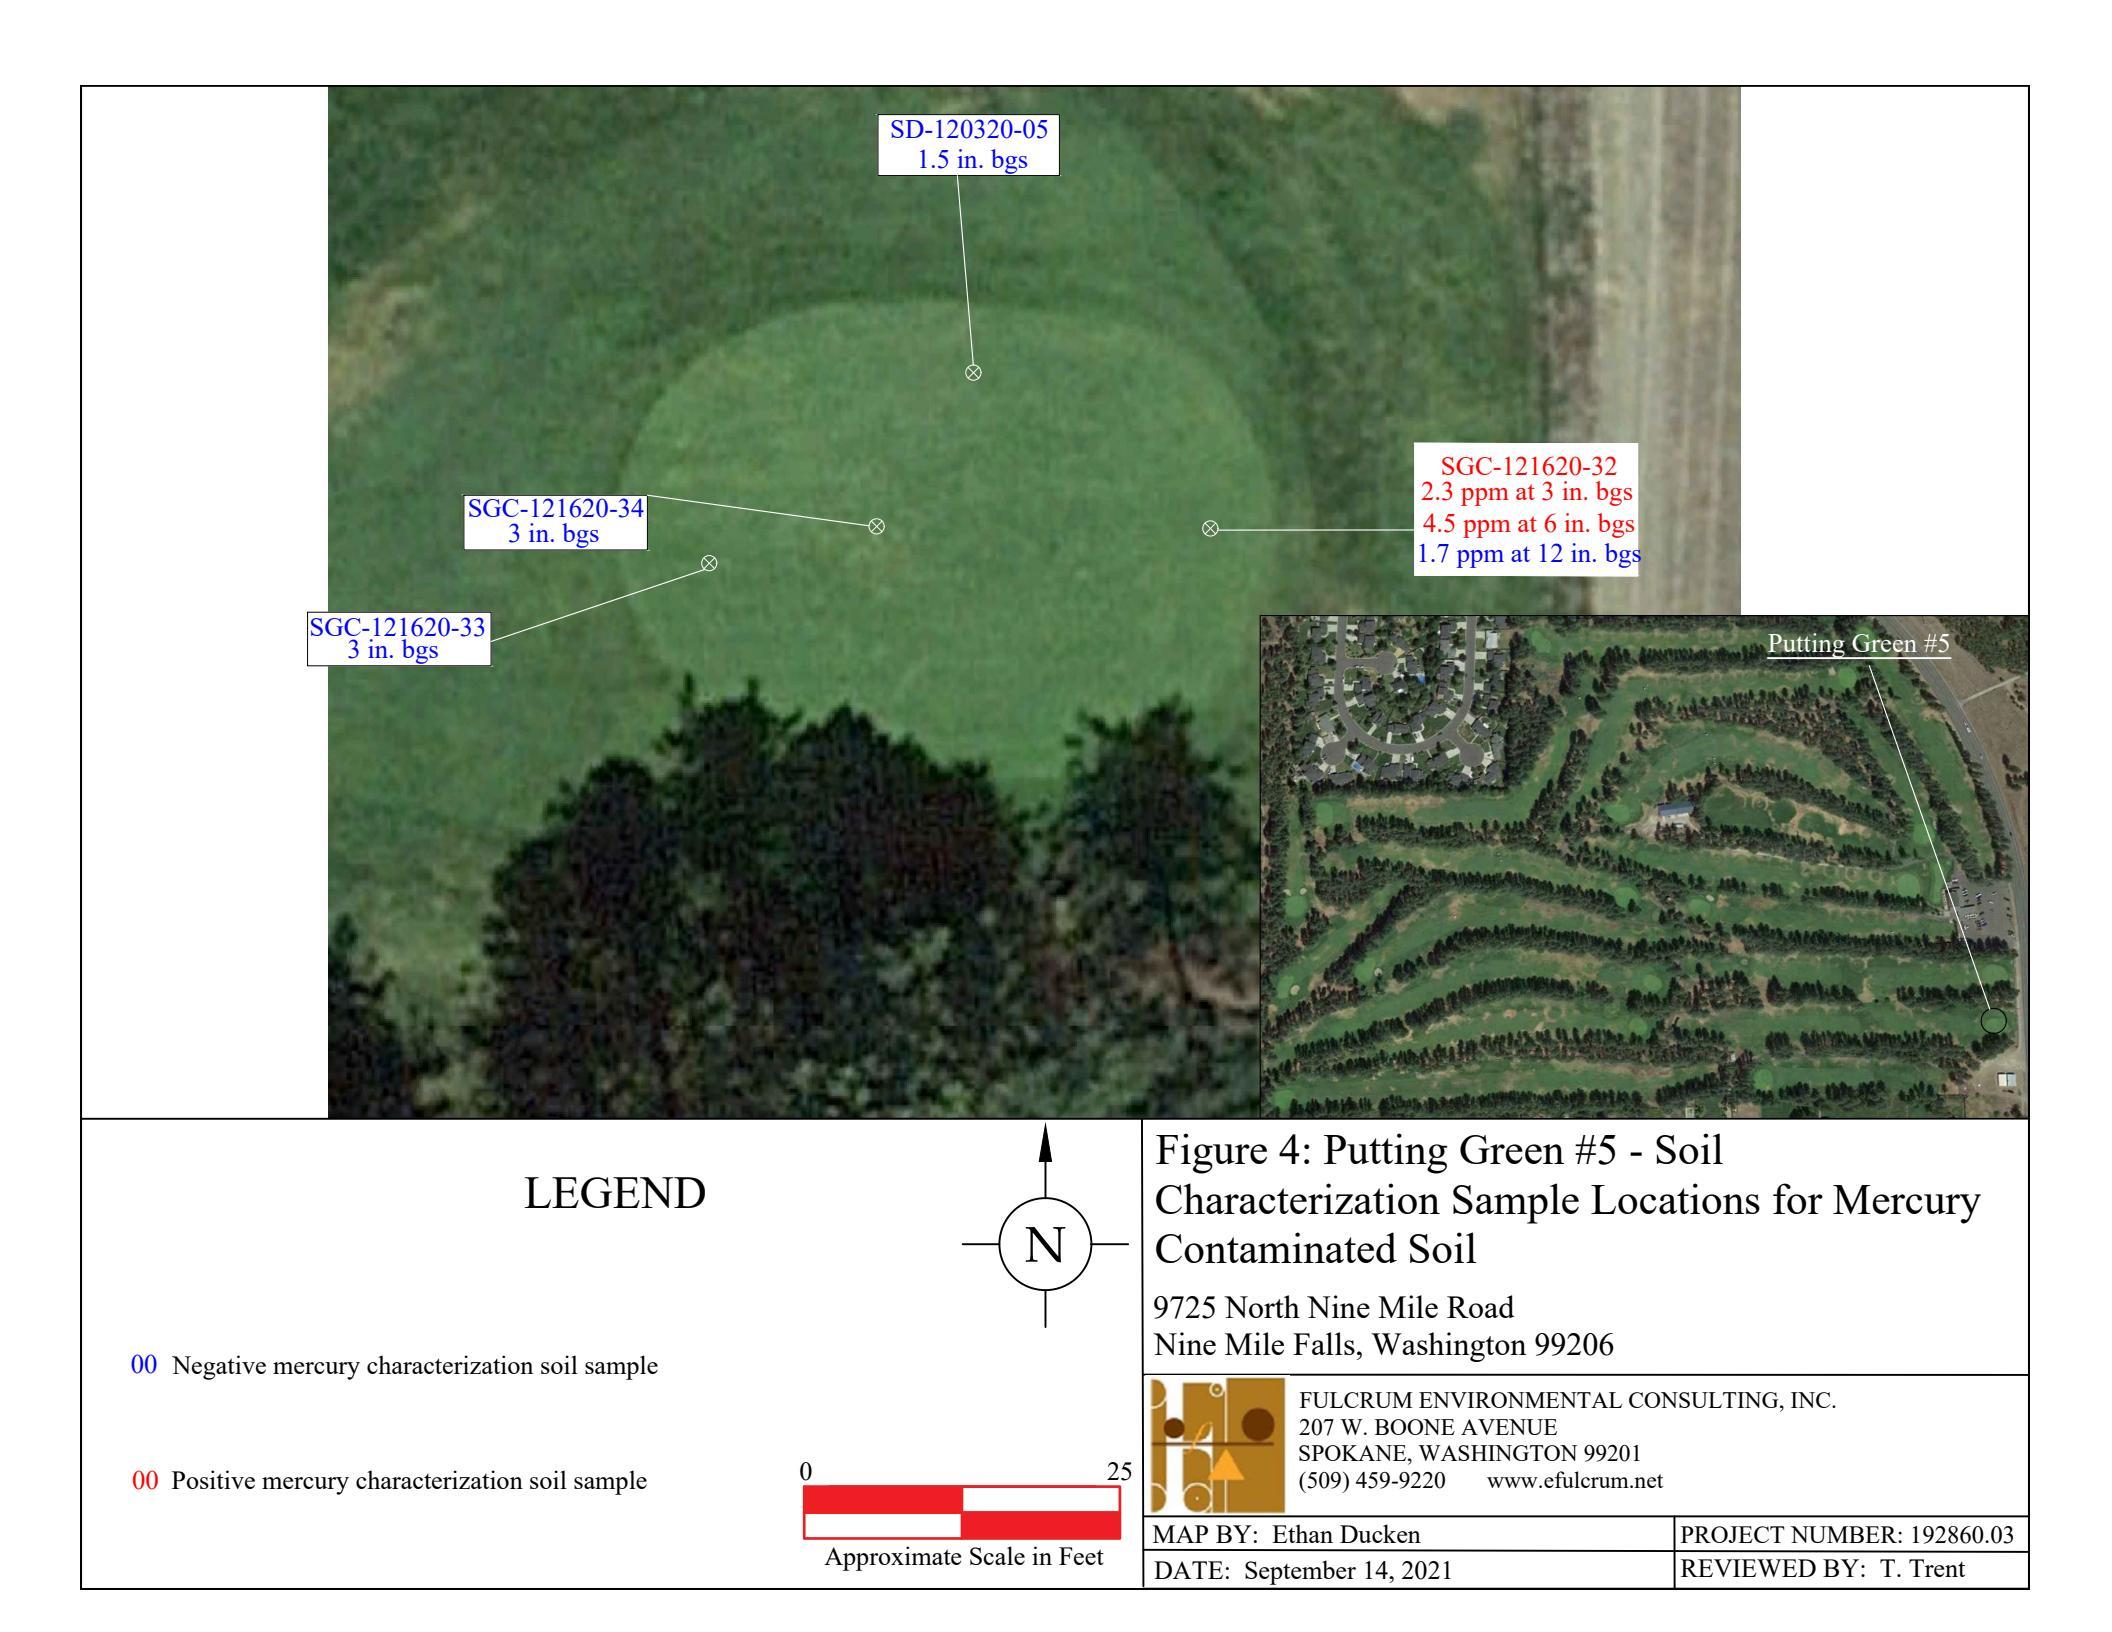
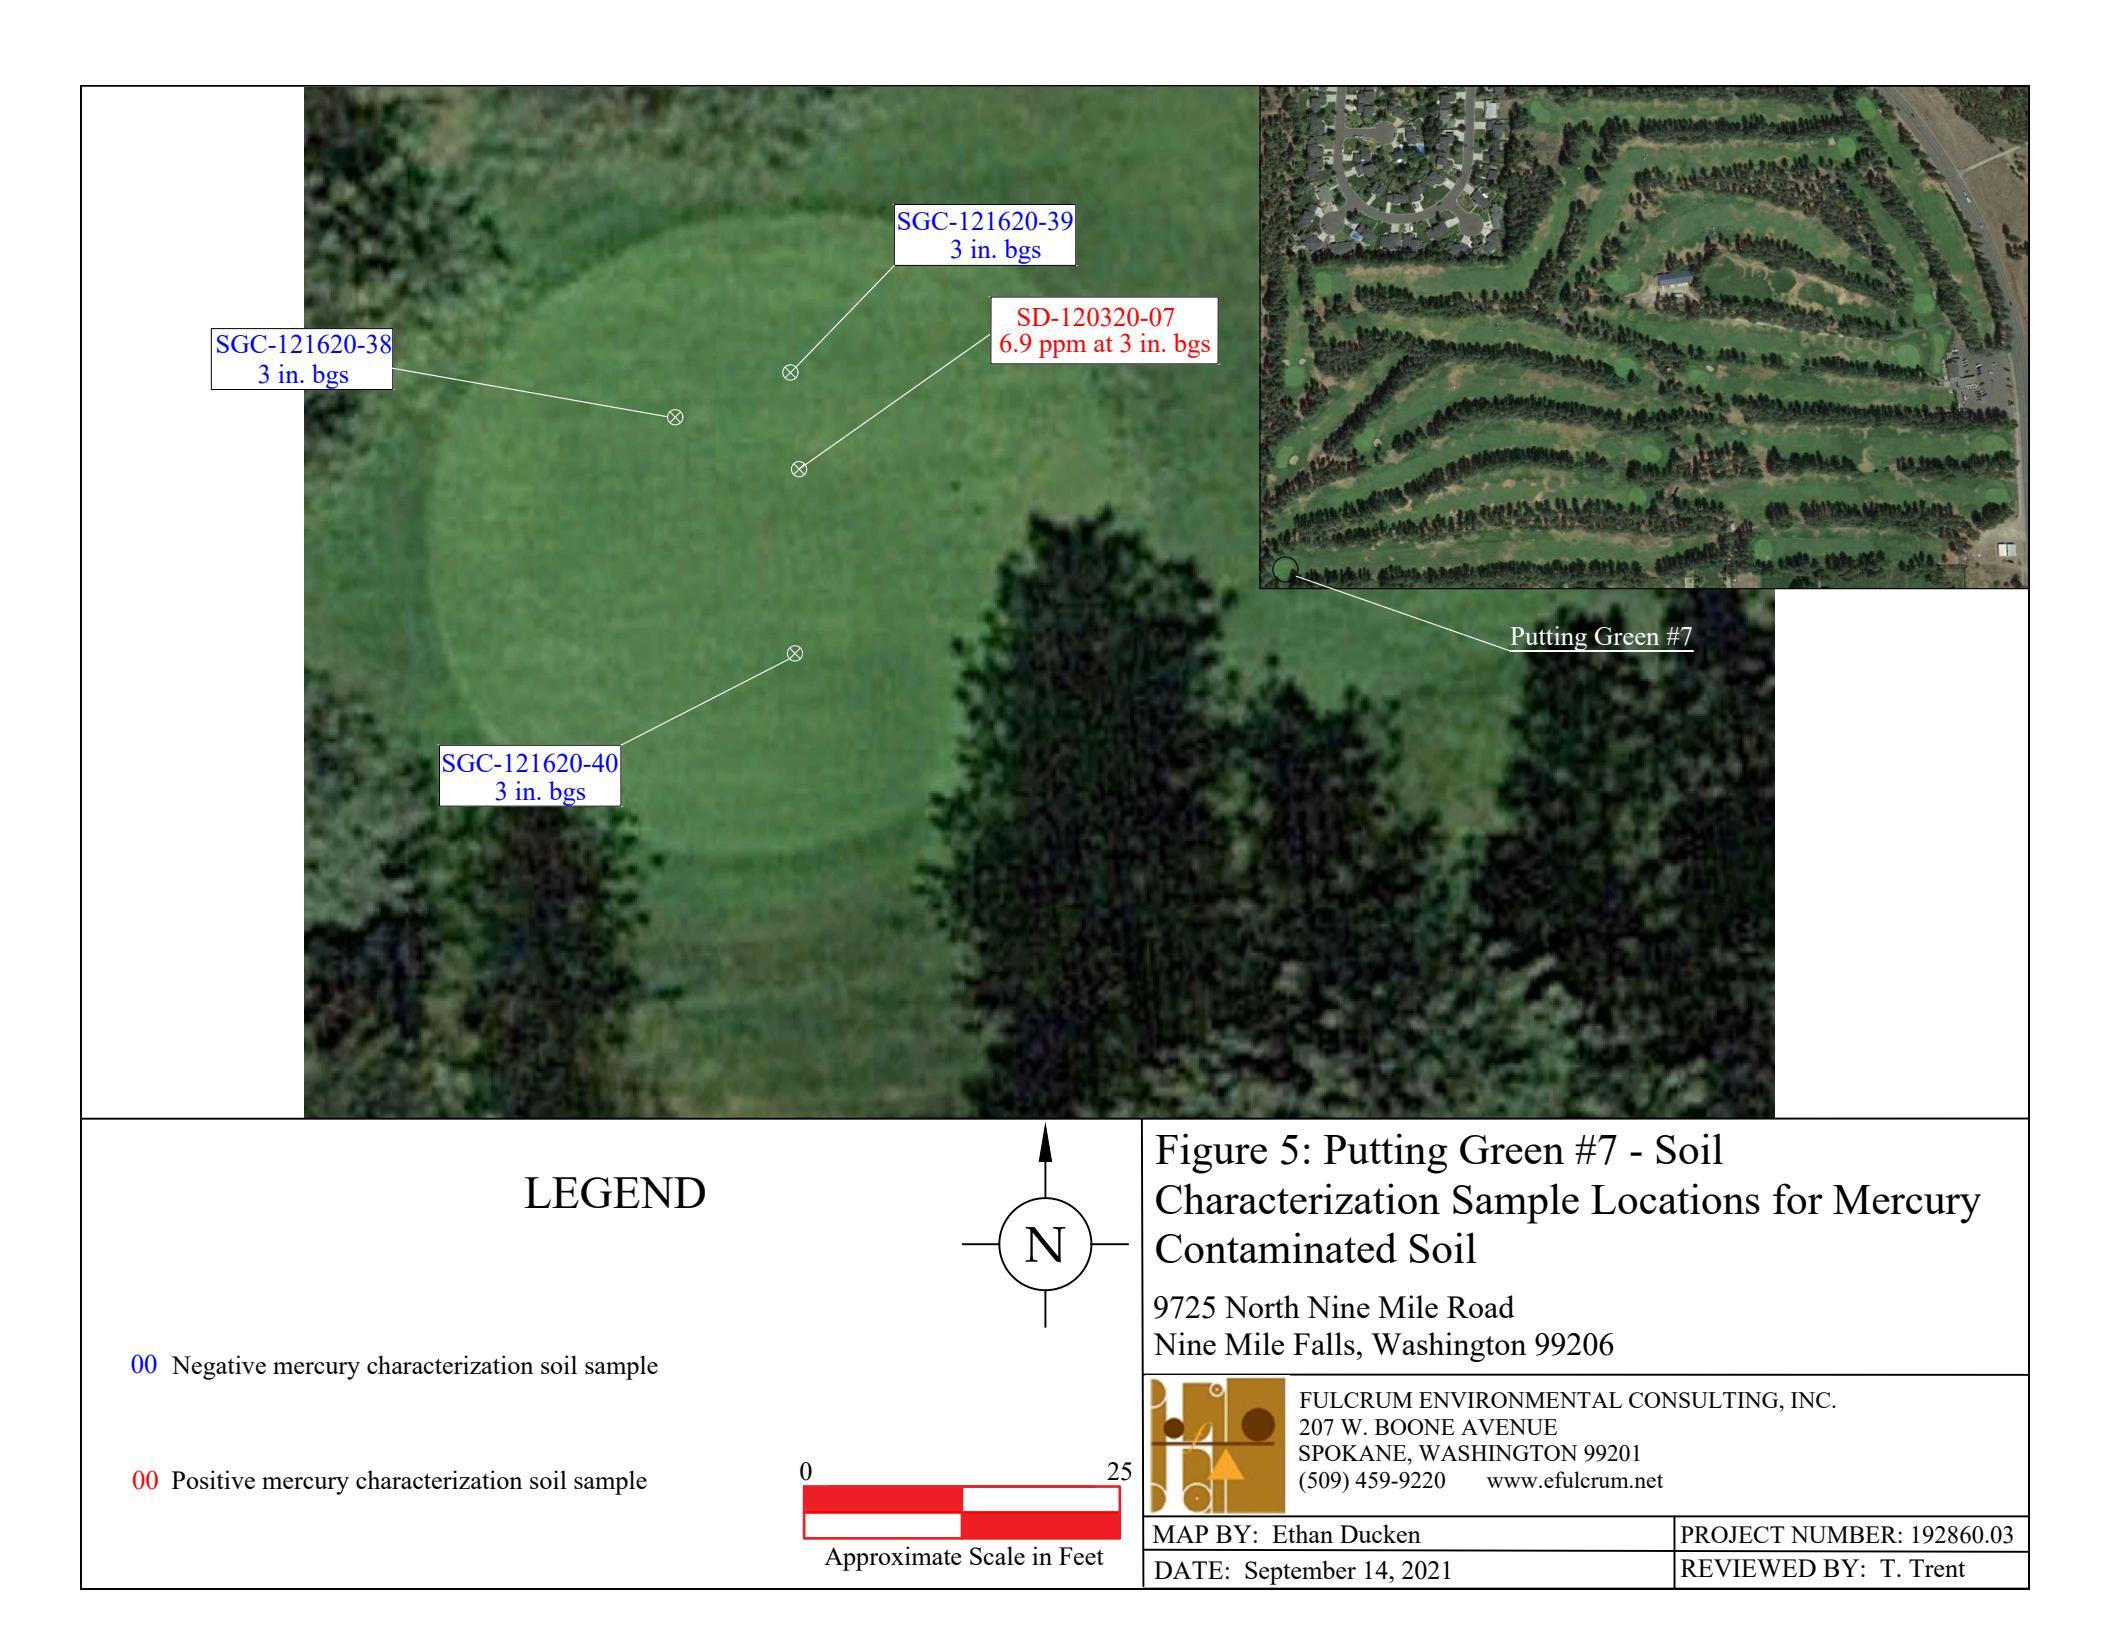
In response to concerns raised by neighbors regarding specific sample locations, Ecology requested soil sample location maps for putting greens and all soil sample coordinates for the site. The requested soil sample location maps from putting greens with detectable levels of mercury are presented in Attachment 1 and the soil sample coordinates are presented in Attachment 2.
